# *FORTUNA VILLA CONSERVATION MANAGEMENT PLAN REVIEW 2016*

PREPARED BY MINERVA HERITAGE FOR FORTUNA PTY LTD JUNE 2016

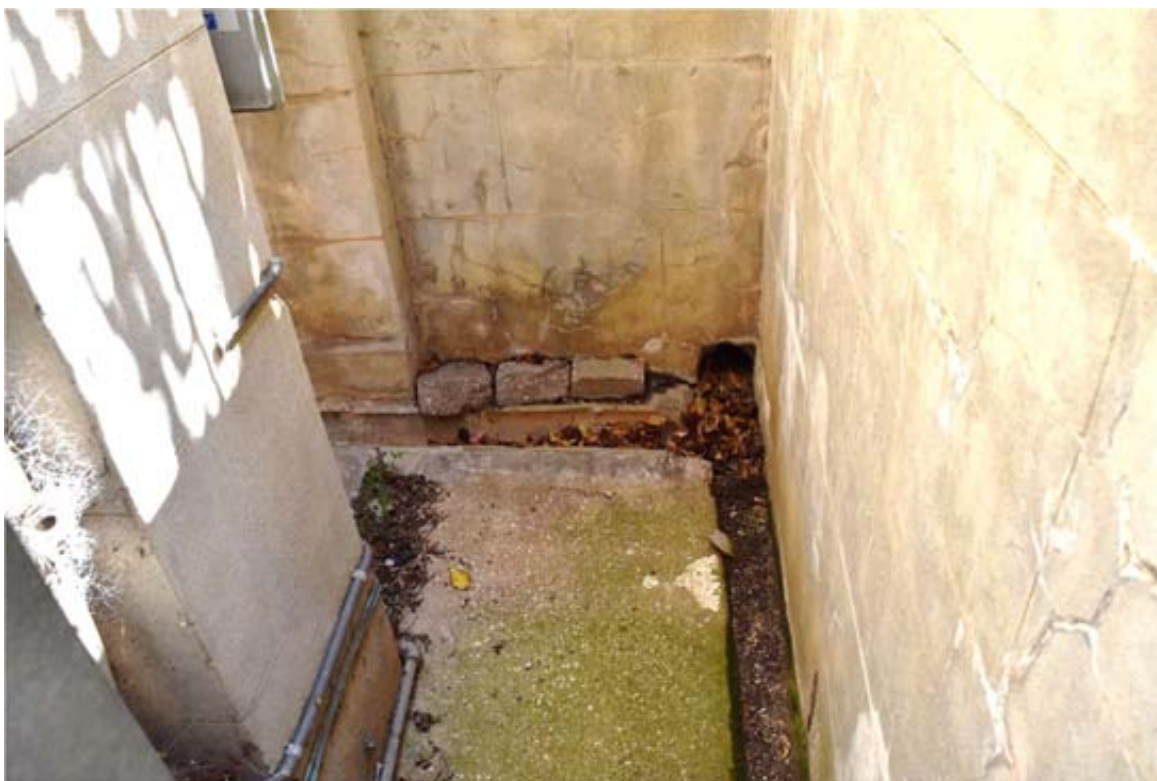
The ground surface between the west wall and rendered retaining wall, lower ground floor, is concreted with a small spoon drain discharging to a drain pipe leading towards the lake. This appears to be restricted.

*Figure 86: Lower Ground Floor drain.*

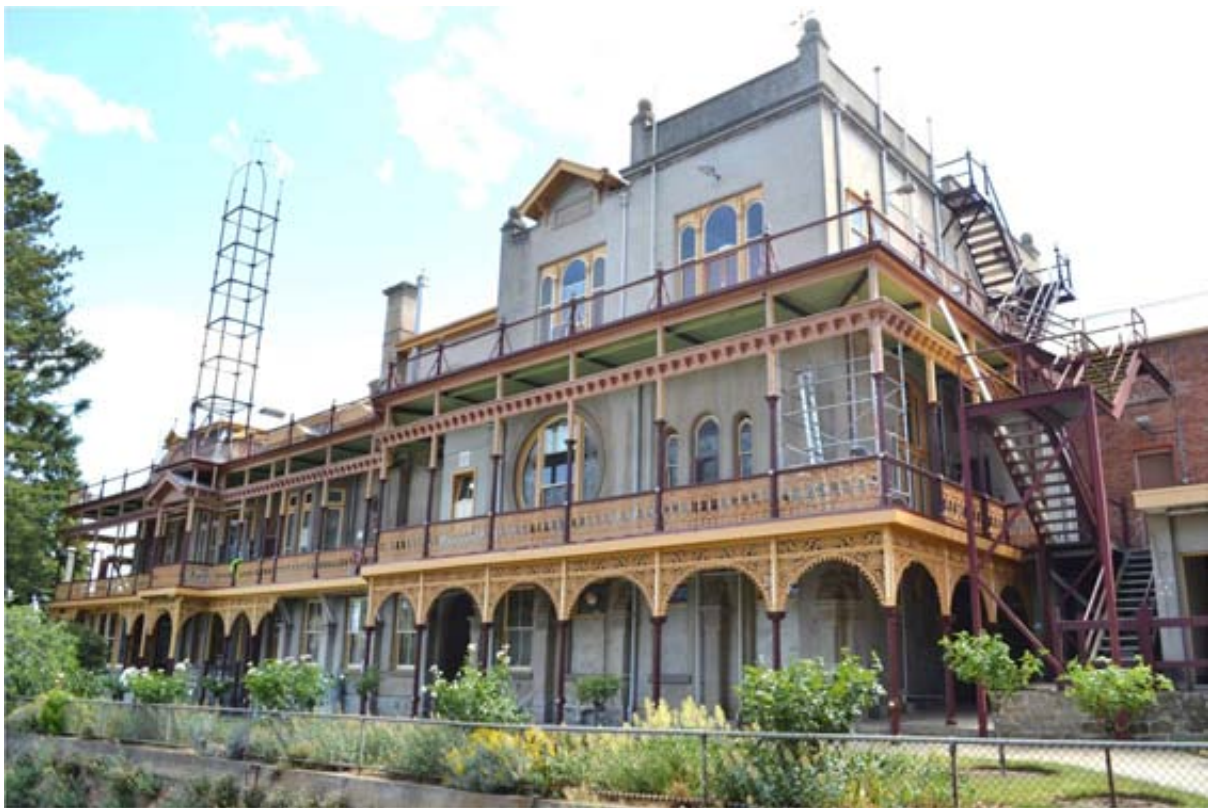
The cast iron lacework is currently being removed, sand blasted and powder coated over most of the building's verandahs. Some sections of damaged timber are being replaced as part of this process, however there are still some timber sections displaying damage which, subject to permit conditions or exemptions, should be conserved where possible or replaced if repair is not possible. A 2013 photo by the authors with all verandah iron in place is used above.

*Figure 100: East elevation, detail of north wing during renovation of verandah 2016*

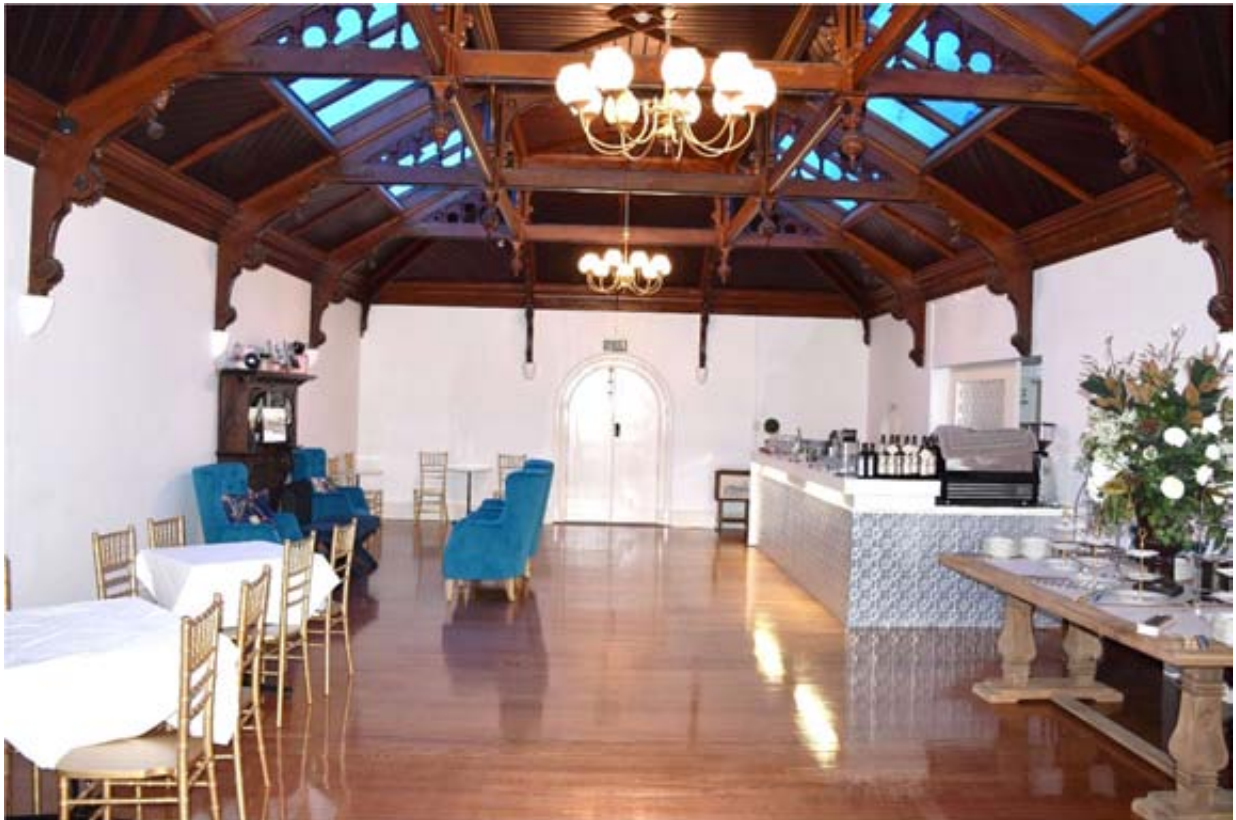
Room 4A, connection between Room 5 and the former shade house has, with the exception of the tiled concrete floor, been removed recently. The remaining floor should also be taken down to its original level.

*Figure 110: Room 5 former billiards room 2015*
