ALL SAINTS' ANGLICAN CHURCH,
SCHOOL AND MASTER'S RESIDENCE
BENDIGO

CONSERVATION MANAGEMENT PLAN

PREPARED BY MINERVA HERITAGE FOR THE
ANGLICAN DIOCESE OF BENDIGO

AUGUST 2012

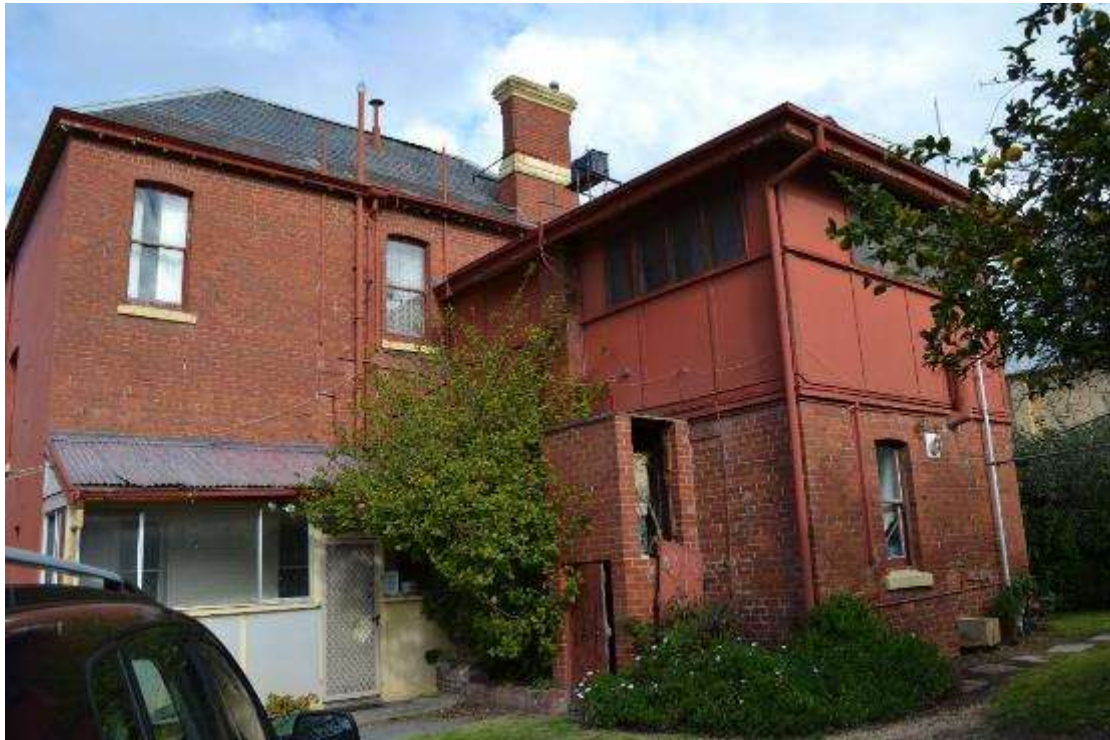
after 1924 as it does not appear in a photo taken in that year. It has been painted and should be inspected for condition and repaired or replaced as necessary. The roof space has not been inspected, but there is evidence of current water damage to the ceiling in the upper room. The guttering and downpipes should be replaced.

Figure 79 Rear of the Master's Residence

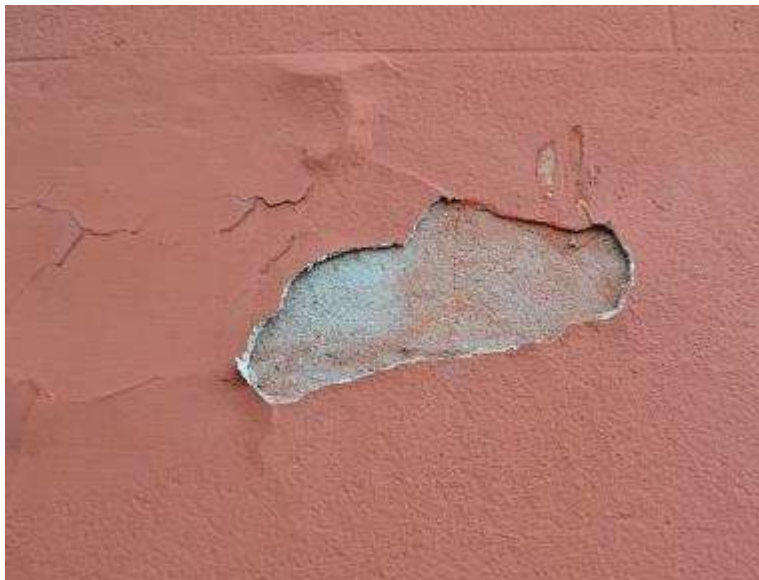
The north wall has been rendered for some time, and the render is being damaged by damp. There are several coats of impermeable paint over the ashlar grooved render, and these are lifting, pulling away some of the topcoat over the damp damaged areas. After the guttering has been replaced, the wall should have all paint removed and be re-rendered where necessary, reinstating the original pattern in the ashlar, which should be recorded and measured before removal of any render. The render has been painted white in the past and currently brick red (Figure 80). New lime based topcoat should be used. It should be repainted in an appropriate traditional limewash paint to allow the walls to breathe. The brick- red colour should be retained.

Figure 80 Paint lifting from render on the north wall of the Master's Residence

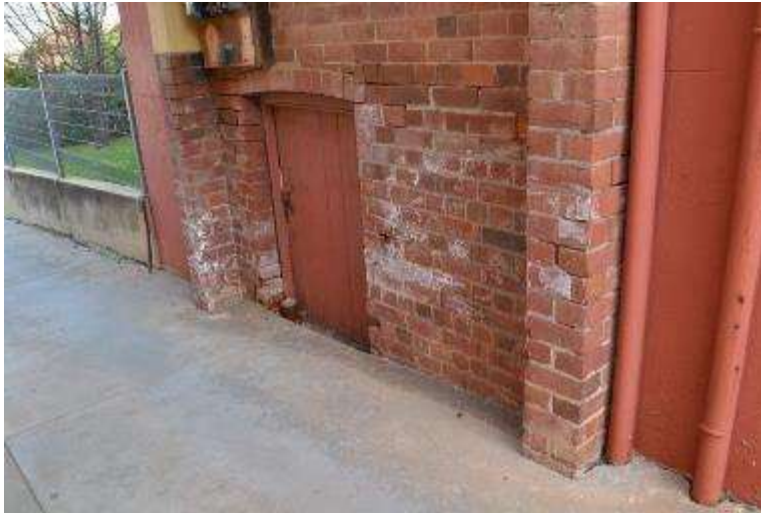
There is an area of significant fretting of both mortar and bricks around the small door to the under floor space which is situated under the Gothic Arch between the residence and school (Figure 81).

Figure 81 Salt damp causing fretting of mortar and bricks under the Gothic archway.

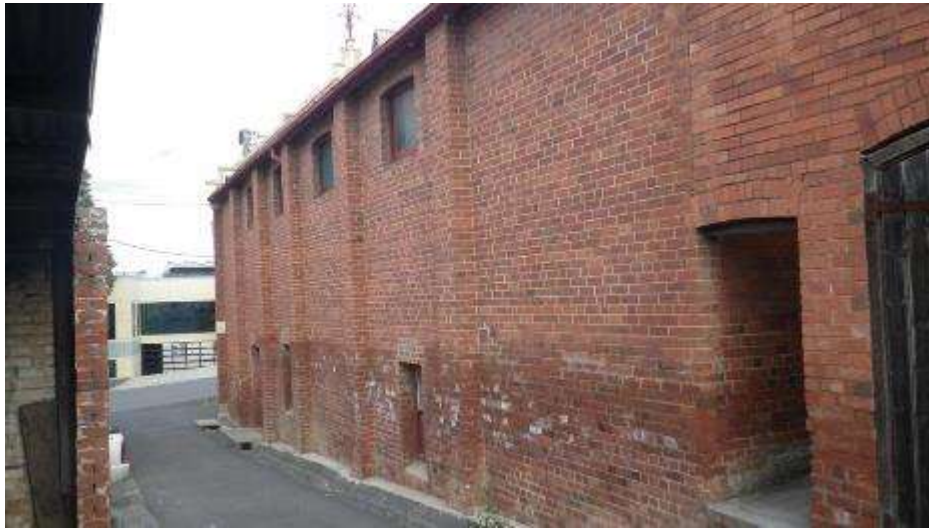
Overall the exterior walls are in good condition, however there are areas of significant rising damp. The kitchen wall has been mentioned earlier, but there is a large damp area along the length of the northern wall adjoining View Lane to the approximate height of the basement ceiling (Figure 100). There is a minimal amount of surface salt apparent. There have been drainage problems in this area for many years prior to the recent removal of a large brick retaining wall on View Lane which used to be part of the tennis courts, now the car park. This used to direct water along the walls of the school and has caused water several inches deep to flood the basement at times. This has been relieved by the removal of the retaining wall and improvements to the drainage.

Figure 100 Side wall of the School from View Lane.

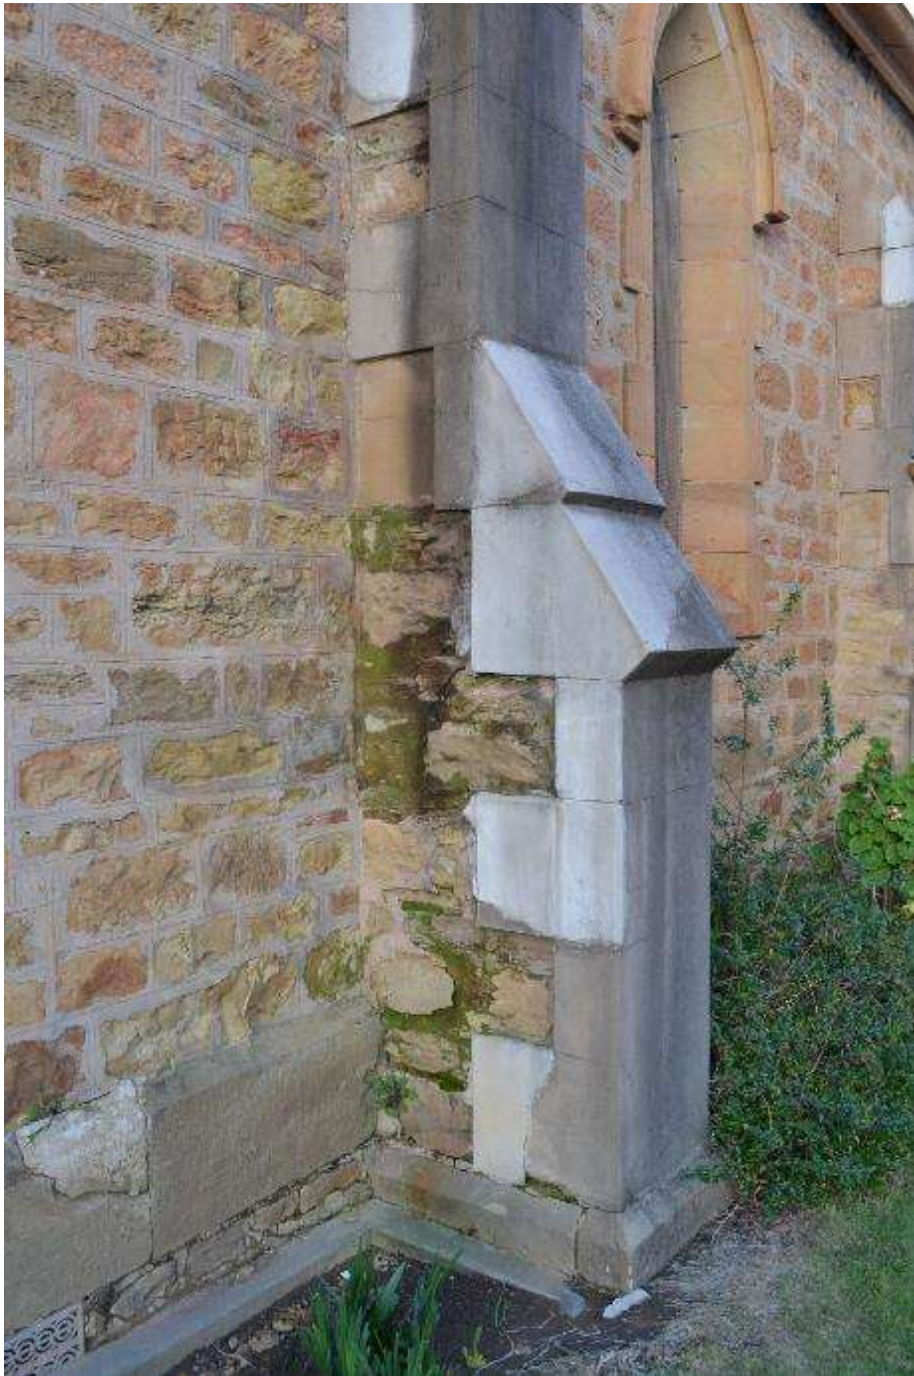
Figure 135 Falling damp from rusted out gutters is causing deterioration in the stone.
