ALL SAINTS' ANGLICAN CHURCH,
SCHOOL AND MASTER'S RESIDENCE
BENDIGO

CONSERVATION MANAGEMENT PLAN

PREPARED BY MINERVA HERITAGE FOR THE
ANGLICAN DIOCESE OF BENDIGO

AUGUST 2012

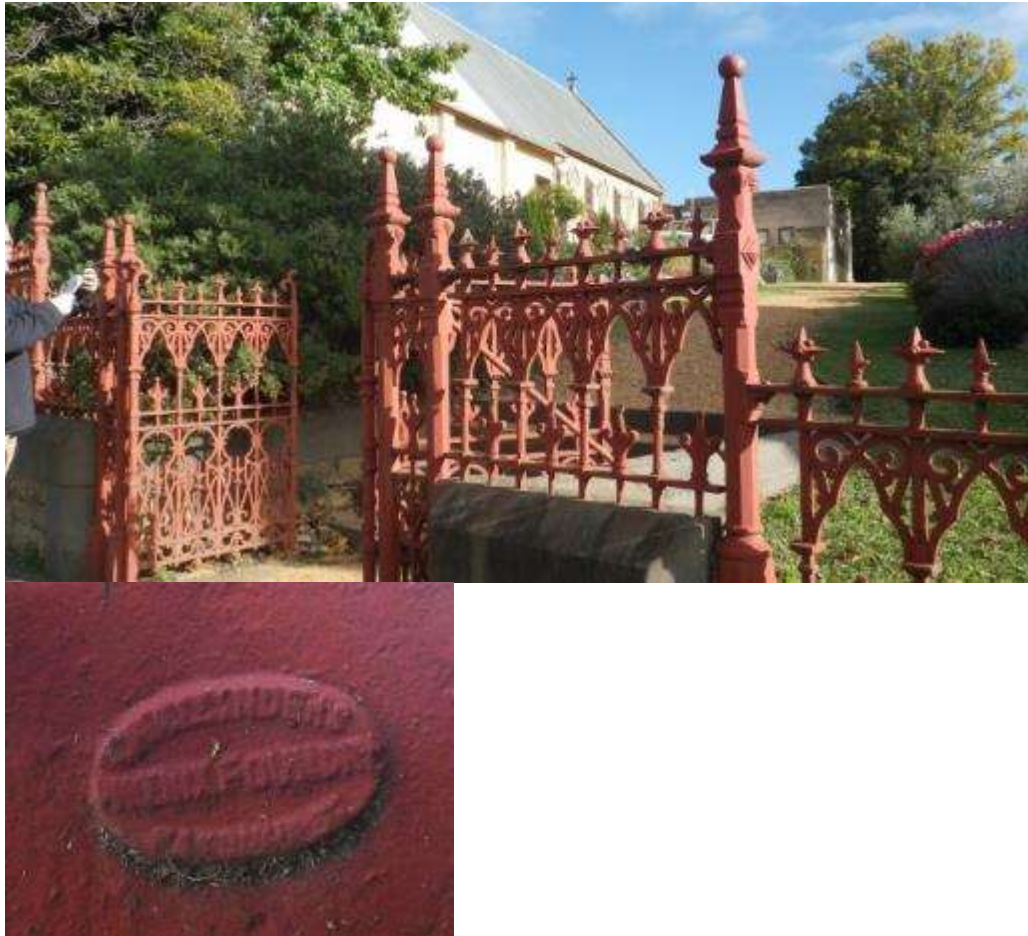
The base of the fence is of Malmsbury bluestone, and the fence is in good condition.

Vahland was responsible for the design of a number of notable iron palisade fences in Bendigo. A stone post at each end of the fence was a feature of every fence Vahland designed. The All Saints' fence and gates are intact, apart from a couple of missing spear points. All of Vahland's fences are of a different pattern.

**Figure 72 (Top) W C Vahland designed fence with Malmsbury stone plinth,
cast at Challinders Phoenix Foundry. Challinders Phoenix Foundry mark (below)**

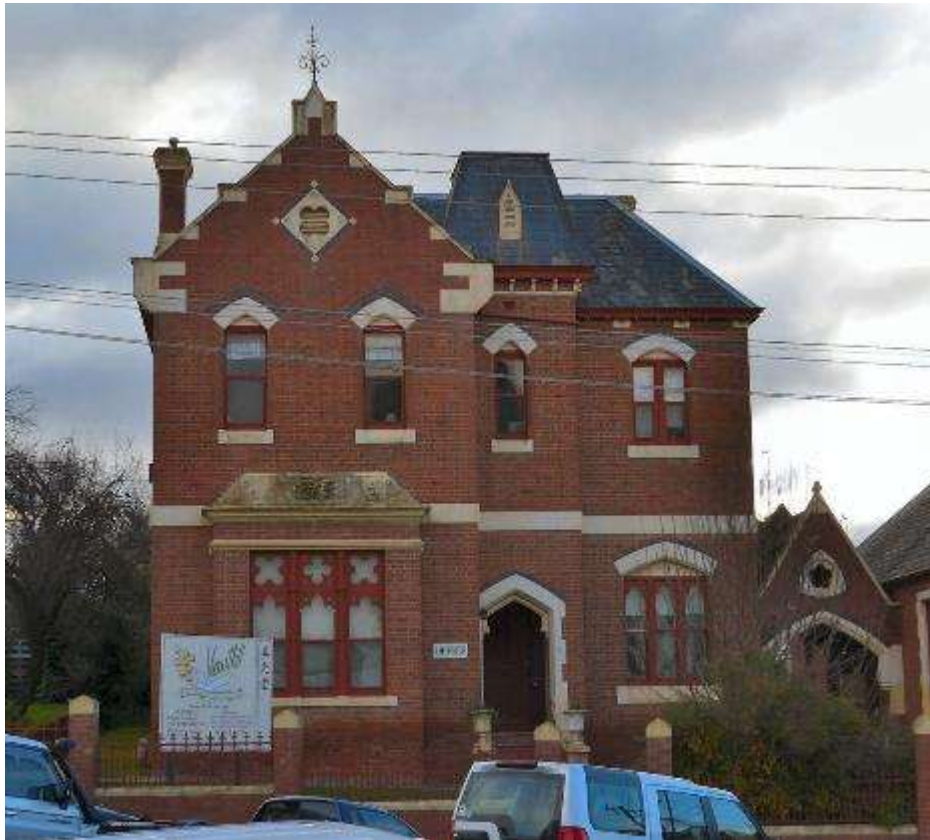
Figure 75 Schoolmaster's Residence

The brickwork is in sound condition, although there is some rising damp below floor level, with some fretting of mortar. The double hung windows and Gothic decorative elements are intact. The paint is deteriorating on windows and stucco over the bay window. The stucco should be inspected, cleaned and repainted in a colour to match the Barrabool stone. The Barrabool stone elements have been painted. Consideration should be given to removing the paint from the stone and cleaning it to return the façade to the appearance intended by the architect, as the current cream colour makes too harsh a contrast with bricks, as can be seen from early photos of the building.

Fill has also been added to the front yard of the residence to the height of the brick wall of the fence. This has allowed water to be retained at the base of the front wall causing, as can be clearly observed in Figure 75, rising damp to be observed in the wall almost to the height of the window sill. This inappropriate fill has been extended to a cement retaining wall at the edge of the concrete driveway and repeated in the currently grassed area in front of the southern front school room as well.

All added fill and hard surfaces installed above dampcourses, or the logical position of a dampcourse, should be removed to the original level. All later fill (see Figure 87 for reference), from the front of the residence and school should be removed to the level of the footpath outside the fence to re-establish the slope from the residence to the front fence, and the surface shaped to run water away from the structures. Weep holes must be made in the fence to prevent the damming of water against the fence.

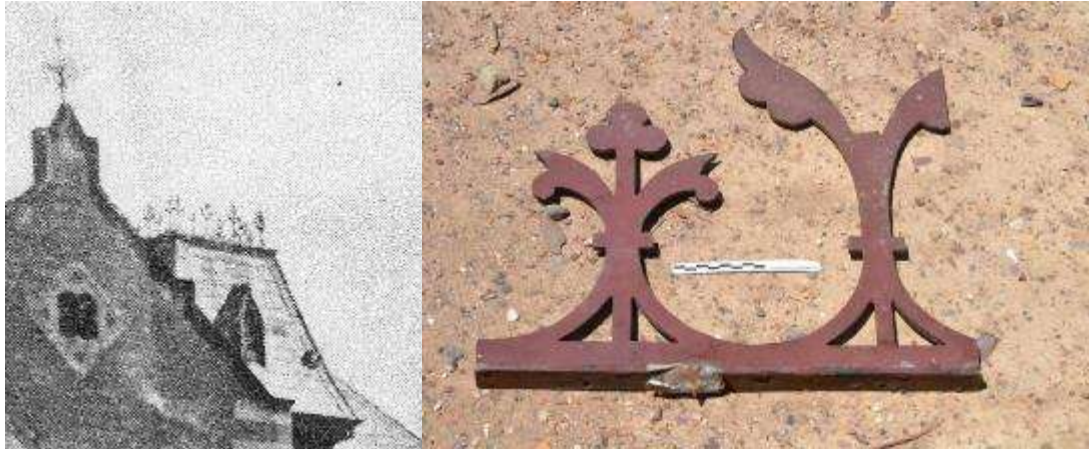
Figure 76 Early photo of Mansard roof with cresting, remnant at right.

The tower has a mansard roof of slate with a prominent gabled roof vent and bracketed eaves with decorative air vents in the soffit. The original iron cresting seen in early photographs is no longer in place, however a piece was discovered during inspection of the roof space which can be used to replicate the original pattern, and reinstate it.

Missing external elements such as the cresting from the mansard roof and finial on the spire should be replaced with originals where possible, reproductions using original samples (as exist with the cresting Figure 76), photographs and catalogues may be used if originals are not available.

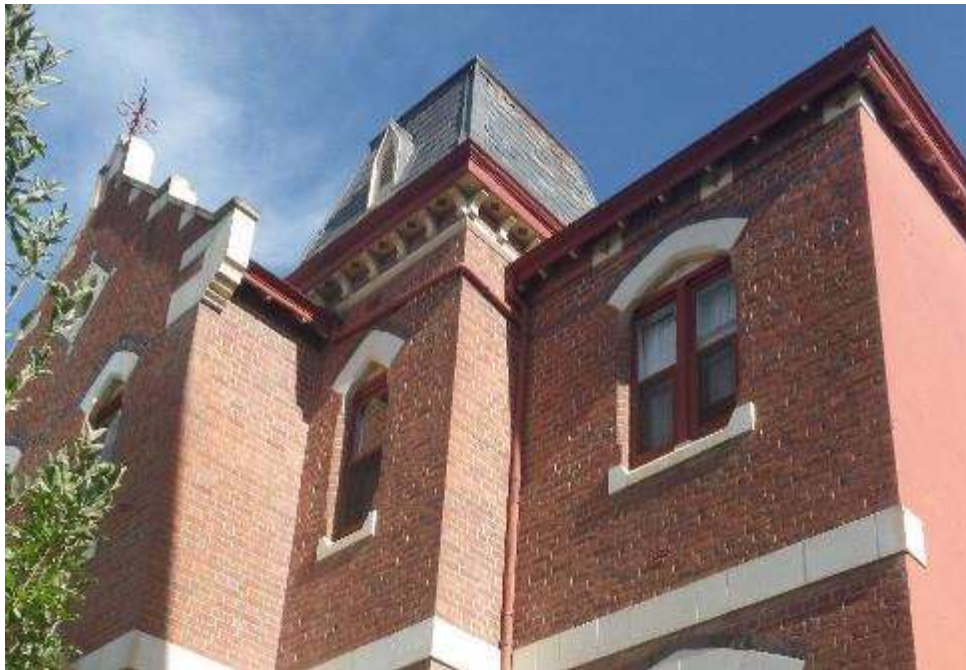
Figure 77 Mansard roof, front wall and finial, Master's Residence

The finial on the gable is present (Figure 77).

The roof of the tower is lined with timber, which is sound. The gabled roof vent is in good condition. The ridge capping to the mansard roof has a decorative pattern on the lower edge.

The downpipes and gutters are blocked, resulting in falling damp which has been causing problems for some time in the area of the tower. The guttering and downpipe on the short wall between the gable end and the front of the tower is causing falling damp in the adjacent wall

The decorative copper ridge capping and slates on the tower may also have shifted, allowing ingress of water. The mansard roof is currently dry inside but has been wet in the past. The ogee guttering has a moulding running along the bottom edge at the fascia which is coming loose and deteriorating. All of the guttering on this building needs replacing with galvanised ogee guttering. The downpipes should be cleared and replaced with new galvanised iron if necessary. The Cast iron downpipes are to be retained if possible. Damaged rainheads should be retained if possible or replaced with a suitable replacement.

The main roof was initially all clad with slate. The valley is currently roofed with galvanised corrugated iron. The whole roof should be inspected, and checked for nail fatigue, and dislodged, damaged and deteriorated slates, which should be reaffixed, or replaced if necessary by a competent slater. The corrugated iron sheets and fixings and all flashings should be inspected at the same time. The galvanised iron ridge capping at the back of the roof has lifted and should be repaired as a priority. Several slates have slipped and caused holes in the roof which may be seen from inside the roof space. Inspection has shown the rafters and battens to be in good condition.

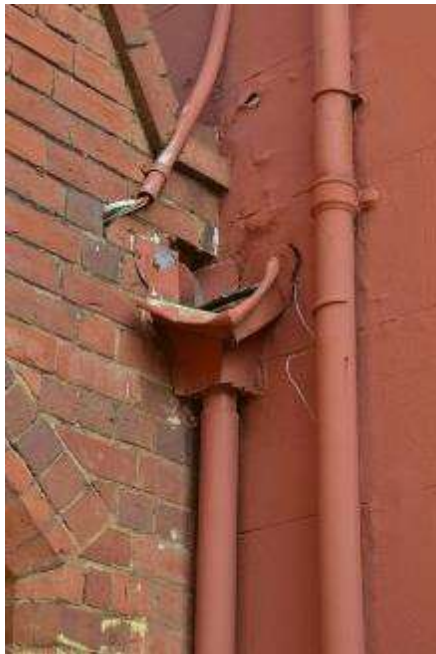
The rear wall at the top of the archway shows fretting of mortar and cracks which should be repaired using lime mortar.

Figure 82 Blocked box gutters and downpipes, broken rain head and delaminating render

This should be repaired using lime mortar after the underlying cause of the damp has been addressed. The concrete of the driveway is higher than the original level and this contributes to rising damp. The front garden has been built up above the dampcourse. Water from the driveway can run down through the doorway to the base of the wall and under the house. Falling damp from damaged flashing, blocked downpipes and dislodged rain heads on the archway is contributing to the problem (Figure 82). There is a small box gutter along both sides of the arch which discharge into the rain heads and downpipes. Corrugated roofing iron, rain heads, box gutters and downpipes on the archway should be replaced using galvanised elements matching the original.

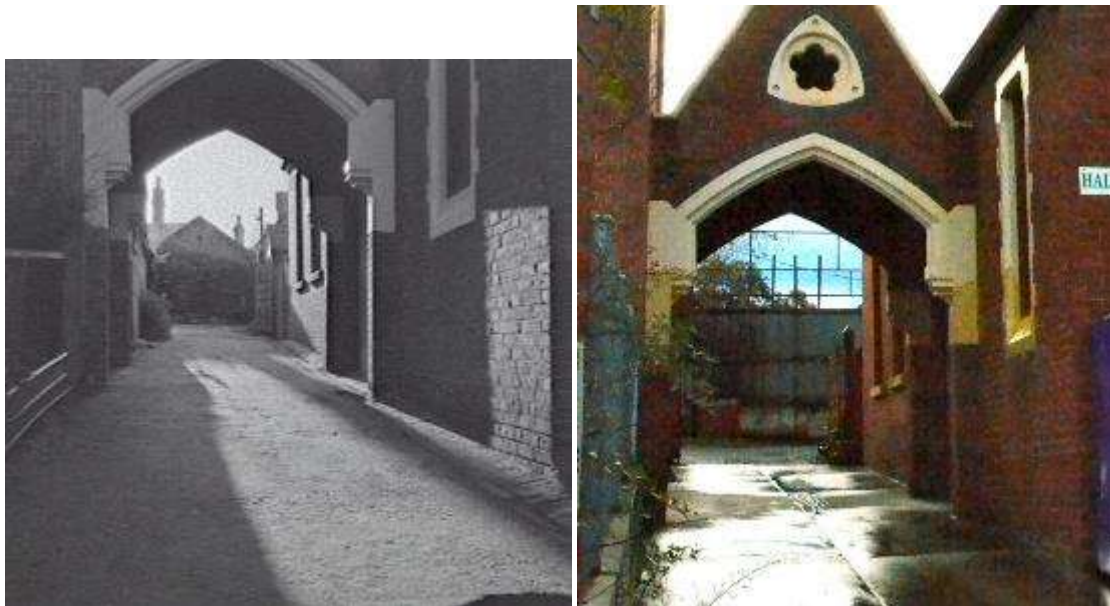
The driveway between the two buildings was originally at a lower level and has been built up by up to 500 mm with fill and concrete. Early sewer pipes and plumbing can be seen disappearing into the concrete and obviously predate it. This has caused problems with rising damp in the adjacent walls in both the Master's Residence and School, as it has been built up higher than the bitumenised sand dampcourse at the back of the former class room, now staff kitchen area, leading to significant rising damp in the wall and dry rot in the floor in the corresponding corner inside. The driveway (Figure 83) should be reinstated at a lower level and slope to a drain in the centre to keep water away from the walls and conduct it to a legal discharge point. After these drainage problems have been addressed repairs to mortar using inappropriate cement material should be replaced with lime based mortar matching the original. All fretted original mortar should be repointed using the same material. Fretted bricks should be replaced by bricks of the same type.

Figure 83 Left: The driveway in the 1950s with the Parsonage in the background.

Photo: Doney Collection, National Trust of Australia (Victoria) Bendigo and District Branch
Right: The driveway today. The level of the concrete is higher and the level of infill for the tennis courts behind can be seen.

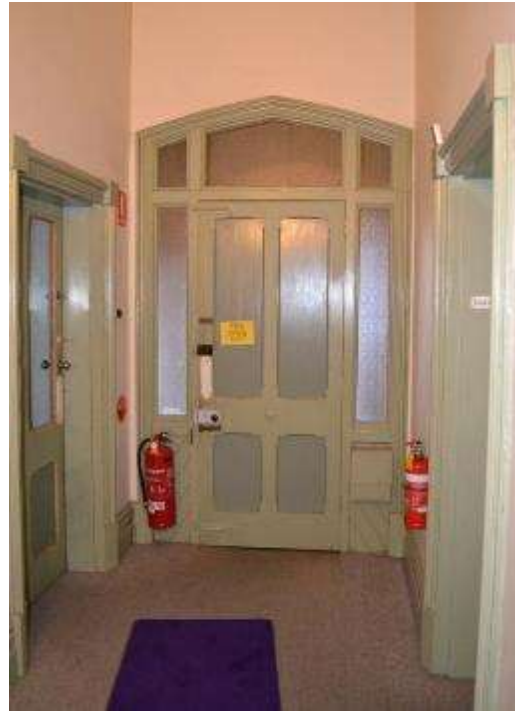
Figure 85 The front hall in the Master's Residence with original joinery

All original joinery and fittings survive in good condition (Figure 85) on both levels, although there has been some reversible damage to the internal doors by the insertion of glass panels and new locks. Some original rim locks survive. The plaster is in good condition in general, with some minor cracks in the ceiling in several rooms. Only the front hall and largest two downstairs rooms have cornices. These show minor repairable horizontal cracks and several small missing pieces, but are generally sound. These cracks should be repaired and missing pieces should be reinstated.

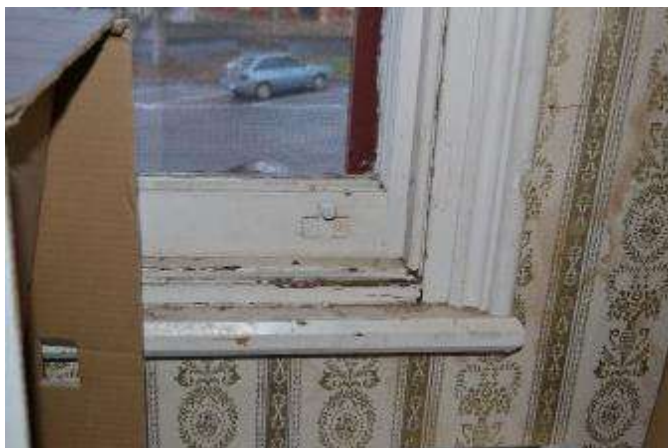
Figure 89 Damage from falling damp in the small tower room.

The small room in the tower above the porch shows evidence of the ingress of water in both the ceiling and particularly the front wall (Figure 89). The room has been wallpapered at some stage. This is lifting from the wall, which feels damp behind it. There is repairable water damage to the window frame, sill and lower sash. This water damage has been caused by the overflow from the blocked gutter and downpipe adjacent to the wall over period of time.

This has possibly also caused damage to the wall adjacent in the upstairs front room next door, as there is a panel of chipboard screwed to the wall, which may conceal damage. This has not been investigated, as it would require removal of the panel. Evidence of water flowing down the outside of this wall can be seen from the window in the small tower room.

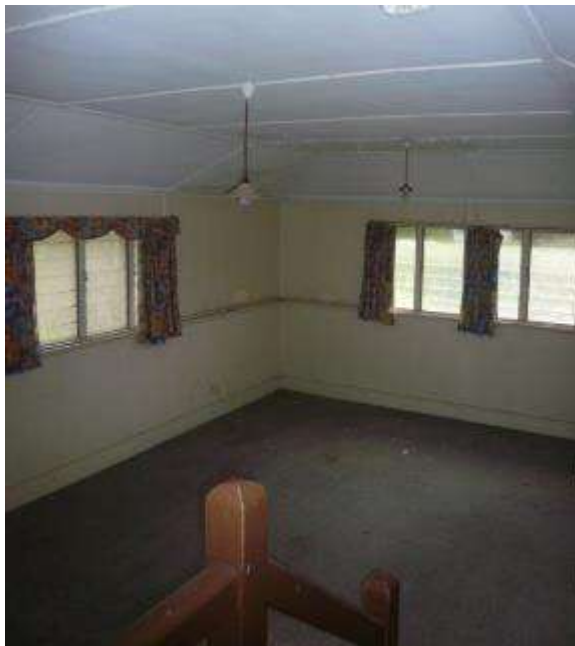
This room is accessed from the upstairs level via the corridor and four steps. The floor is carpeted. It has a coved ceiling of fibrous plaster with joins covered by battens. There is evidence of water damage to the ceiling in this room with staining and flaking of paint. This room has louvre windows, which are probably original to this 1930s addition. The lower half of the wall is lined with fibrous plaster, and the upper half between the windows is of Masonite, probably in combination with fibro asbestos cement. This is currently covered in paint in reasonable condition (Figure 93).

Figure 93 Added room over the kitchen area.

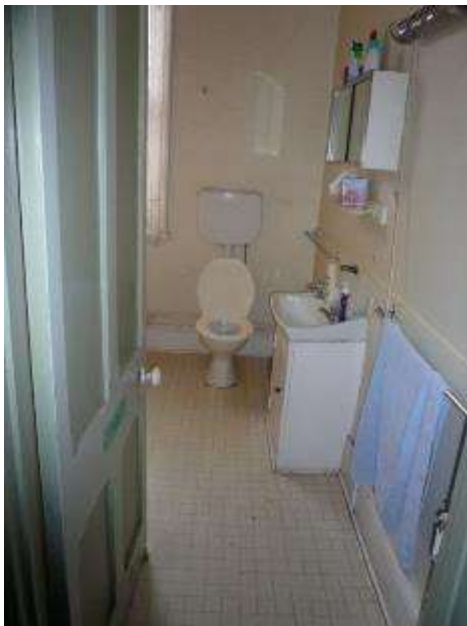
There has been a problem with leaking water, as mentioned earlier, and there is evidence of damp in the room next door on the lower part of the wall adjoining the bathroom. There is a disused shower recess accessed from the corridor protruding into the bathroom. This should be removed and the bathroom plumbing lines made good. It has its original window.

Figure 95 The bathroom.

The old galvanised iron water pipes penetrating the back wall of the bathroom are severely rusted and have been leaking, and are in imminent danger of failing. These should be replaced urgently. There may also be water leaking from the pipes at the back of the hand basin contributing to damp in the room next door. This should be investigated and repaired.

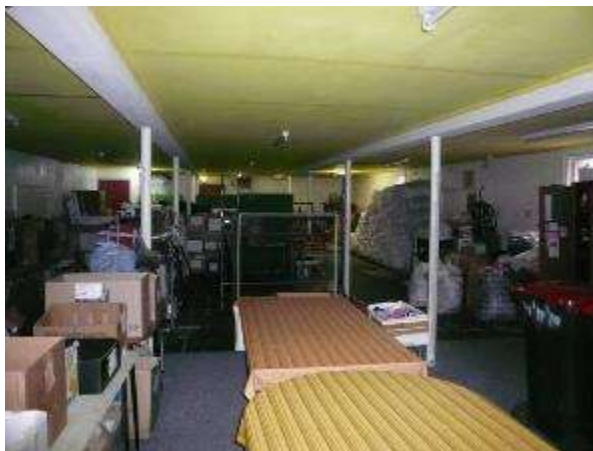
The wall may continue to slowly dry out without further intervention, especially if ventilation can be improved in the basement by removing the battens holding the windows shut. These should be opened as often as possible when the basement is in use. It is currently used for storage and sorting material for the Op-shop in the large schoolroom above (Figure 101). Security screens could be inserted for the peace of mind of volunteer staff+.

Figure 101 The Basement

The damp course may have failed and should be examined with a view to identifying problem areas. There is also some evidence of damp internally on the access stairs from the schoolroom and the northern wall of the basement.

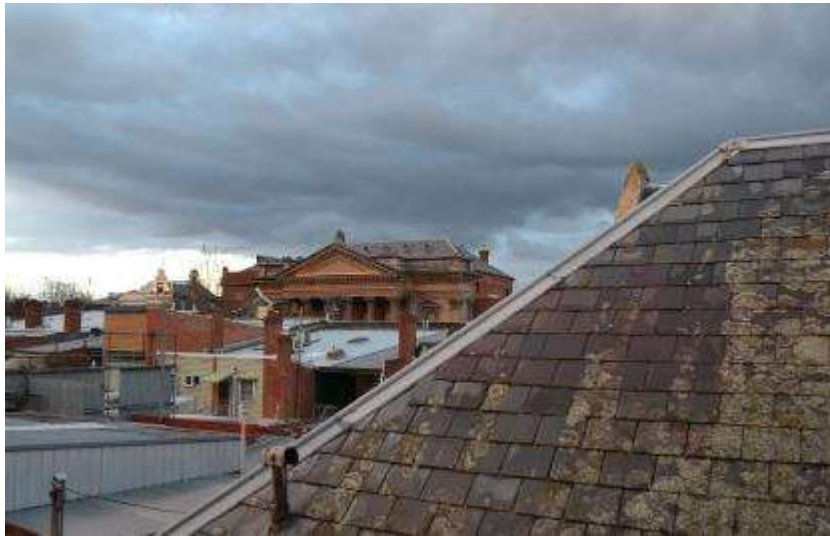
The entire roof was originally clad with slate, but one side has been replaced by corrugated iron which appears to be in good condition. The slates should be inspected for slipping, deterioration and damage, along with ridge capping and flashing to parapeted gables and chimney. There is some lichen growing on the southern side of the slate roof. This should be removed (Figure 103).

Figure 103 The classroom roof, with rear of View Street shops and Capital Theatre in the background.

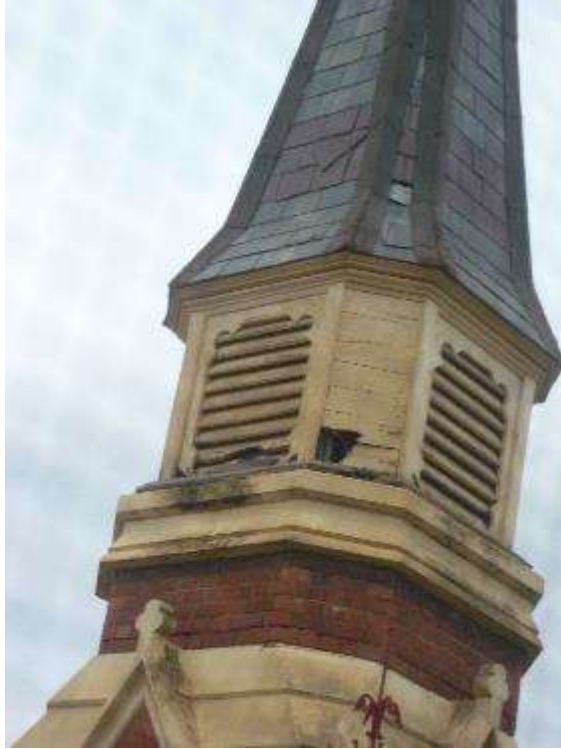
Figure 108 The belfry.

There are several slipped slates on the spire, windows need reglazing, and repairs are needed to the wooden elements of the belfry (Figure 108). Efforts should be made to keep out the pigeons which have been nesting inside. The external wood work needs to be cleaned back, repaired and repainted. The cast iron finial seen in early photos is missing, but a replacement should be made using an existing one from the small gable as a pattern.

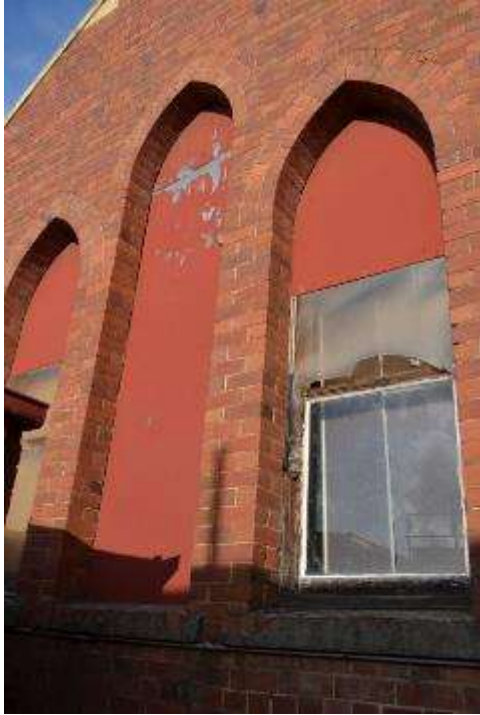
The area behind the stage is now used as a storeroom. The end wall here contains three large lancet windows in poor condition. The centre window has been blocked off with sheet galvanised iron, and the others partially blocked with the same material and Perspex (Figure 109). These should be repaired as soon as possible. A door and new brickwork have been put into the back wall.

Figure 109 Rear of the Schoolroom.

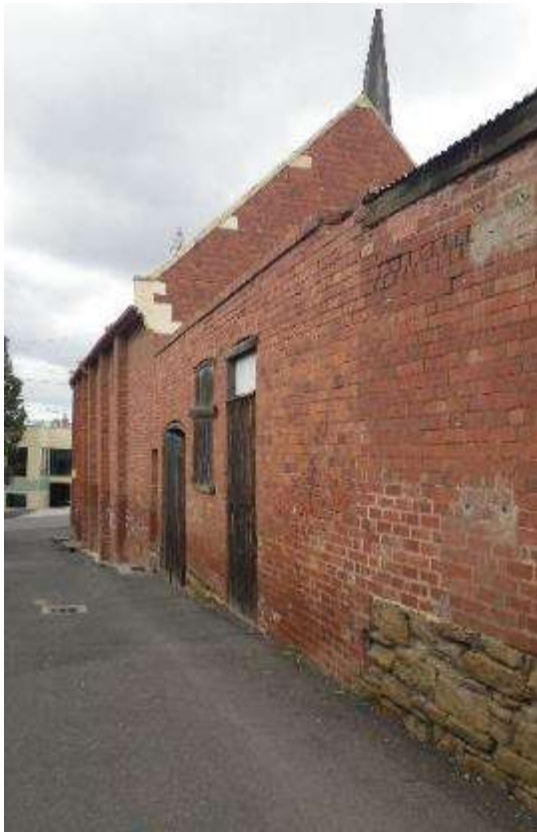
The toilets on the western end of the stables were probably associated with the school and appear to predate the connection to the sewerage system. They appear to include the base of a stone wall or foundations of an earlier building (possibly related to the Old Parsonage) as can be seen in Figure 117. They were originally fitted with openings at the rear of the cubicles to facilitate the removal of full cans, and the position of these openings can still be seen by the fact that they have been bricked up (Figure 118). Repairs have been made over time to the north wall of the toilet block. These toilets appear to be functional. The original cubicles remain. A stainless steel urinal has been added to the older cubicles and may replace an older one.

Figure 117 Old toilet block and stables next to the School in View Lane

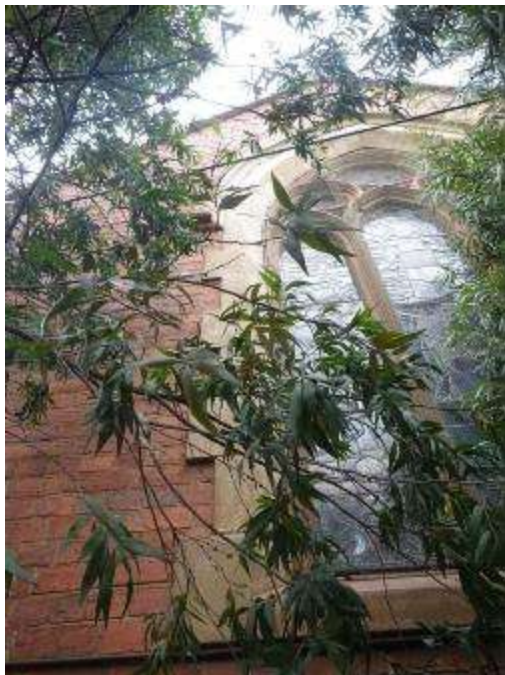
The large window is faced with stone and has a hood moulding also of stone, which has an area of deterioration. The bar tracery in the window shows evidence of loss of mortar and movement and should be attended to before damage to the stained glass window by William Montgomery occurs. These works should be carried out by a competent stonemason. The window should also be inspected by a stained glass expert as a small amount of displacement of lead comes can be seen.

Figure 120 The exterior of the chancel window by William Montgomery.

A large Weeping Bottlebrush and shrubs growing against the wall should be removed as they are contributing to the damp problems, and causing damage to the stained glass window by staining from leaves, flowers and sooty mould. Inspection of the wall, the

stone, the dampcourse and the window should be carried out after the tree and other shrubs have been removed, and action taken to remediate any problems.

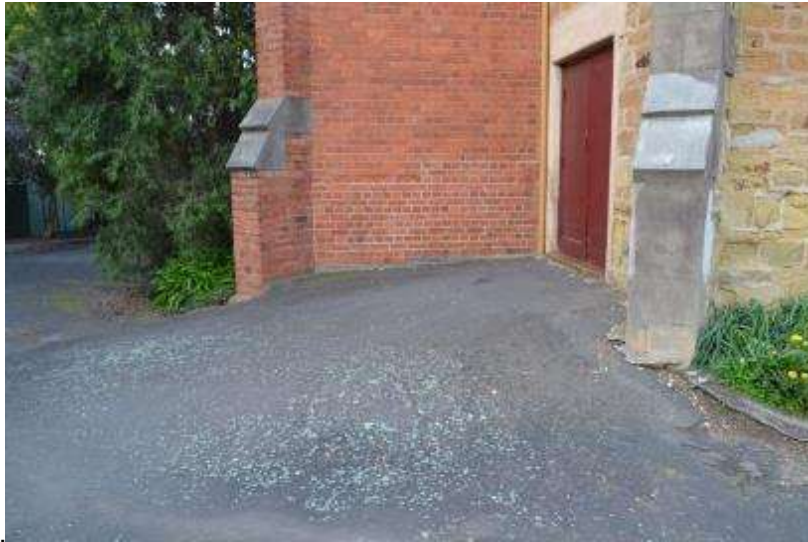
The damp problem in this wall is caused by the building up of the ground level at the northern side of the chancel. This has raised the ground level to well above the damp course level (Figure 121).

Figure 121 Raised ground level at the entry porch.

The ground level has been built up against the brick wall of the chancel to allow disabled entry. This should be taken down to the original ground level as it causes rising damp in both the entry porch and the chancel walls. A freestanding ramp away from the wall may then be placed for disabled access.

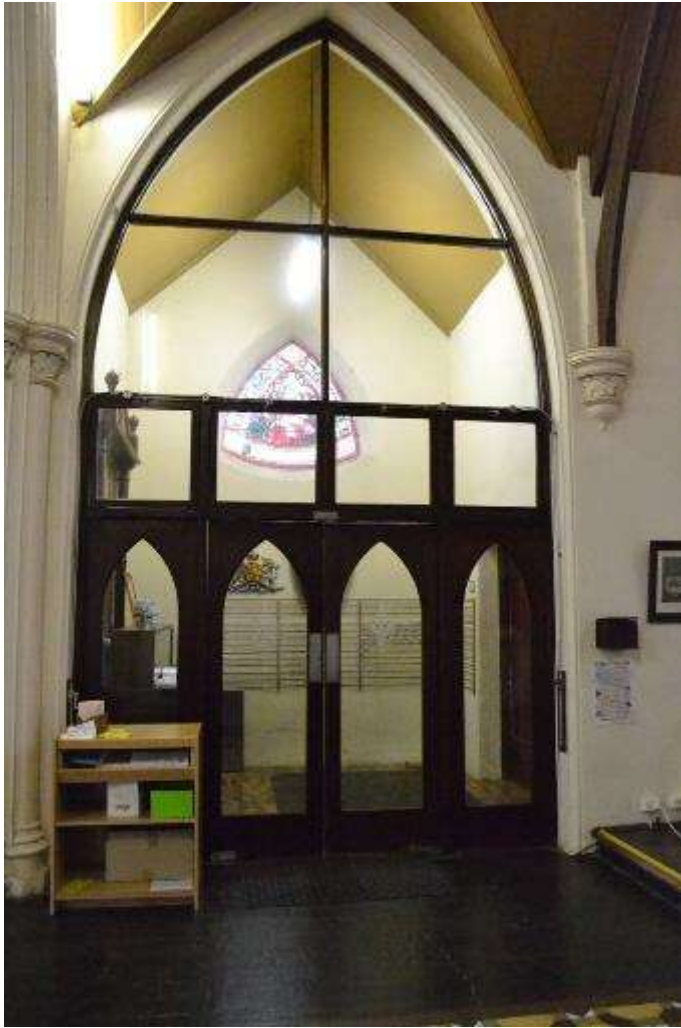
Figure 123 View of original Organ Chamber from the Chancel.

The interior (Figure 123) is generally in good condition apart from erosion due to damp at the very bottom of the west wall, and some cracks around the top of the window, probably associated with the movement of the bar tracery visible from outside.

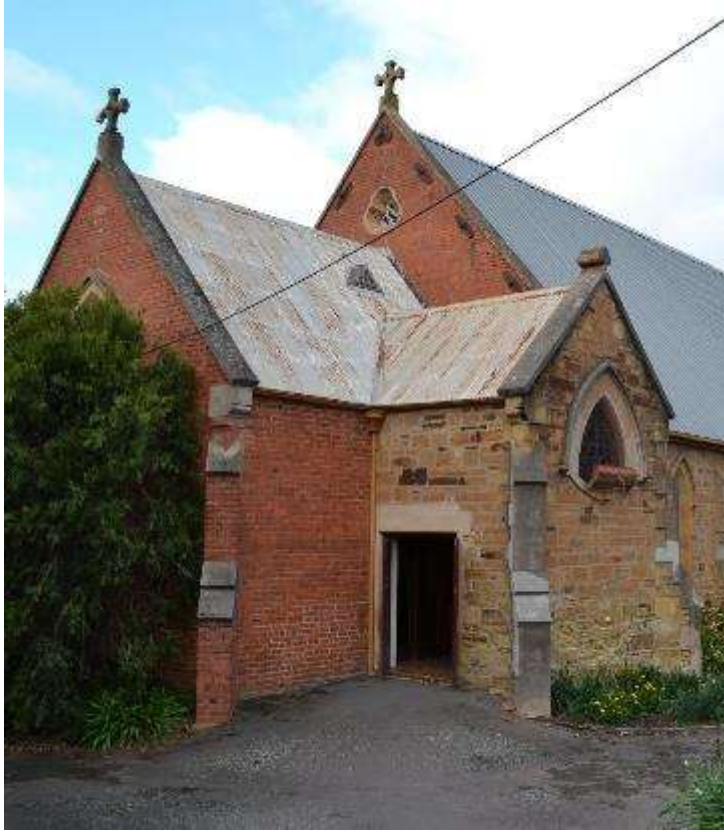
A stone porch, formerly the organ chamber, is attached to the northern side of the chancel (Figure 124). It is constructed of local Ordovician stone, with a corrugated galvanised iron roof which joins the chancel roof at right angles, and appears to be of the same age and condition. This roof should be treated as part of the chancel roof. The gable is parapeted with a stucco cap and cross, similar to that on the chancel.

Outside there is some fretting and deterioration of the stone walls, exacerbated by the raised ground level. The corner buttress, in common with all stone buttresses on the church, has been repaired several times with concrete.

Figure 124 The western end of the church, with red brick chancel and original organ chamber.

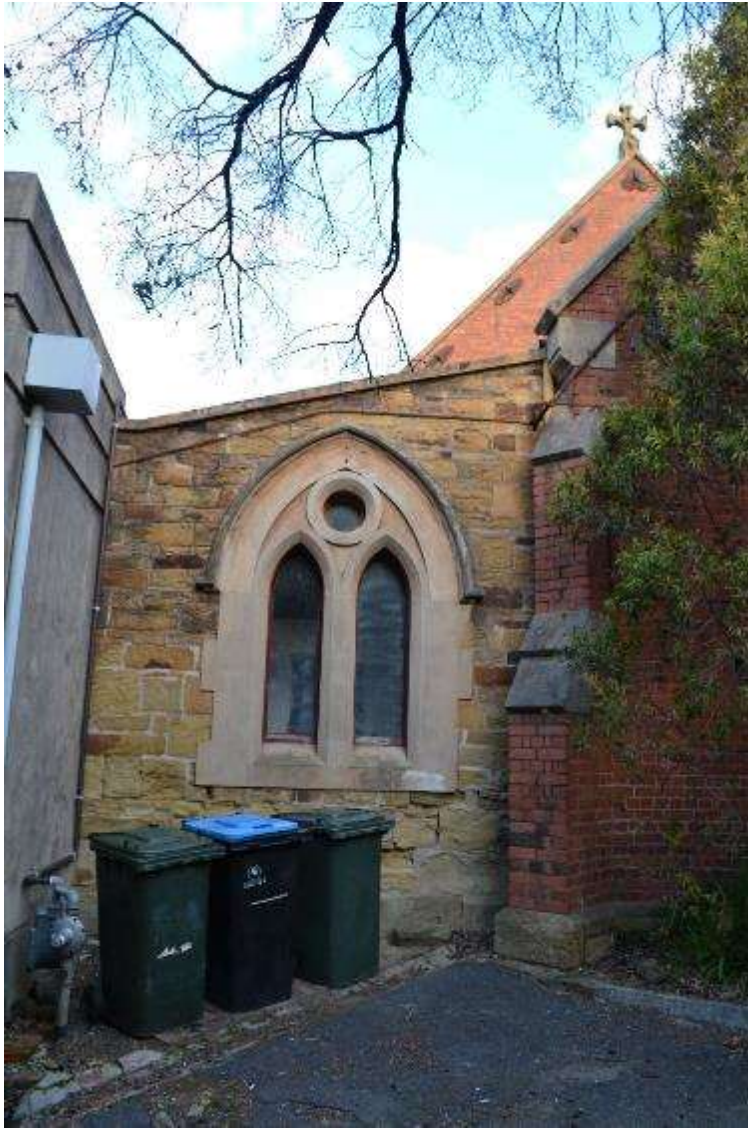
Figure 125 The western wall of the vestry.

The Vestry is attached to the northern side of the chancel and has a skillion roof of galvanised corrugated iron with a raked parapet on the western side (Figure 125). There is a two light window with plain fixed glass and one medallion light, included in simple plate tracery in this wall. The window is faced with stucco, and the wall is constructed of squared random rubble. There is serious fretting of both stone and mortar below the window, penetrating right through the lower wall in several places. This is mainly due to poor drainage from the chancel roof.

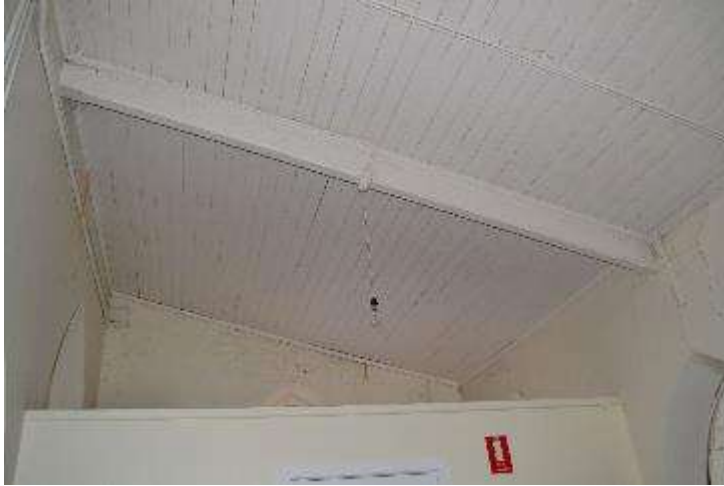
Figure 126 Lining board ceiling of the Vestry

The vestry retains its original lining board ceiling.

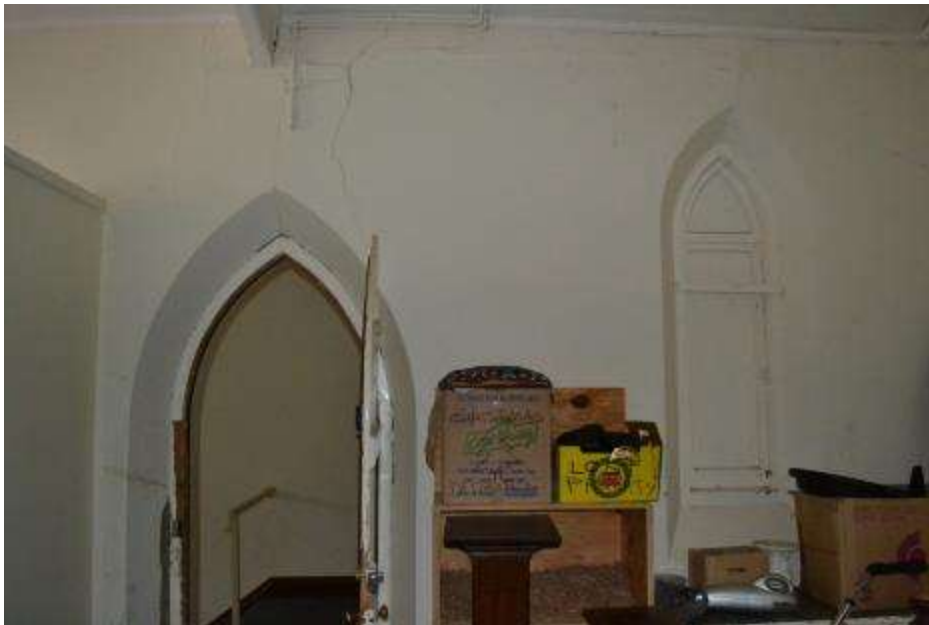
Figure 127 Interior of the Vestry showing original door and window

The entire vestry is in situ, although the northern wall, including original windows and door (Figure 129), is included in the later guild rooms and forms one wall of the entry hall into the guild rooms. A disabled toilet has been added as part of the guild rooms adjoining the wall, and the original vestry window blocked off on this side. The window is still in place and can be seen from inside the vestry (Figure 128). The entire wall has been rendered and painted, and shows areas of rising damp in both the hall and the toilets. The hood mouldings may have been removed at this time.

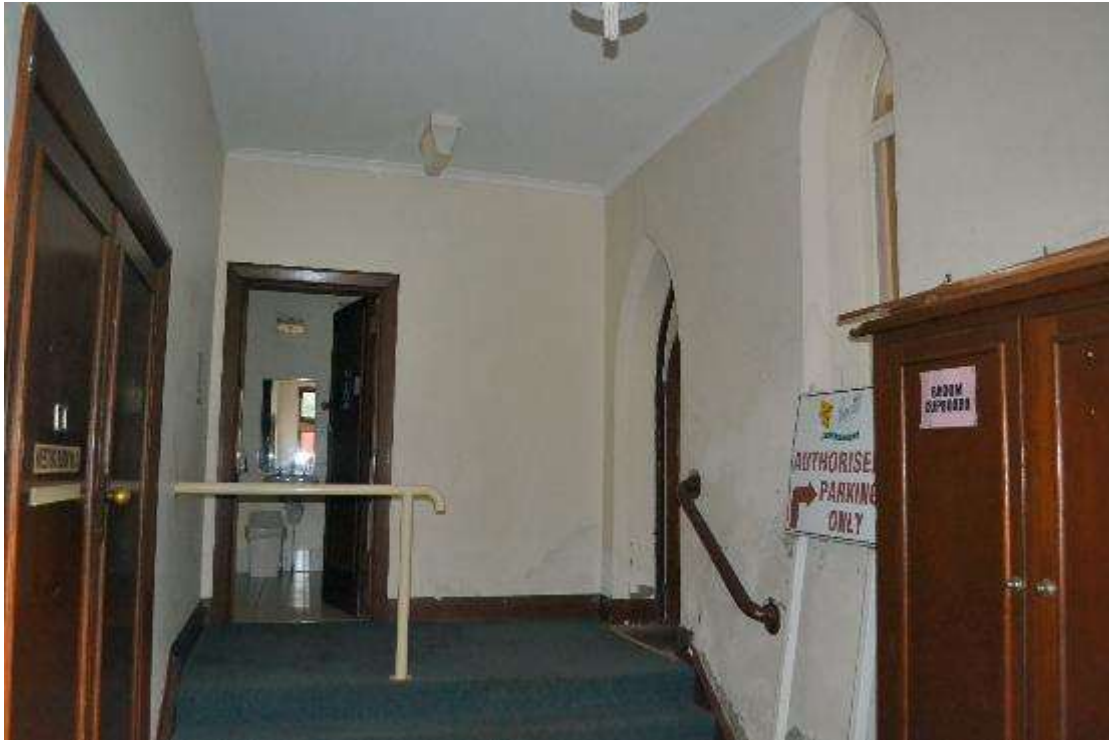
Figure 128 The hall and disabled toilet in the Guild rooms.

The original vestry wall with window and door is on the right.

The wall should be taken back to its original stone surface as part of the renovation of the vestry, and the blocked window reinstated. Steps have been built in the hall against the wall up to the original granite doorstep, and these should also be removed. The vestry is divided by a partition, and has three doorways, one which was the entrance from outside, now from the guild room hall, one directly into the chancel, and the third into the nave. This door has had repairs to the surrounding render in cement, which should be removed and replaced with lime mortar. The vestry has a painted lining board ceiling following the slope of the roof. It has a wooden floor.

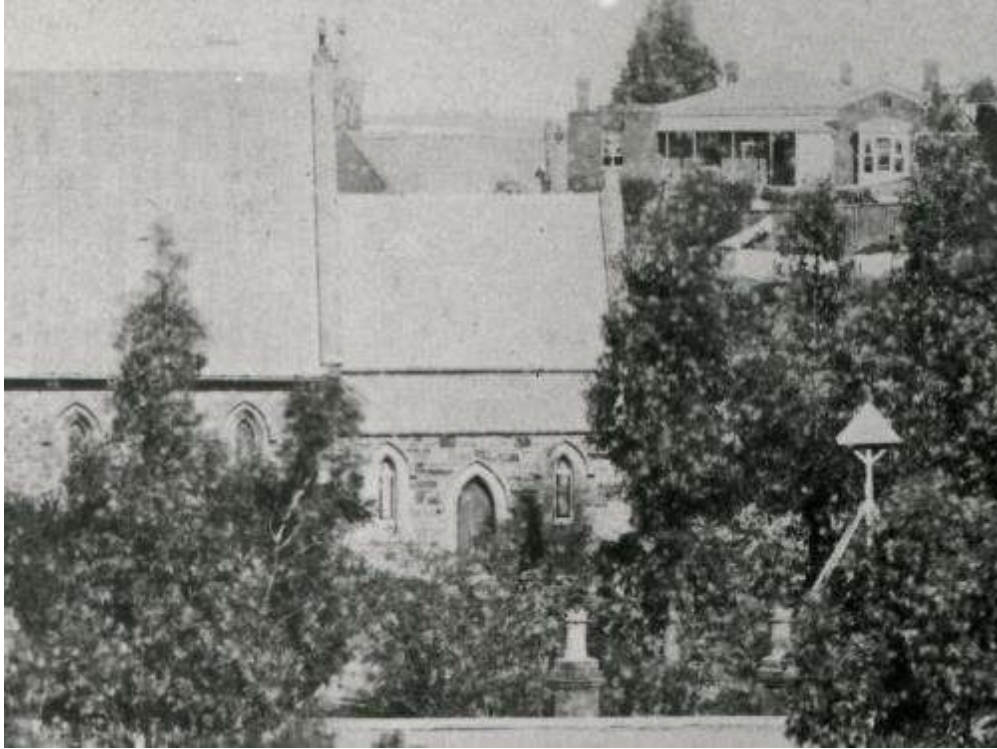
Figure 129 shows the vestry before the guild rooms were built in 1938. The short eastern wall of the vestry is in situ.

Figure 129 Detail of an early photograph. Showing the vestry.

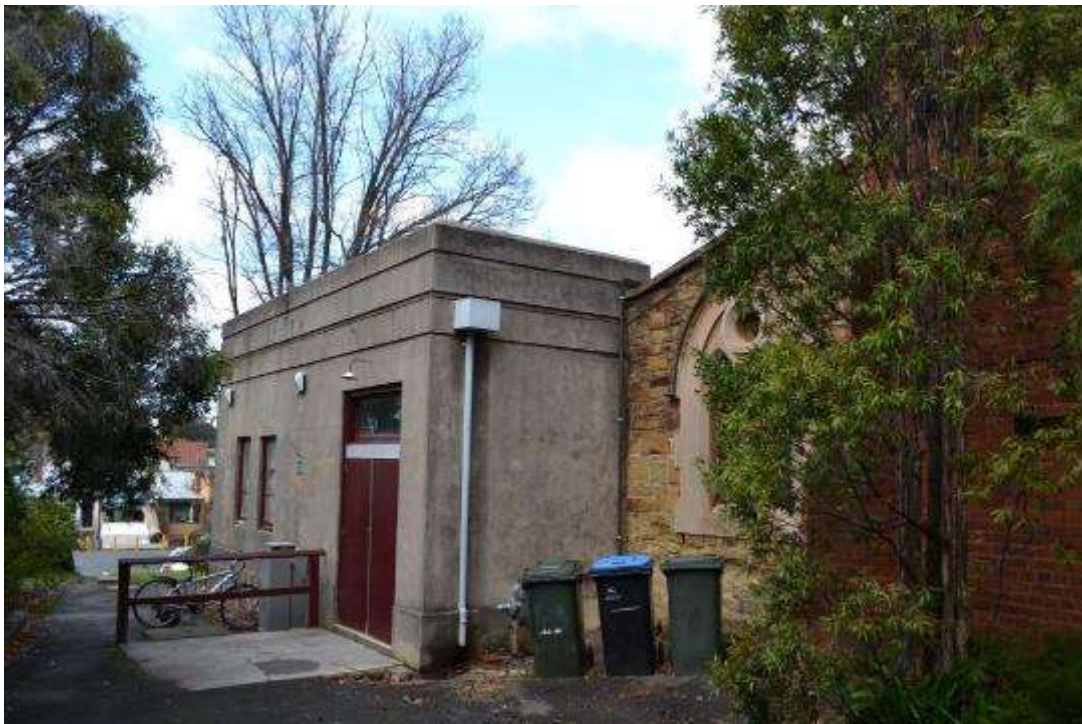
The Guild Rooms were built in 1938 as an extension to the existing vestry (Figure 130). This addition is not of significance.

Figure 130 The Guild Rooms built onto the Vestry.

The new walls are constructed of red brick and cement rendered. There are a number of cracks evident in the walls. There is a large meeting room, a kitchen, a hall and toilets. There is another toilet attached to the eastern wall of the guild room, and a large plastic

The structural integrity of the foundations and lower walls of this section must be established by a suitably qualified and experienced Engineer and if found to be unsafe or detrimental to structure of primary significance the 1935 additions should be removed. The Guild room (red area Figure 152) does not contribute in a significant way but does have a detrimental effect on the stone structure of the church and it is recommended that it be demolished and the north wall of the Vestry restored.

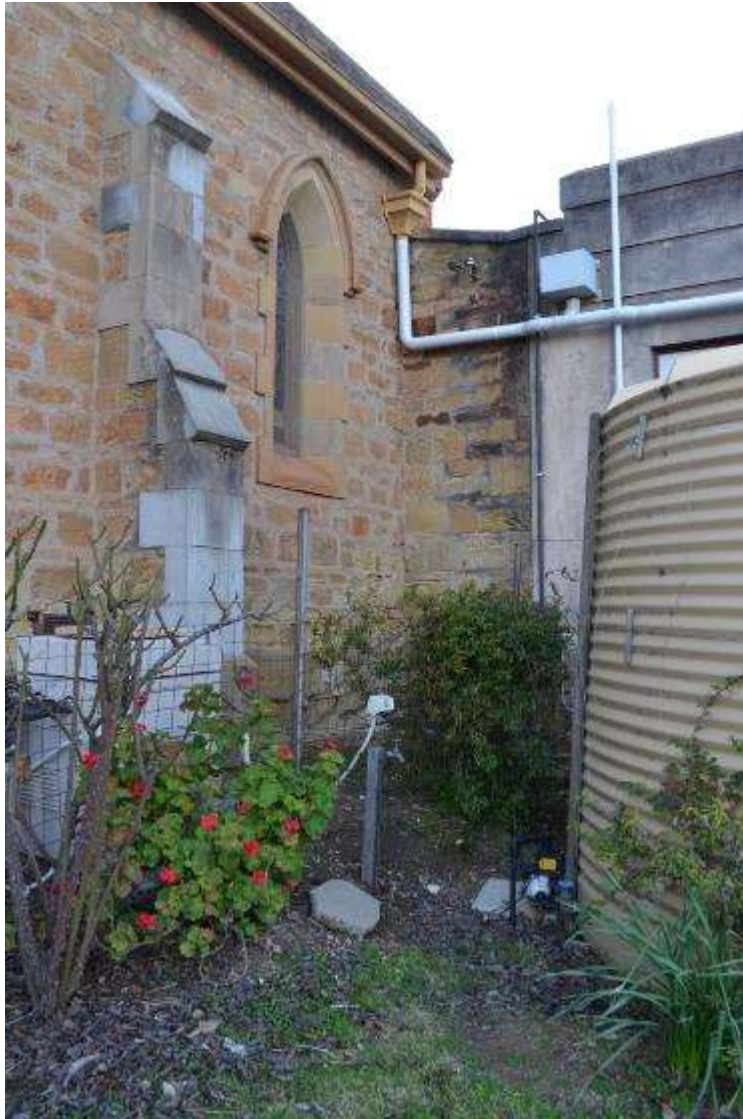
rainwater tank. The nave wall and buttresses adjacent to this area show significant fretting due to damp. A box gutter from the vestry roof now feeds into the rain water tank (Figure 131).

The original steps to the vestry door may still exist below the new steps and higher floor level at the disabled toilet.

Figure 131 The northern side of the nave with the short eastern wall of the vestry and the Guild room.

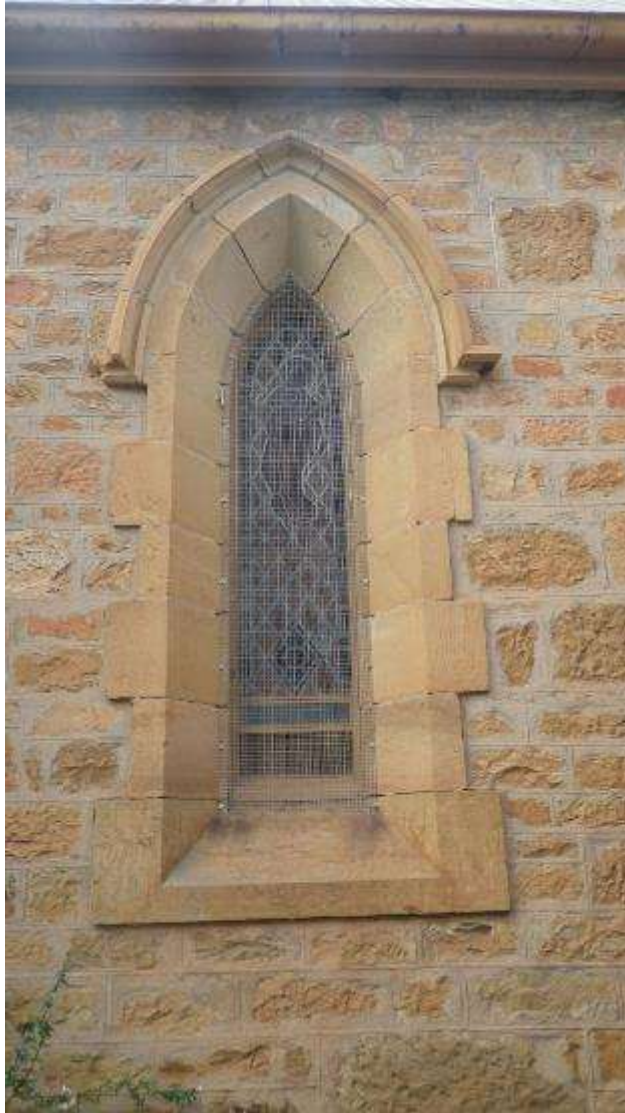
There are lancet windows filled with stained glass separated by simple buttresses, originally forming six bays on the northern side and five bays and an entry porch on the south. The window openings are faced with stone and have stone hood moulds (Figure 132). These should be inspected for condition and movement.

Figure 132 The southern wall of the nave with lancet window.

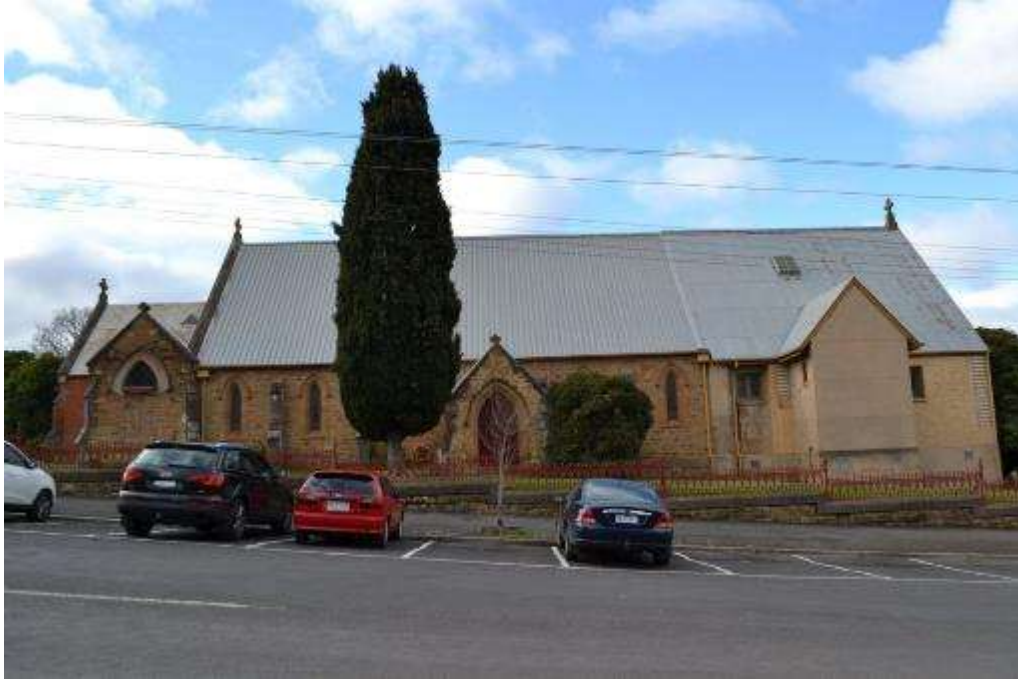
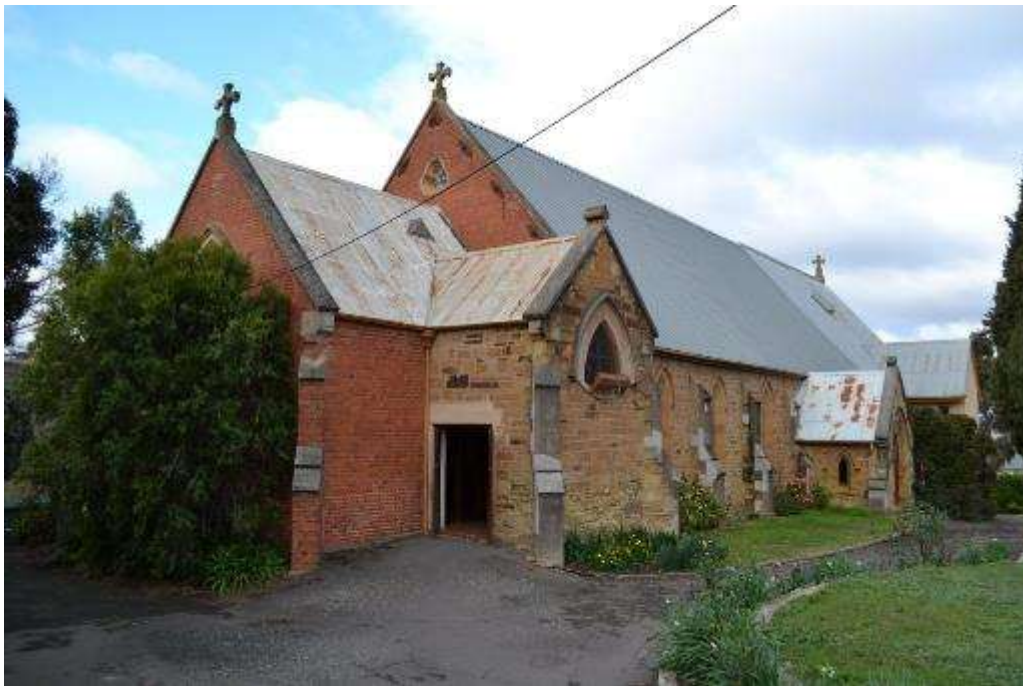
The roof of the nave is of modern trimdeck pattern galvanised iron, and has no vents. It appears to be in sound condition.

Figure 133 The southern side of All Saints' church

Figure 134 The southern side of the church from the west.

It was formerly clad with sheet metal tiles with three roof vents on either side and two ridge vents. This earlier roof can also be seen in photos taken by Bishop Riley in 1956 (Cole p.104, 105) If the roof needs to be replaced it should ideally be replaced with galvanised sheet metal tiles, which are being remade, however if this is impracticable, with galvanised corrugated iron.
