ALL SAINTS' ANGLICAN CHURCH,
SCHOOL AND MASTER'S RESIDENCE
BENDIGO

CONSERVATION MANAGEMENT PLAN

PREPARED BY MINERVA HERITAGE FOR THE
ANGLICAN DIOCESE OF BENDIGO

AUGUST 2012

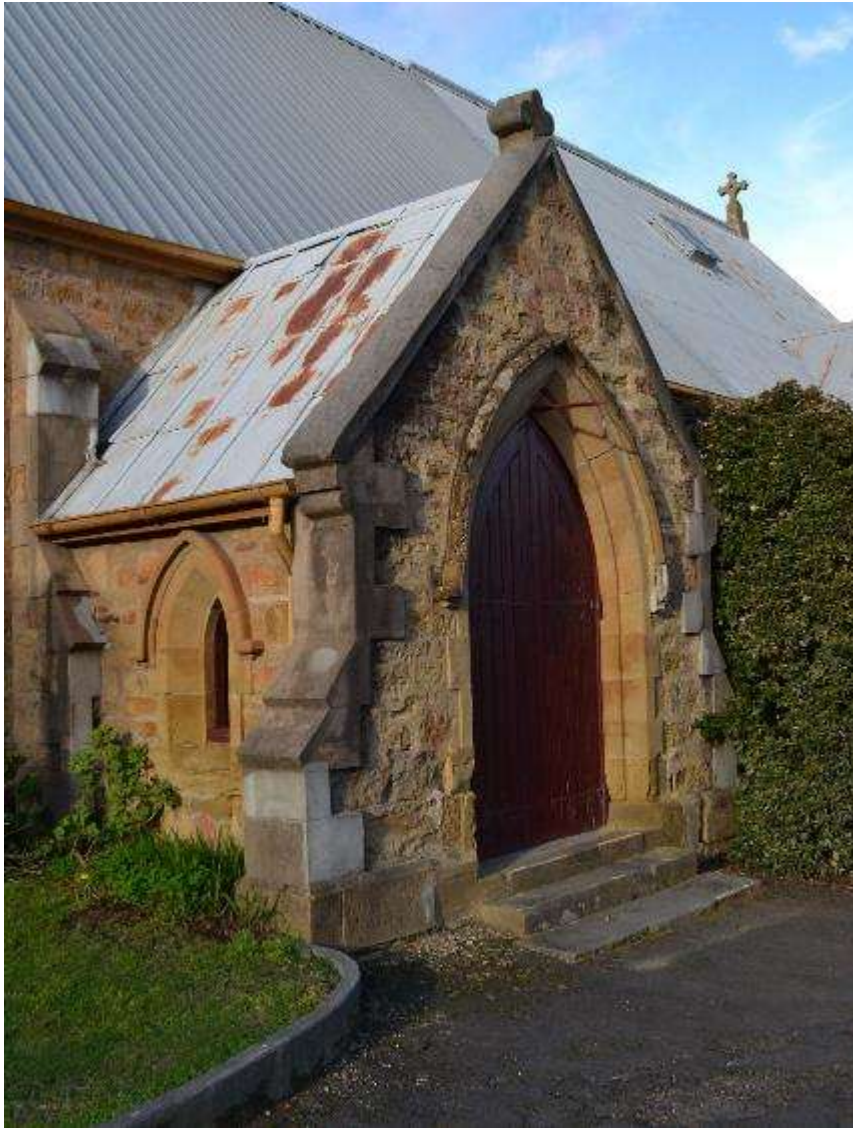
There is an entry porch on the south side of the nave (Figure 136) which takes up one bay fitted between two buttresses, and may be the oldest intact part of the building.

Figure 136 Original entry porch on the southern side of the church.

The walls are of Ordovician stone in coursed squared rubble showing tool marks. The walls show deterioration due to damp, as does the hood moulding over the doors. There are small lancet windows filled with obscure glass with stone facings and hood moulds on either side of the porch, and double doors with wrought iron hinges at the front entrance, with another set of doors through a pointed arch at the entry into the church. These last have a cut away section into the stone jambs to facilitate the opening of the doors into the porch. The roof is lined with painted Baltic pine lining boards and supported by two trusses with chamfered details (Figure 137).

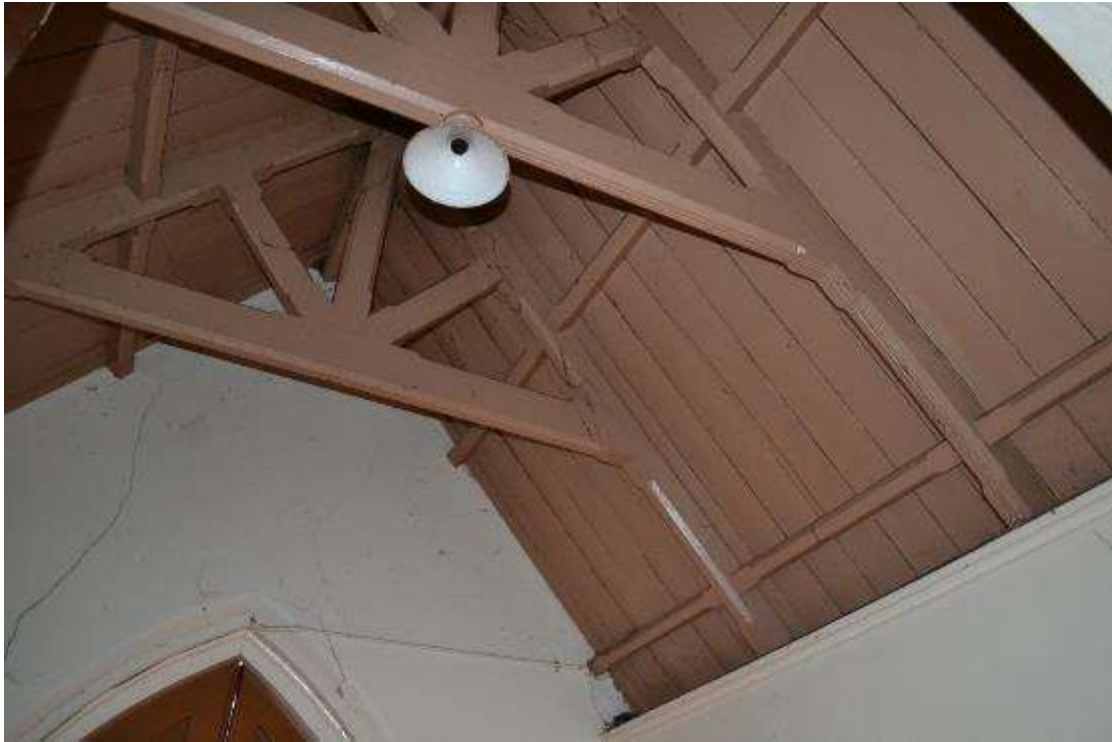
Figure 137 Roof detail of the original south entry porch.

The inside walls have been rendered and painted white. There are some repairable cracks and areas with loss of render in the walls.

The roof of the porch is clad in galvanised sheet metal tiles, and these should be retained and conserved in situ. They are probably the same as those on the original church roof. The guttering on the western side is of half round heavy gauge galvanised iron, and should be kept as an example, along with the gutter brackets, and downpipe, and used as a template to make new gutters for the porch. The downpipe on the eastern side has come away from the gutter and water is flowing down the wall. All guttering and downpipes should be replaced as a priority on both sides of porch, as both rising and falling damp are evident. The flowers and shrubs in the garden beds along all of the walls should be removed, and replanted elsewhere if desired. The ground level should then be taken down to the bottom of the ashlar base of the walls. There is a damp course of slate in situ, and this should be inspected and repaired or reinstated if necessary after these measures have been taken.

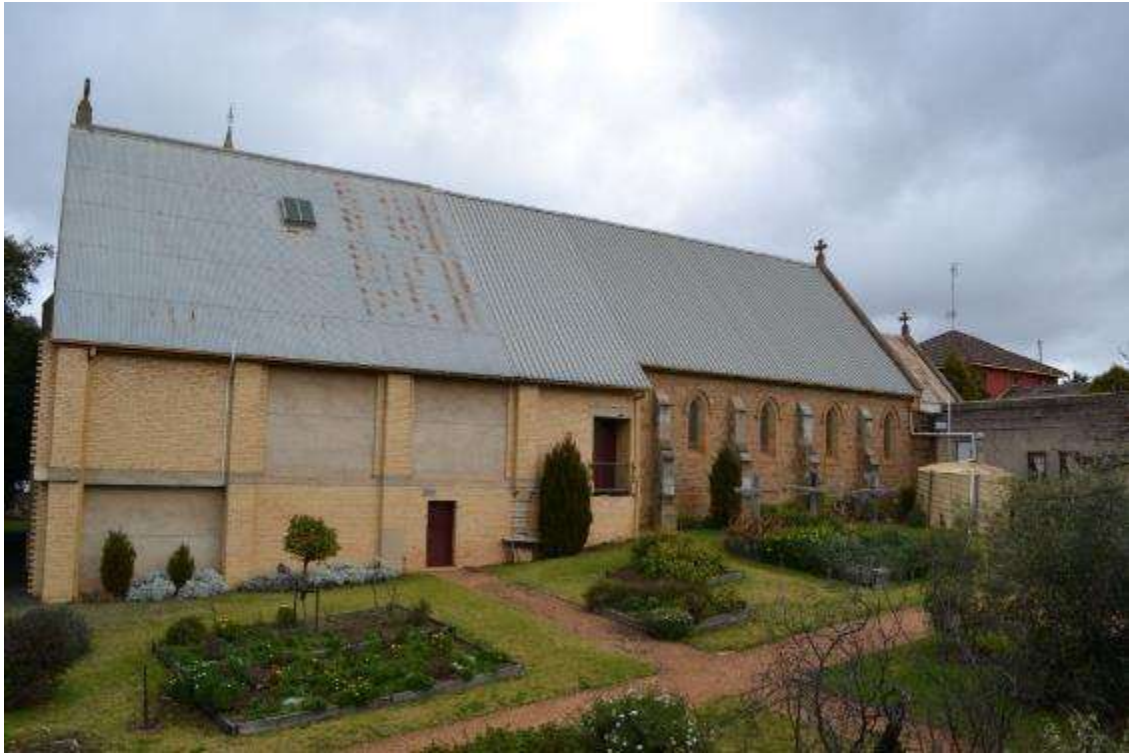
The cream brick chancel at the eastern end of the church was opened in 1935. It was fitted out with a rood screen, pews, altars and bishop's chair, the organ was refurbished and moved to the new organ chamber, and many other furnishings were put in place. A stained glass tripartite stained glass window by Christian Waller was placed in the temporary end wall until such time as the new cathedral was built. Only a part of the internal side walls of the intended curved chancel was ever built (Figure 138)

Figure 138 The northern side of the church.

The cream brick walls (Figure 138) were intended to be internal walls of the new cathedral, as there was to be an aisle along either side of the nave. They are in sound condition.

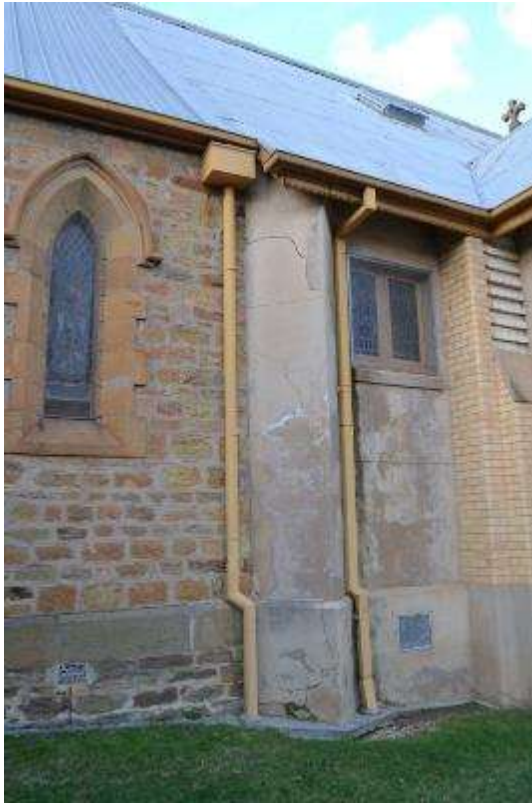
The new organ chamber on the southern side was also a temporary measure. There is a pair of casement windows by Derek Pearse either side of the organ chamber. These were placed in 1985. There are large cracks in the render covering the original corner buttress at the junction of the stone and brick parts of the church. There is falling damp from blocked gutters and downpipes which should be remedied.

Figure 139 The junction of stone and brick on the southern side of the church.

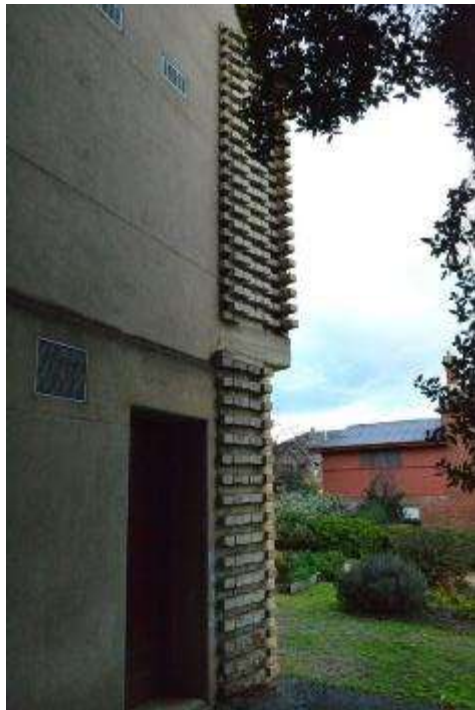
Figure 140 Temporary end wall ready for curved chancel end to be keyed in.

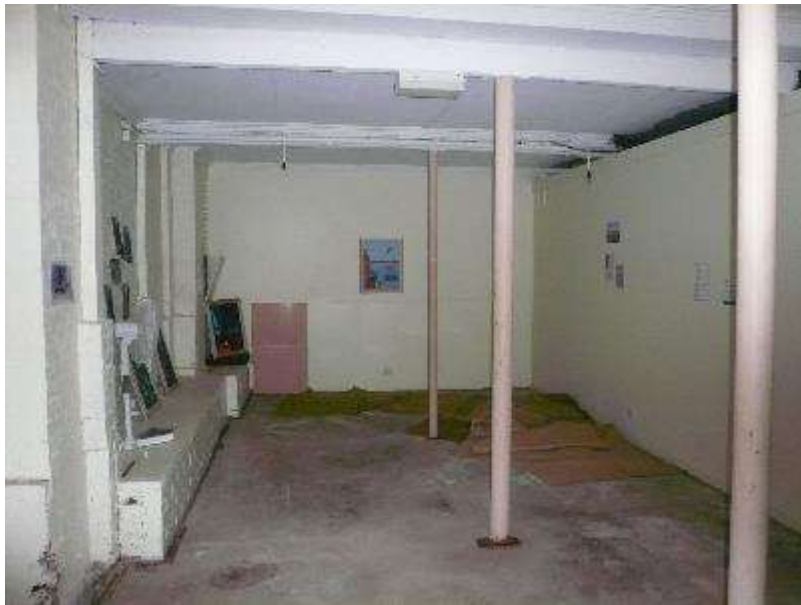
After 1989 the internal fittings and furnishings were removed, leaving the church empty. The condition of the interior is good, apart from some repairable cracks. There are a pair of doors on the northern side of the church which were placed in an opening made through the original stone wall in 1935. A wooden porch and stair has decayed and been removed from the outside of these doors. A section of the exterior of the stone wall is clad with cream brick in this area to support it after the doors were put in. The crèche was built in the chancel in 1998, as were the new toilets in the basement, to accommodate needs of View Hill Fellowship. As part of the 1935 construction the crypt (now basement) was excavated and given a concrete floor, vents, and extractor fans. The vents have mostly been closed off, and the fans are no longer in use, restricting air flow and encouraging damp. In 1998 the area was further excavated to the west to accommodate the new toilets. Currently the concrete floor is seriously degraded through attack by water and salt. There is evidence of structural movement of the brick walls in the basement area, these need to be further examined in the future. The floor coverings have become wet and have been rolled up (Figure 141).

Figure 141 The basement under the southern side of the new chancel.

The brick walls in the basement have been painted and this has restricted movement of water through bricks, contributing to the problems with damp.

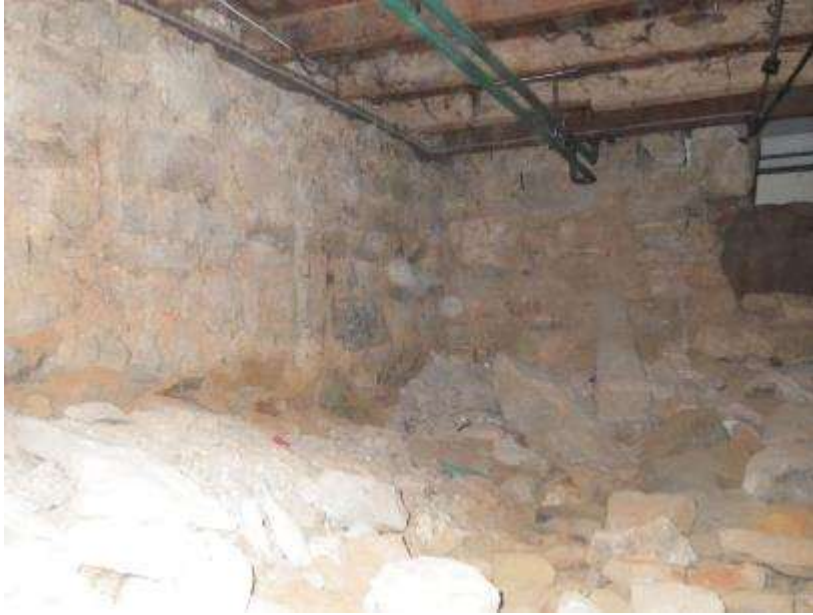
Access can be obtained through a panel in the wall at the western end of the basement to the underfloor space of the original church. A portion of the original east entry porch up to the level of the original floor is in situ as are original floor boards (Figure 142).

Figure 142 Original walls and floor under the church.
