# *FORTUNA VILLA CONSERVATION MANAGEMENT PLAN REVIEW 2016*

PREPARED BY MINERVA HERITAGE FOR FORTUNA PTY LTD JUNE 2016

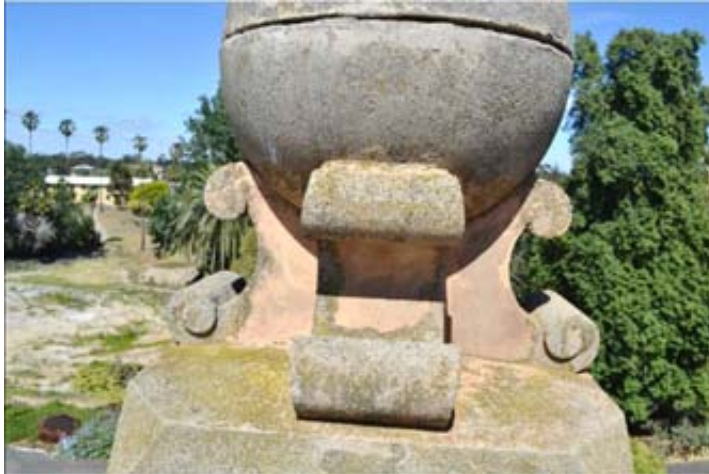
There is evidence in a number of places that the external walls were lime washed, including on the 1907 roof deck. This was common practice at the time of construction to both colour and protect the rendered walls. Most has disappeared over time, or possibly been washed off. These remnant finishes should be retained and conserved. The walls were never painted and should not be painted in future.

*Figure 72: Remnant biscuit coloured lime wash on Roof Deck ornament.*

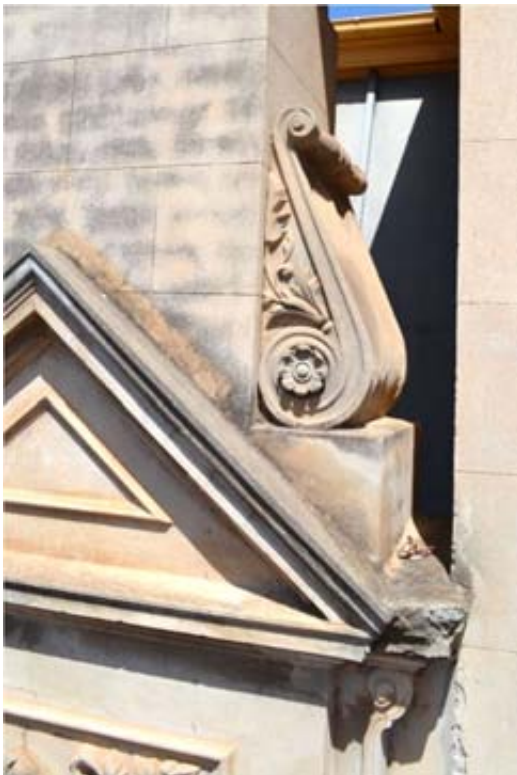
*Figure 73: Remnant lime wash, Chimney on the walkway, First Floor.*

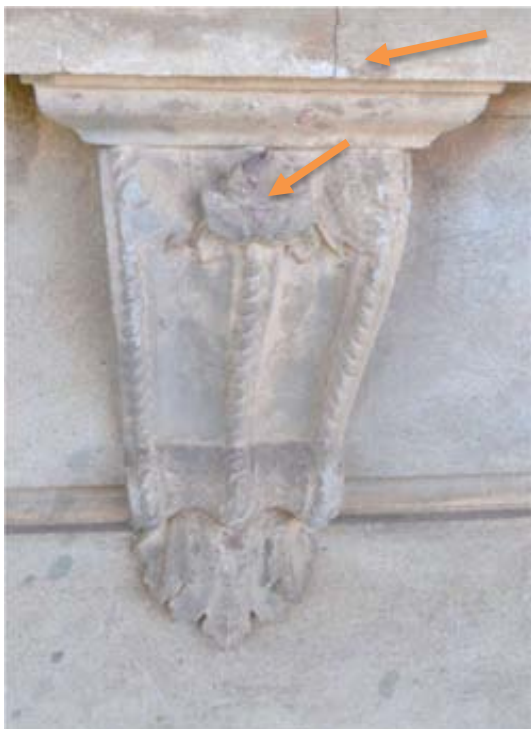
**Figure 74: Remnant lime wash North Wing.**

*On this console and sill to a blind window by Vahland on the West wall, First Floor verandah, two colours can be seen.*

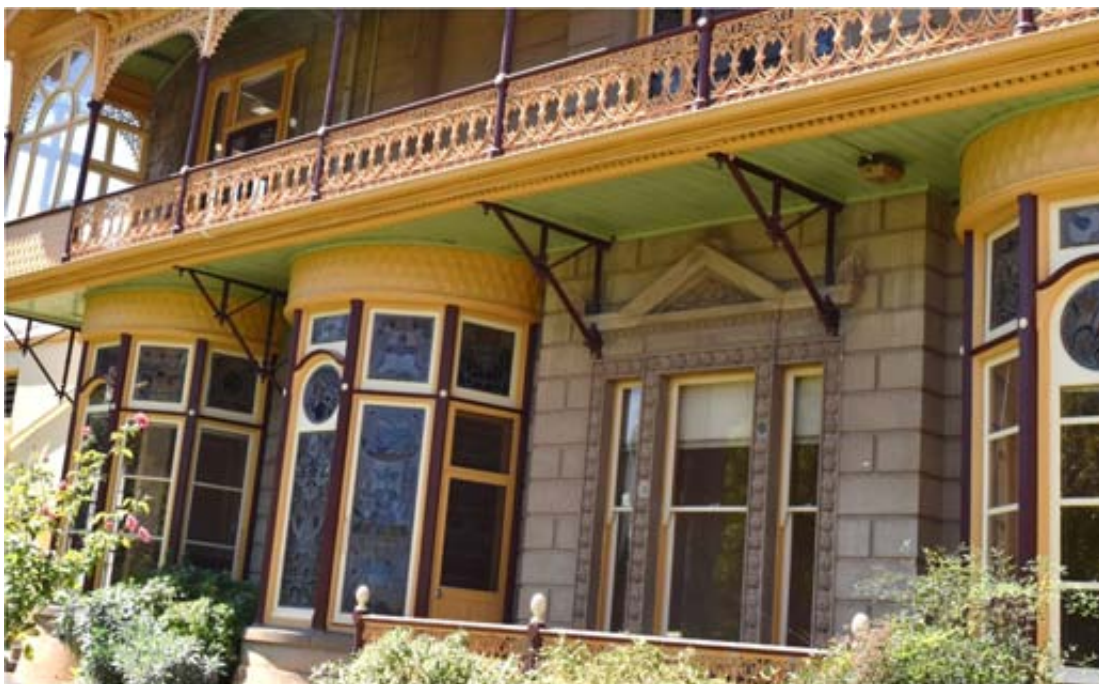
At ground floor level are three bow windows with stained glass highlights, contemporary with the verandah (Figure 84). Only one bay retains its original stained glass casements, the remainder having been replaced with clear glazing. The central window at ground floor level is a tripartite double-hung sash with rendered architraves enriched with a repetitive rosette motif, part of Vahland's 1888 facade. His 1893/5 entrance also uses this decorative element. At first floor level, a pair of French doors with leadlight sidelights and highlights opens out onto the verandah, flanked by blind windows.

*Figure 84: Bow windows added to the north wing in 1904*

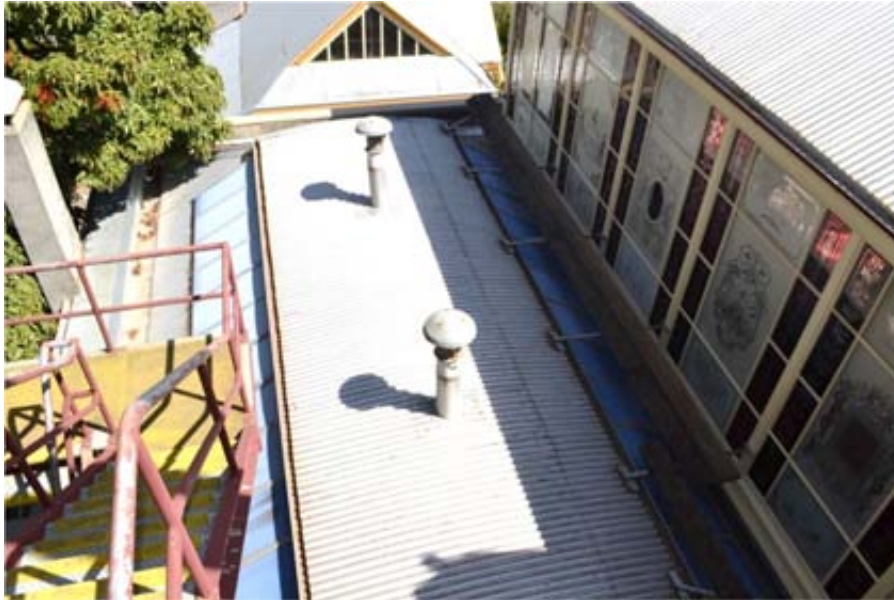
The top of the billiard room roof, above the skylights, is of original curved corrugated steel. The hipped roof is also original. The original ribbed plate glass skylights have been replaced with blue Perspex, probably c. 1970s. The Perspex should be removed and replaced with ribbed or obscure toughened glass similar to original. Beebe's detailed specifications for the Billiard Room are extant. They are reproduced in Appendix E, O'Connor 1987 CMP.

*Figure 92: Roof of the 1893 Billiard Room by W Beebe.*

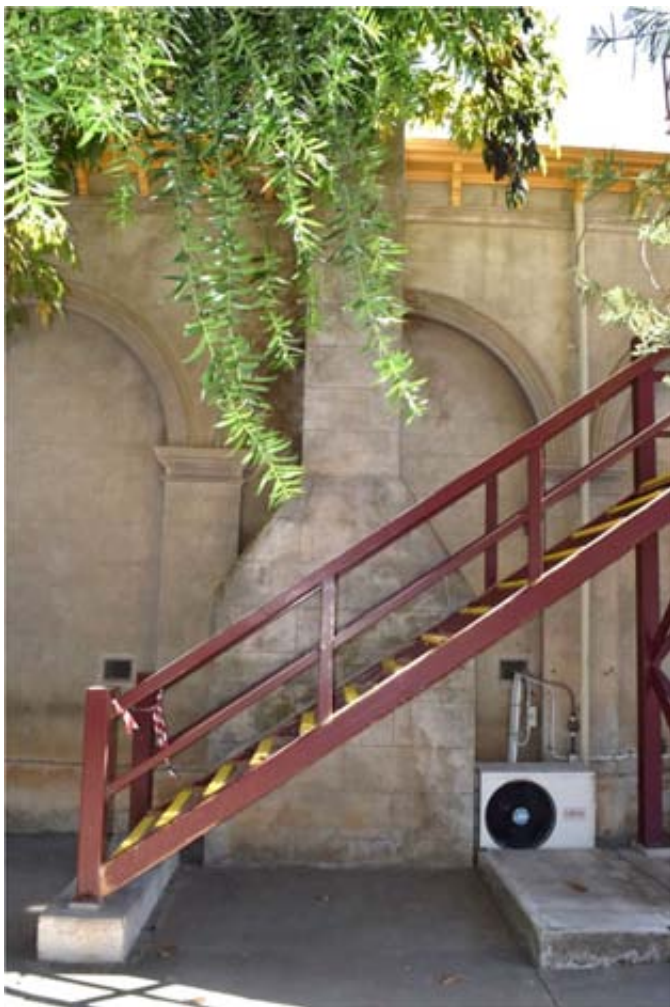
The east elevation of the 1893 billiard room (Figure 94) is largely obscured by a post-War timber escape stair. The ruled, cement rendered walls are articulated by blind arcading and shallow pilasters with moulded caps. A cement rendered chimney breast and flue, added c.1945, obstructs this ornamentation. The roof is hipped corrugated galvanised steel, with timber bracketed eaves.

*Figure 94: East elevation, 1893 billiard room with 1945 chimney and fire escape stair*

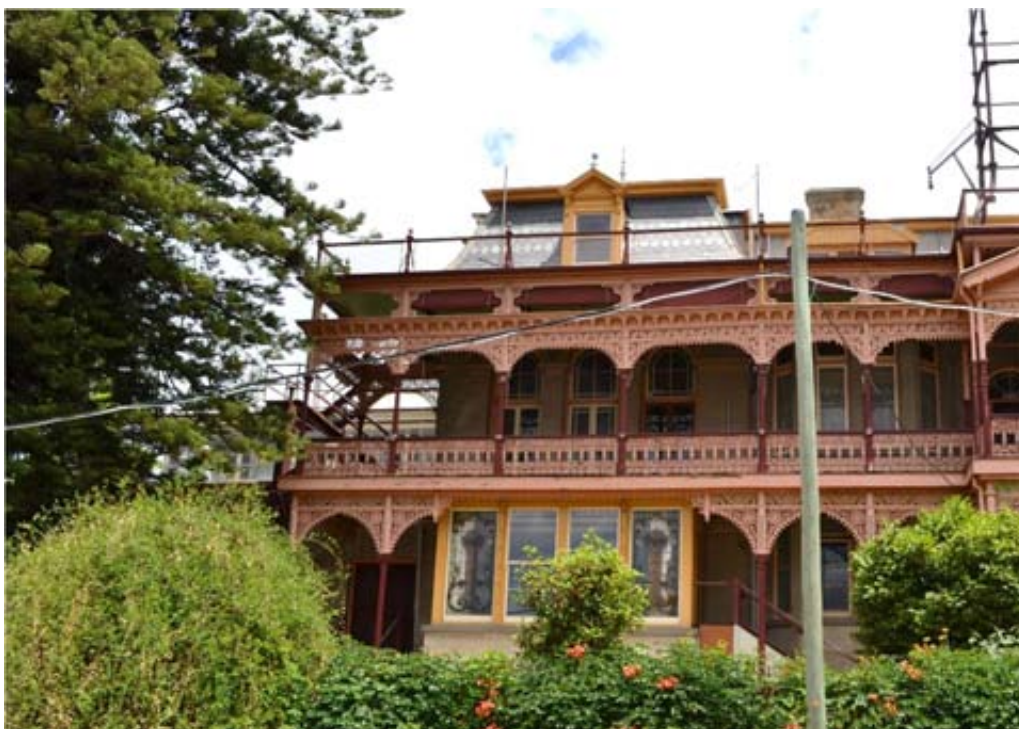
*Figure 95: East elevation, south wing with complete cast iron in 2013*

The cast iron lacework is currently being removed, sand blasted and powder coated over most of the building's verandahs. Some sections of damaged timber are being replaced as part of this process, however there are still some timber sections displaying damage which, subject to permit conditions or exemptions, should be conserved where possible or replaced if repair is not possible. A 2013 photo by the authors with all verandah iron in place is used above.

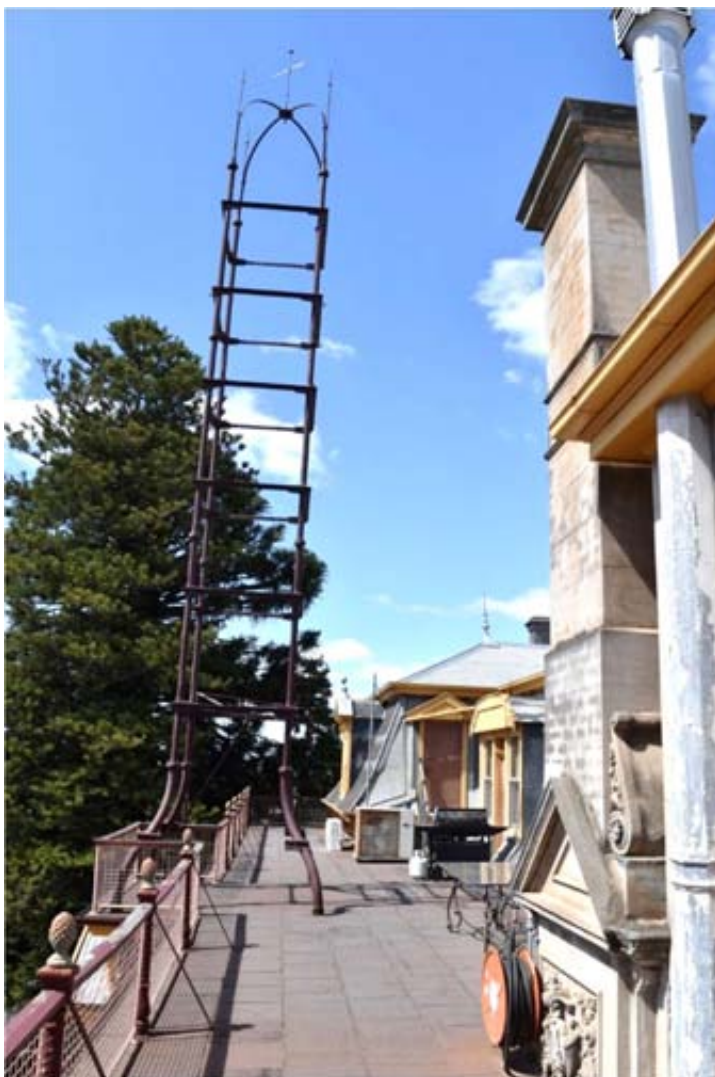
*Figure 97: Detail of the steel tower, east elevation*

The hexagonal vent pipe on the North side of the chimney (Figure 97) is original and should be retained and conserved. The fire hose reel and air conditioning units should be moved to a less obtrusive position.

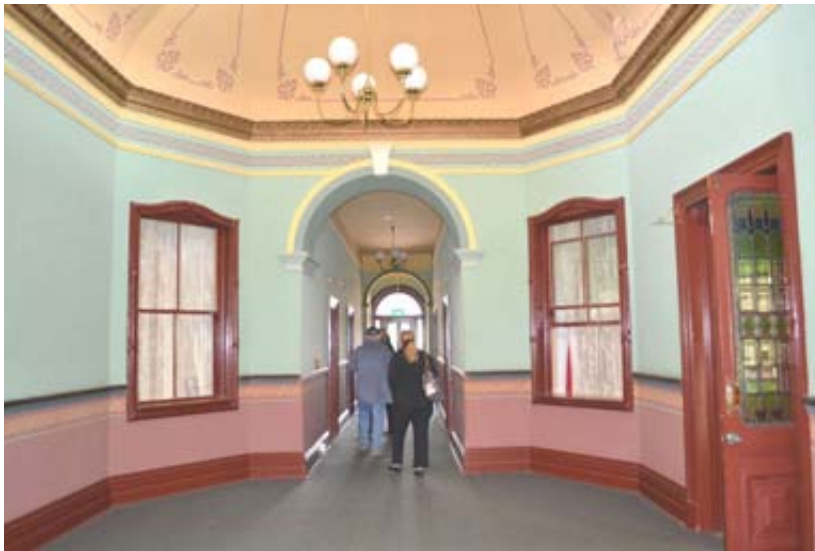
*Figure 108: Entrance hall, designed by Vahland (2013)*

The original white marble fireplace survives on the north wall. The present decorative painted stencilled scheme is based on the original<sup>69</sup>, which is visible in an early photograph (Figure 109). Carpets and brass pendant light fittings are recent.

*The original colour scheme as determined by Allom Lovell and Associates in 1982 is seen in this image.*

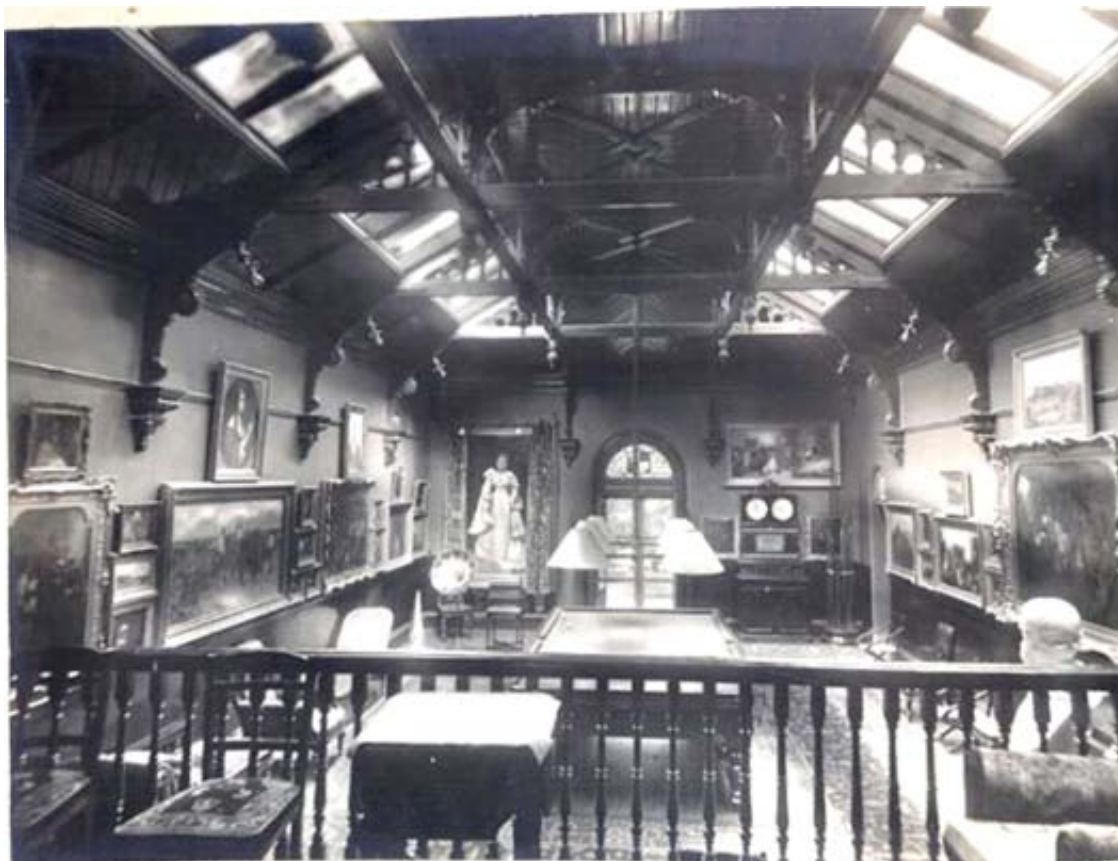
*Figure 111: The billiard room in 1908*

The 1893 billiard room (Room 5, Figure 110 and Figure 111) is a large, rectangular plan room with exposed timber-trusses with carved details and brackets. The ceiling is lined with V-jointed timber boards. Originally, the floor level was lower and had a raised dais at the north end: the present floor was installed at an unknown date by the Department of Defence.

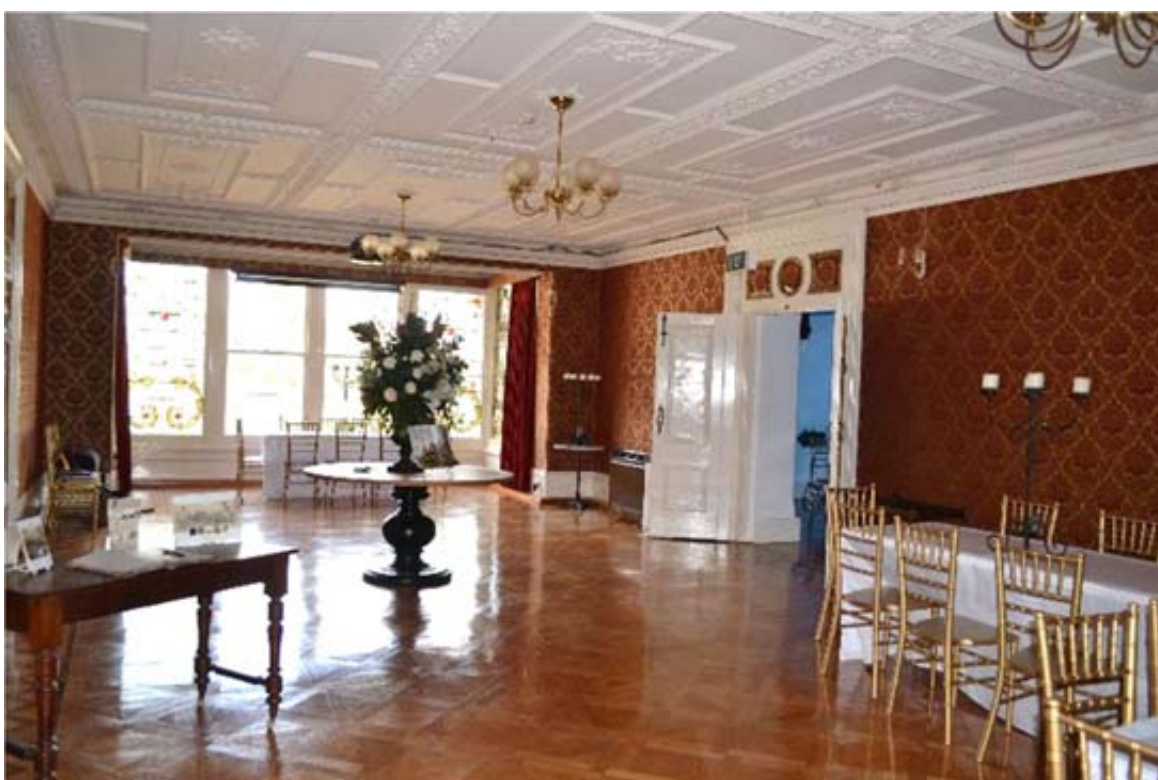
*Figure 112: Former dining room (Room 9), lower ground floor*

The dining room (Room 9) features a rectangular bay window at the east end (Figure 112, Figure 113). The fabric of the room incorporates remnants of the 1869 addition, which contained a much smaller dining room in this location with a loggia facing east. The room was subsequently extended c.1900 and again in 1904. Pairs of elaborately panelled timber doors with carved ornament are located on the north and west walls. The parquetry floor and ornate plaster ceiling date from the 1904 refurbishment. Textured wallpaper was added probably c.1970s.

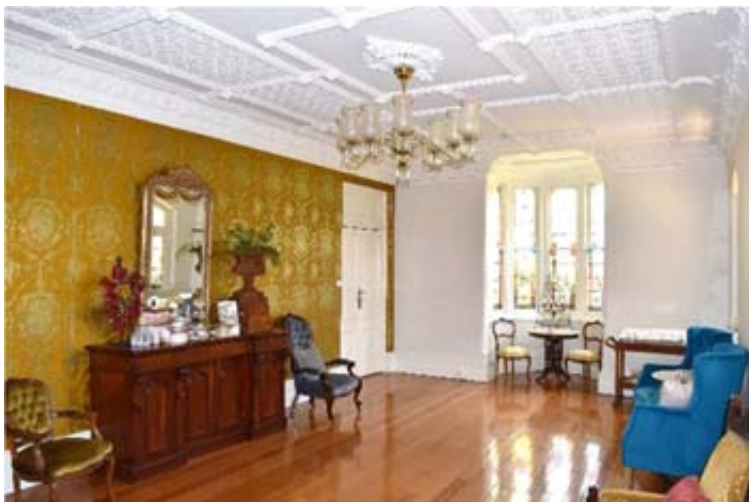
The former statuary gallery (Room 10) forms a vestibule to the dining room (Figure 116, Figure 117). Added as part of the 1904 works, it was described at the time in the Bendigo Advertiser as follows:

The leadlight and stained glass in the bow window at the southern end of Room 10 is extant and intact. The 1970s wallpaper and carpet have been removed. The floorboards have been polished.

*Figure 116: The former statuary gallery (Room 10), lower ground floor, looking south*

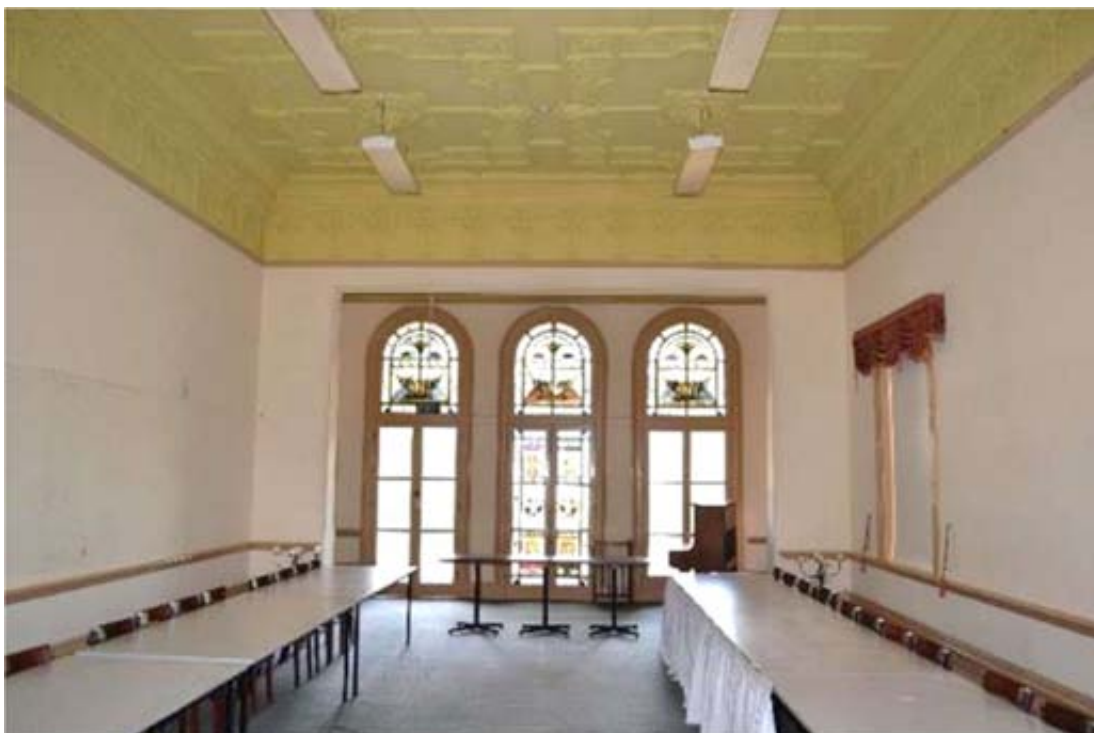
The principal fabric and 1904 decoration of the room remains, however the timber overmantel and the turned timber grille at the east end described in the article have been removed and the parquetry concealed by recent carpet. Some of the original leadlighting has been replaced by clear glazing. That which remains contains depictions of various musical instruments, fruit and putti and musical-related mottoes. In place of a window to the conservatory are a pair of French doors, which appears to date from c.1940s or 1950s. Fluorescent light fittings are recent.

*Figure 119: The former music room (Room 32), ground floor, looking east*

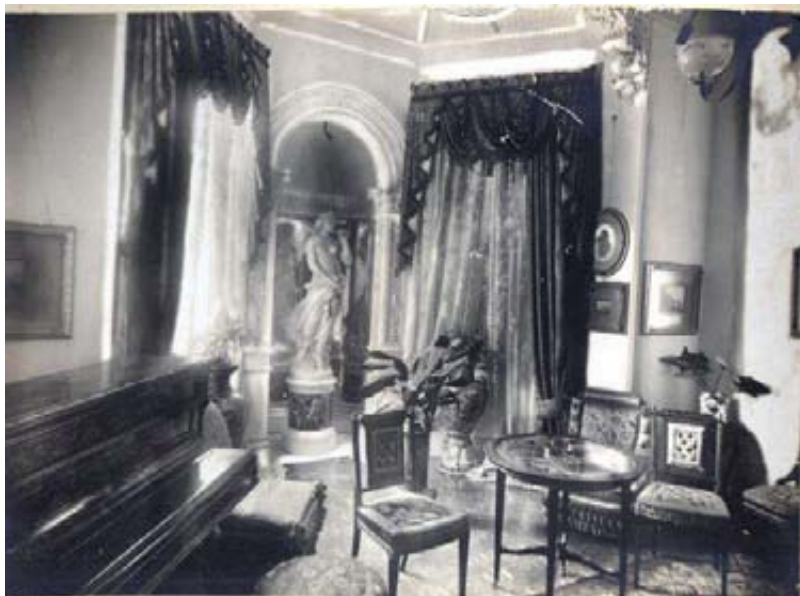
*Figure 126: The reception room in 1908*

Opening off the music room to the north is the former reception room (Room 35, Figure 126). This small room was part of the original Ballerstedt house. A canted bay was added to the west wall c.1875, to which a decorative mirrored niche was added probably c.1895.<sup>A7</sup> Early photographs show the niche housing a marble statue. The bay has a pressed metal ceiling with unusual circular glass skylights.

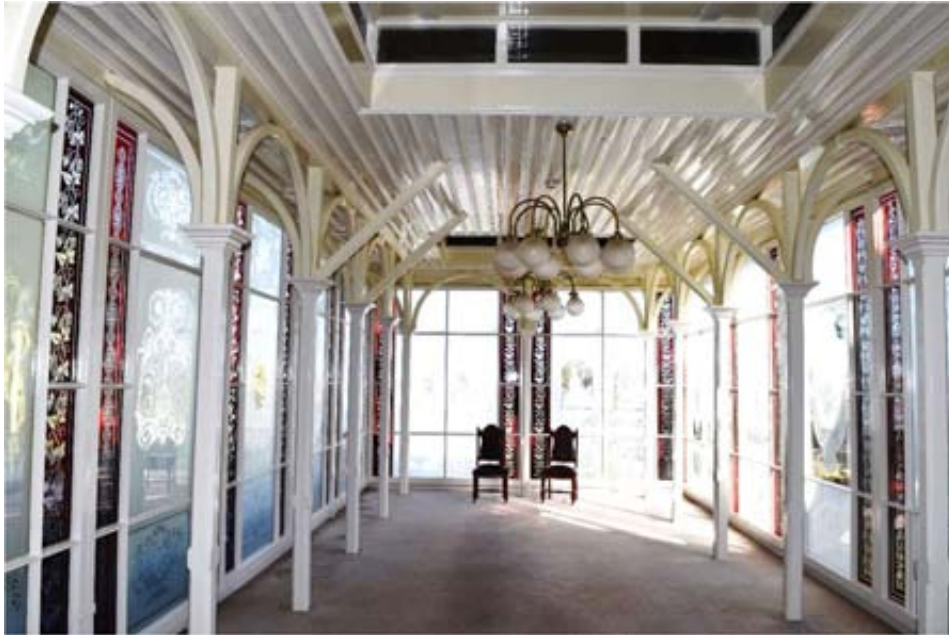
An unusual series of underground miners are depicted in one window. The original colour scheme seen here had been reinstated in the 1990s conservation program, but has recently been painted over. Timber balustrading, visible in early photographs of the conservatory interior, and later removed is being at least partially replaced since the photographs were taken (Figure 129 and Figure 130). The design for the new railing should replicate the original in these images.

*Figure 128: Conservatory with recent paint scheme (2016).*

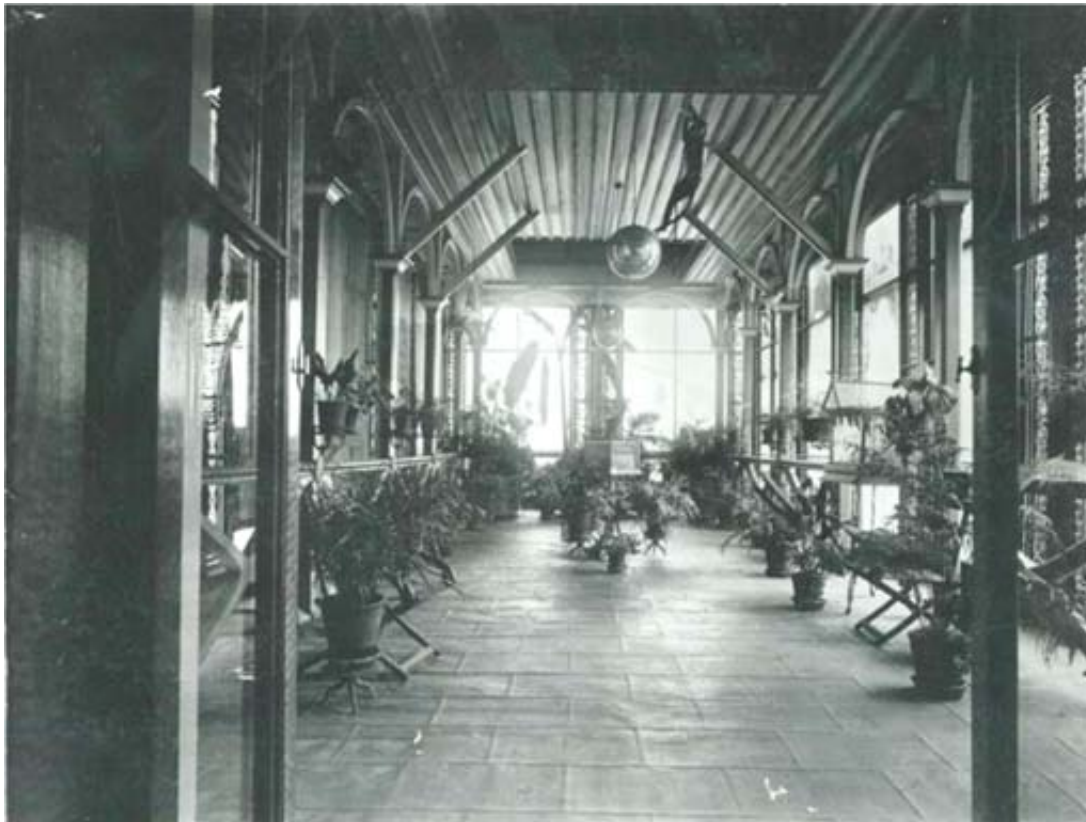
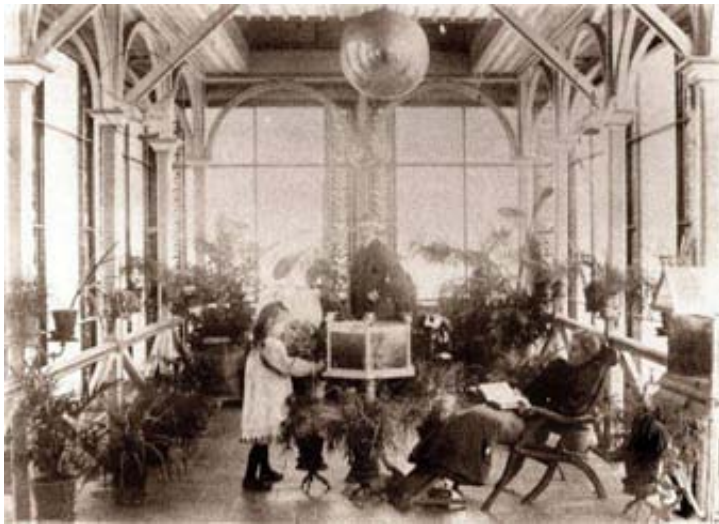
*Figure 129: Early view of the conservatory looking south*

*Figure 130: The conservatory c. 1900.*

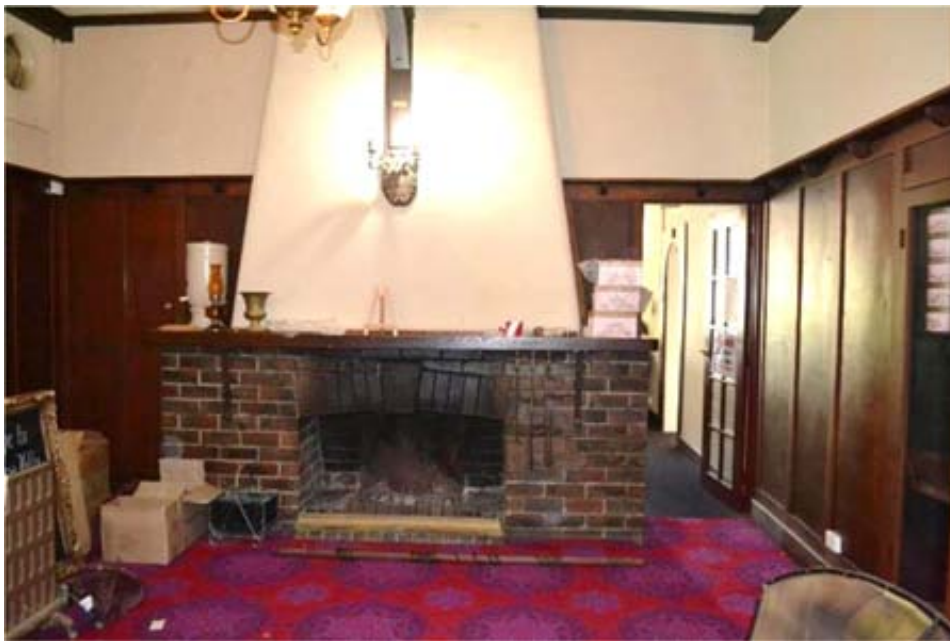
Rooms at lower ground floor level were altered by the Department of Defence for use as mess rooms in the 1940s (Figure 135). The treatment of these interiors is typical of mess rooms found in army drill halls constructed by the Commonwealth during the inter-War period, featuring dark-stained timber dado panelling, strapped fibrous plaster ceilings and tapestry brick fireplaces. Other rooms have been remodelled c.1970s (Rooms 13 and 14) and c.1980s or '90s (Rooms 18 and 19).

*Figure 135: Room 12, lower ground floor.*

*This room was refurbished by the Department of Defence for use as a mess room c.1940s.*

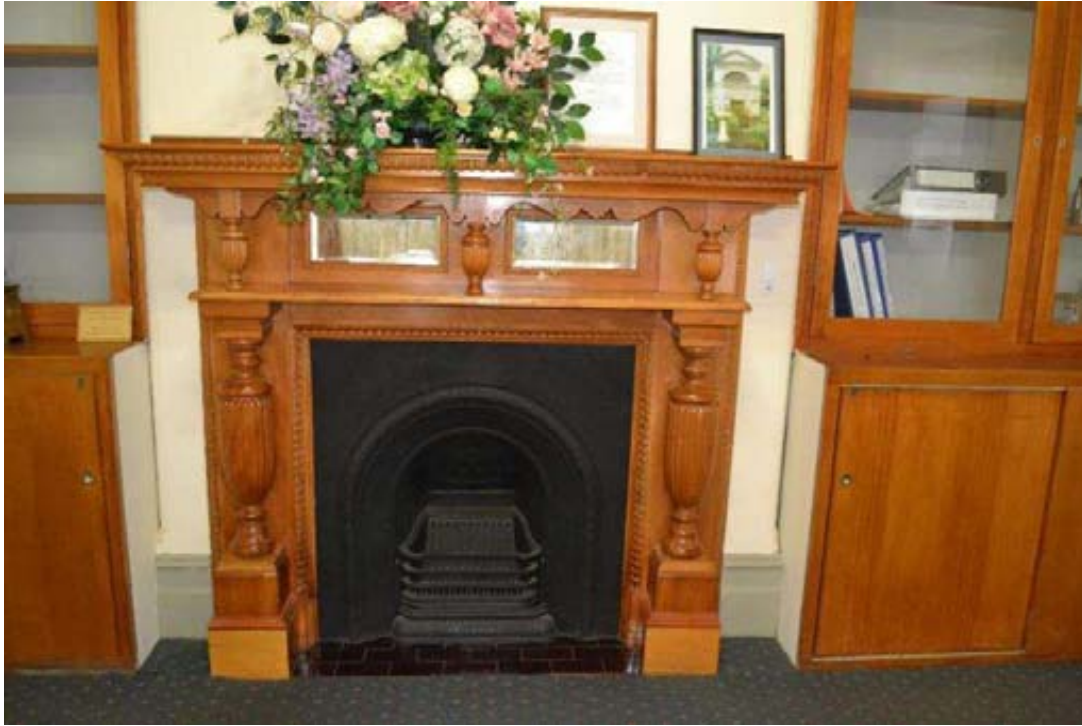
**Figure 138: Room 36, ground floor**

*The flanking cupboards and ceiling light and fan were added c.1990s. The mantel is the original, returned by family members in 1991.*

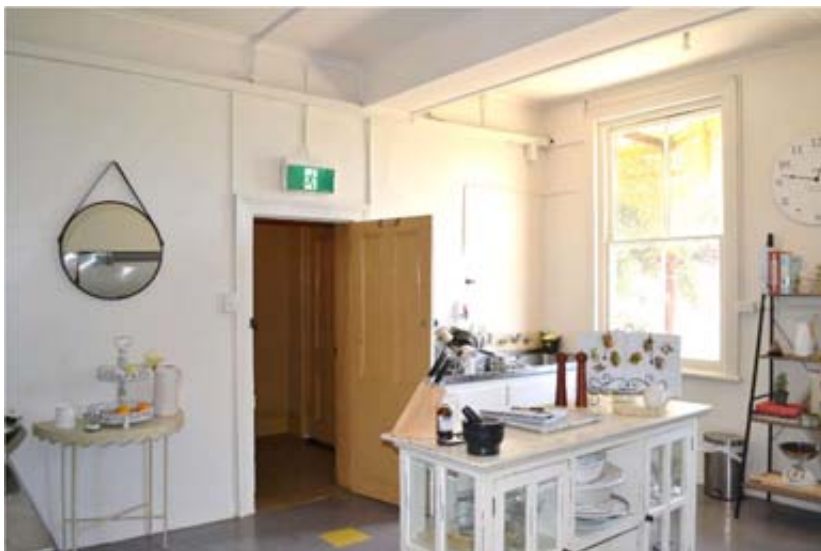
Following the sale of the property the commercial fittings in the kitchen have been removed and replaced with domestic appliances.

*Figure 141: The kitchen, Room 23, lower ground floor*

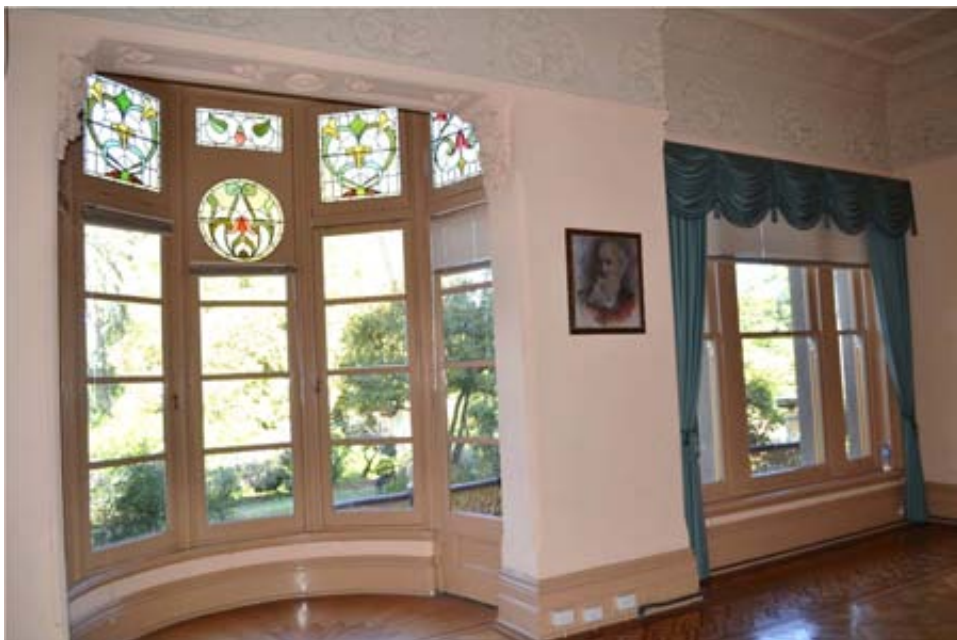
The former main bedroom is located on the ground floor (Room 42), facing west (Figure 143). This room was refurbished in 1904 and has an elaborately decorative plaster ceiling, parquet floor and bow windows. Some of the original lead lighting to the window has been replaced with clear glazing. The adjacent room (Room 43) was remodelled at this time to form a dressing room. It has built-in floor-to-ceiling panelled varnished timber wardrobes and shelving on the north wall. Two of the wardrobe doors open to reveal a marble bath and basin (Figure 146, Figure 147) – an unusual feature. Nickel-plated plumbing fixtures are original. The bow window in this room retains its original lead lighting.

*Figure 143: The main bedroom (Room 42), ground floor level.*

*The plaster ceiling decoration and bow window (altered) dates from 1904.*

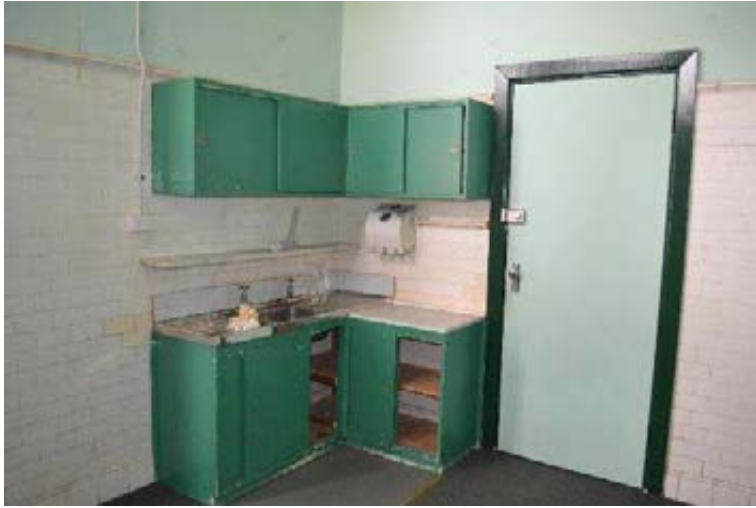
*Figure 151: Room 46, former bathroom, now kitchenette*

Remnants of a third bathroom survive in Room 46, now used as a kitchenette (Figure 151). This small room is believed to have originally been a dressing room c.1900, and refurbished as a bathroom in 1907. All that survives is a dado of white glazed tiles, partly obscured by relatively recent kitchen cupboards and fittings. Fluorescent light fittings, carpet and vinyl flooring are also recent.

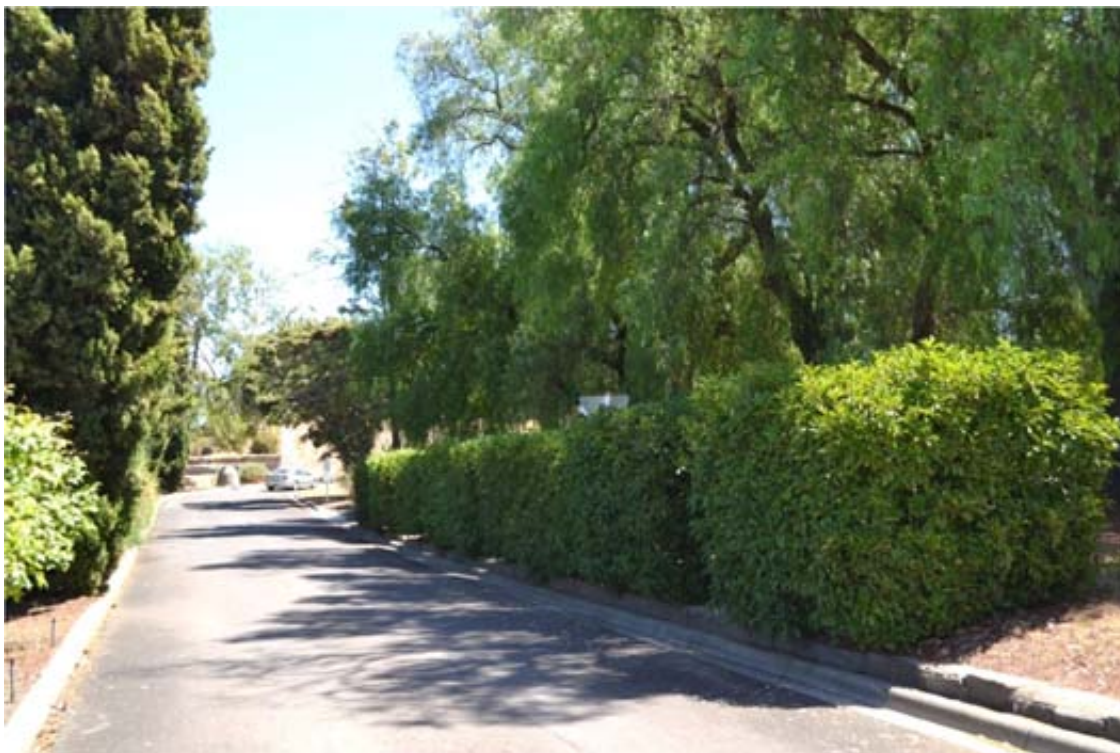
*Figure 171: Driveway, from the Chum Street entrance*

Retain driveway alignment. Remove concrete edging and replace asphalt with aggregate finish.

**Policy:** The current drive and edging may remain, but if alterations are planned in the future the asphalt should be replaced with an aggregate finish and suitable edging installed. The row of Peppercorn trees to the north of the Chum St alignment of the driveway (Figure 171) are of primary significance and should be retained and conserved.

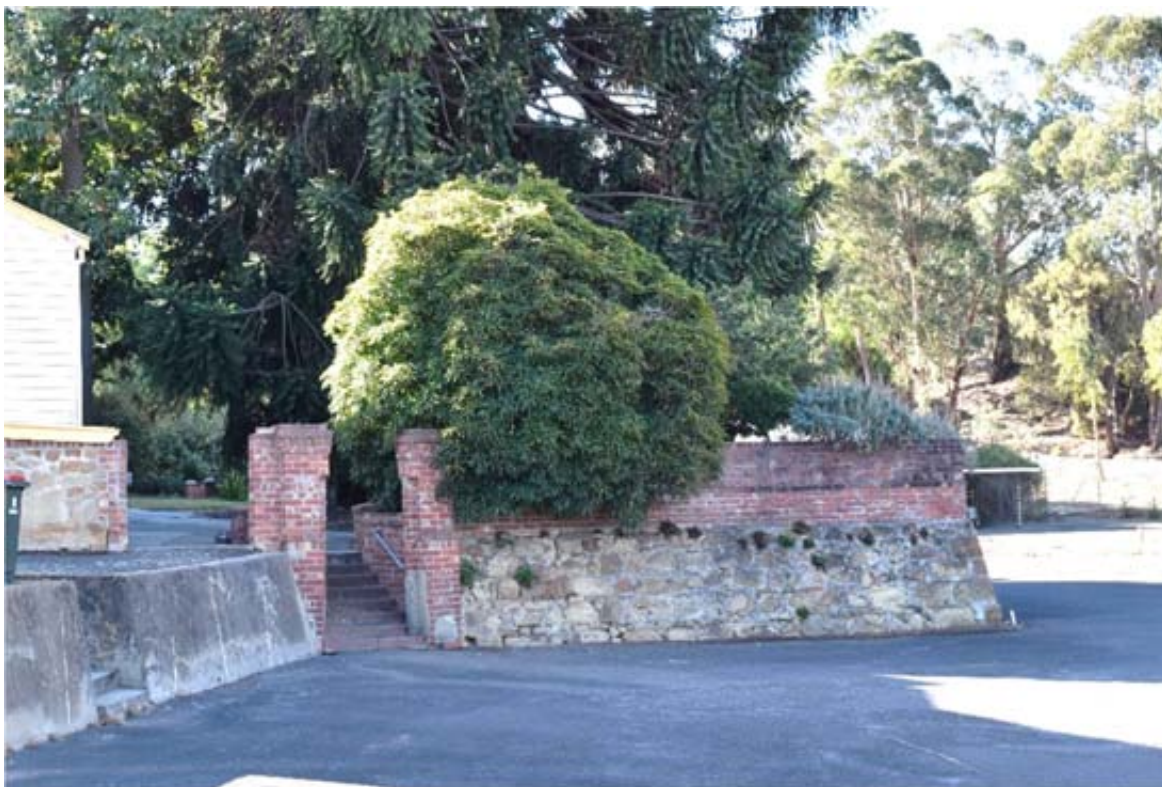
*Figure 174: South garden wall*

The south wall has been largely altered with some sections replaced towards the western end, where concrete blocks have been used to reconstruct the alignment. The south section of wall also contains a pair of red brick piers either side of a pedestrian opening. The retaining wall along the southern side of the Wayzgoose Hall is constructed of random rubble.

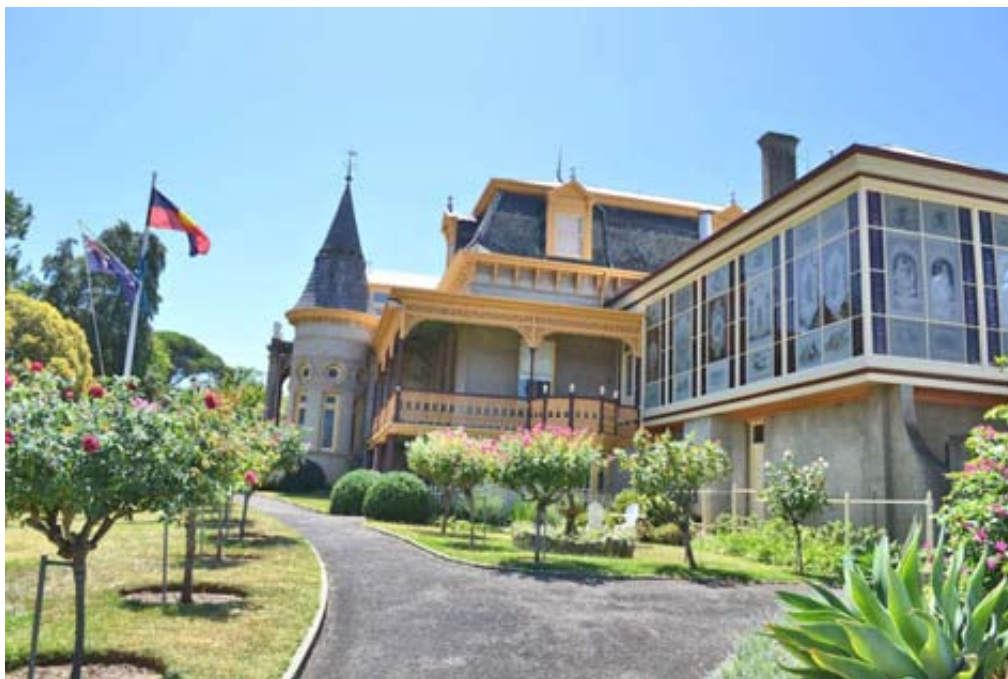
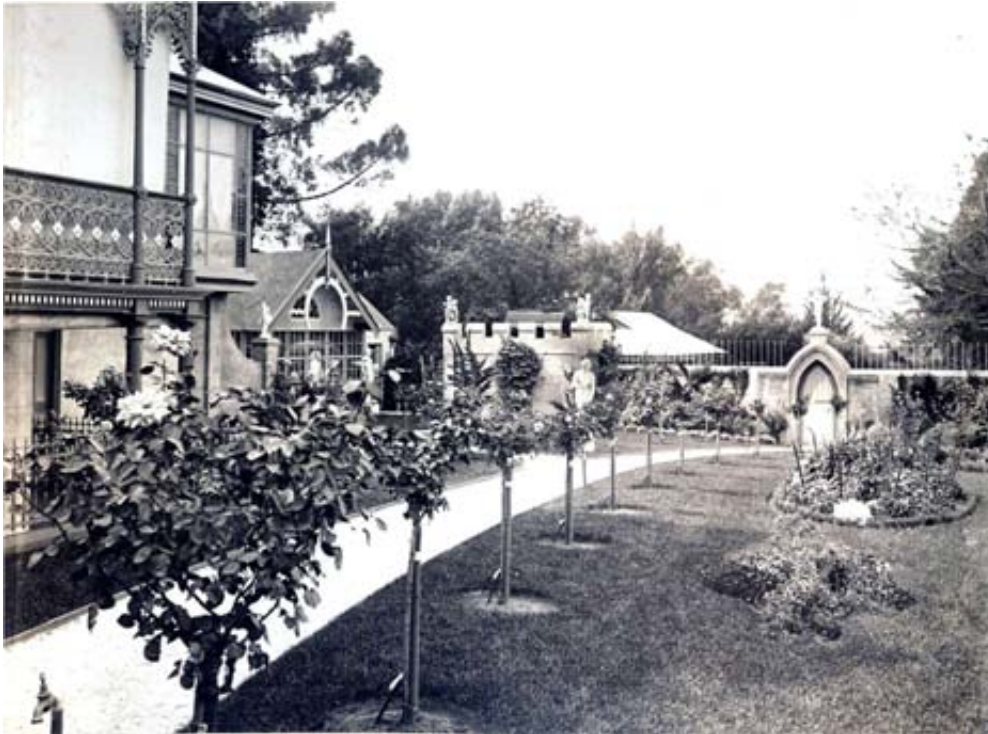
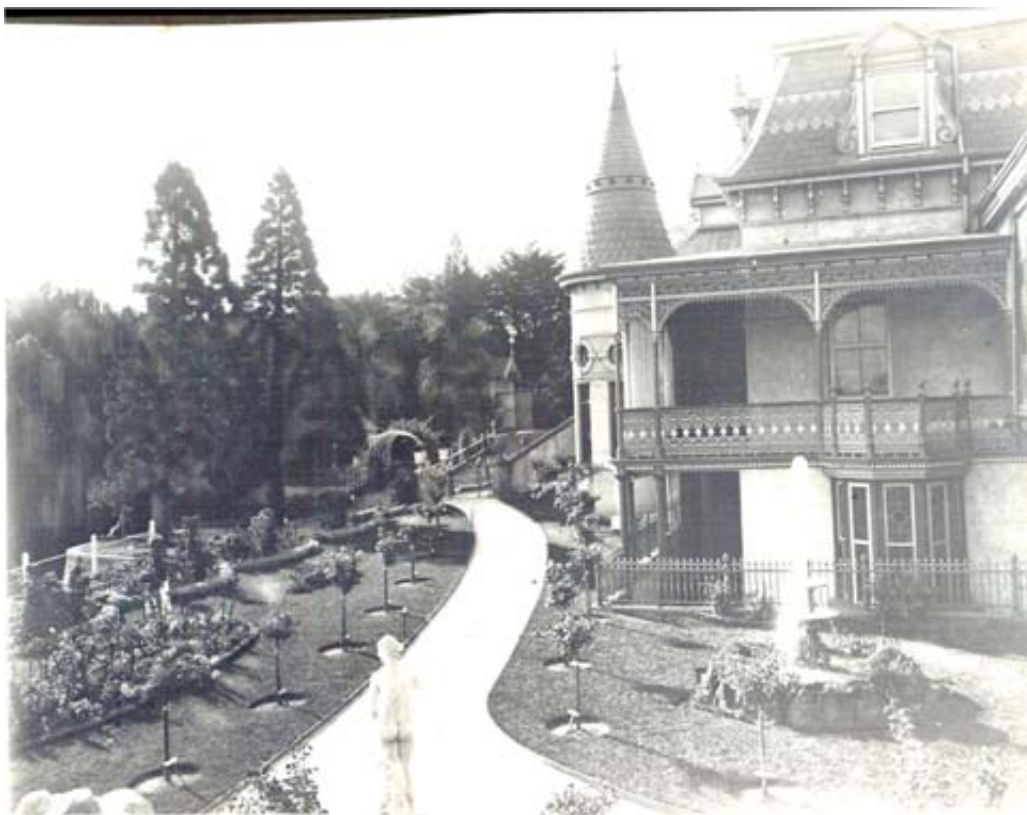
*Figure 179: Garden and fountain south of front entrance*

Where reconstruction of the south wing west verandah was undertaken in recent years the posts and lacework panels have been incorrectly spaced (See Figure 179, Figure 180, Figure 182.) Photographic records exist of the original design which should be reconstructed.

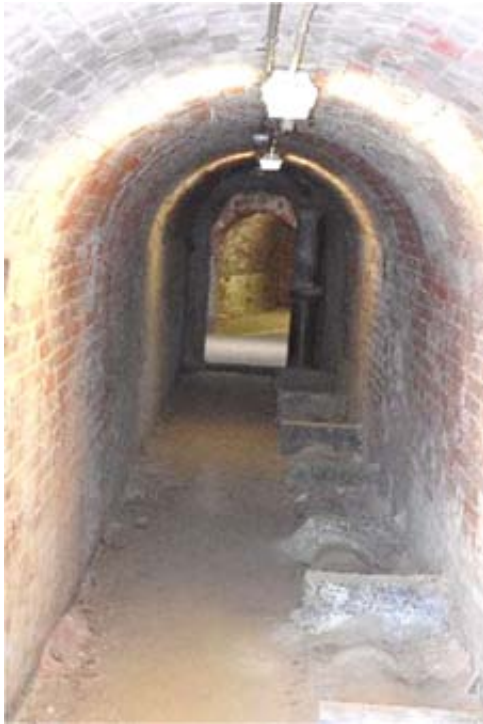
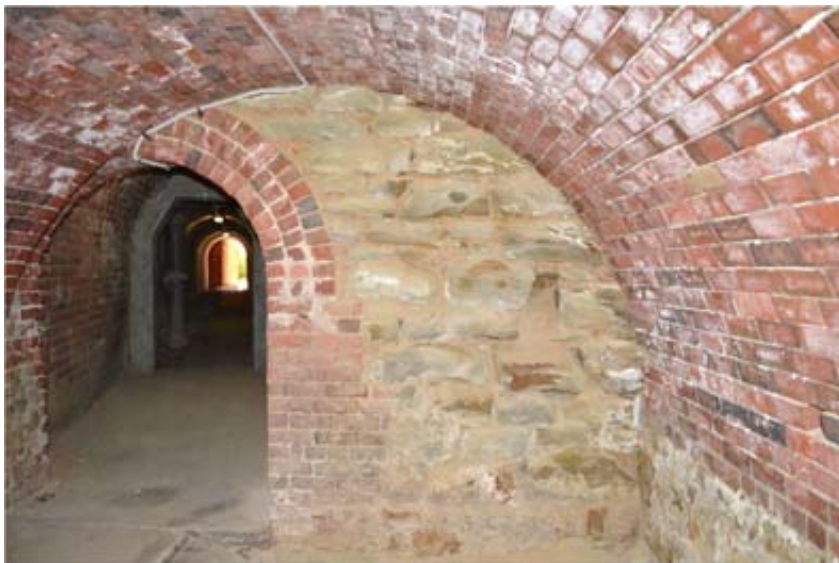
*Figure 187: The tunnel looking west*

*Note salt glazed drainage pipes on the right.*

*Figure 188: Tunnel interior looking East*

The tunnel has been constructed in two phases, the eastern section being the earliest. Both ends of the tunnel have been partially bricked up and doors fitted. This has severely restricted the flow of air through the tunnel and contributed greatly to the build up of damp and salts in and on the brickwork and their deterioration.

Repoint brickwork where missing and deteriorated.

Replace eroded bricks.

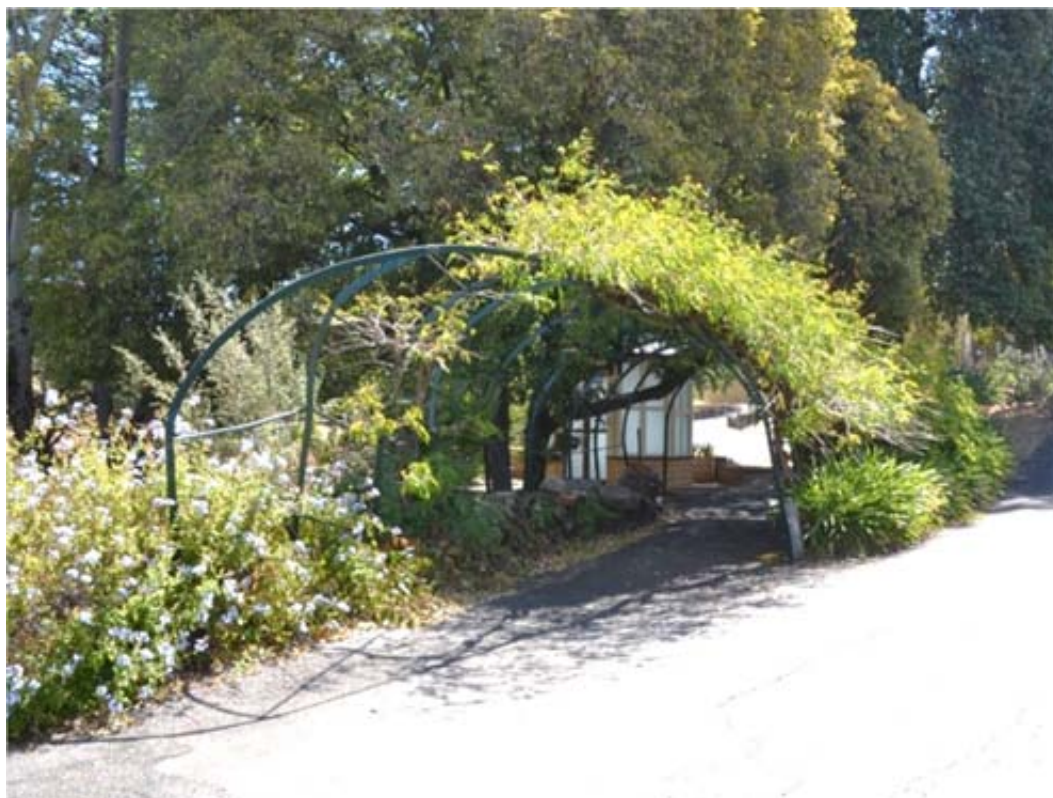
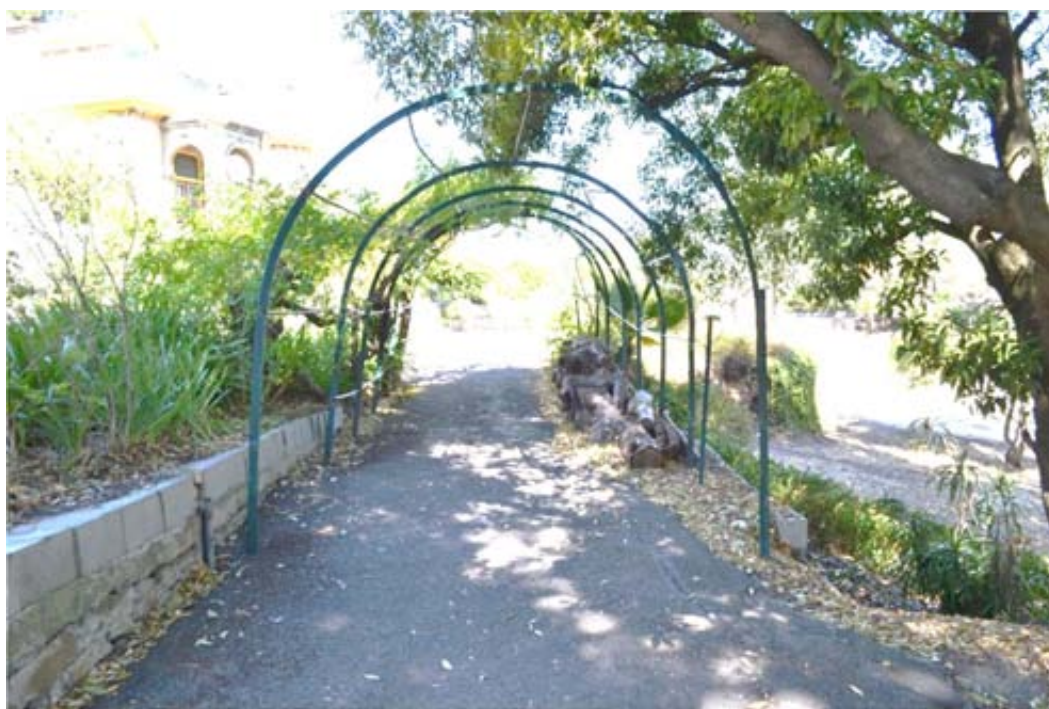
*Figure 190: Arbour from the south*

*Figure 191: Arbour from the North*

**Policies:** Remove bitumen and replace with compacted gravel type material. The steel framing of the arbour has been distorted out of shape over the years and the stone retaining wall on the western side of the arbour requires repair. The arbour should be dismantled, the steel elements straightened and then re-erected in its original position when the wall has been repaired. It was originally painted in a light colour. The sweet pittosporum has been trimmed. Two fence posts next to the Wisterias adjacent to the arbour are remnant of the fence visible in the 1907 photo and provide physical evidence of the post design. They should be retained.

The sweet pittosporum should be trimmed back to allow more light onto the arbour. As the wisteria senesce, they should be removed and replaced with climbing roses to re-create the original planting of the arbour.
