# *FORTUNA VILLA CONSERVATION MANAGEMENT PLAN REVIEW 2016*

PREPARED BY MINERVA HERITAGE FOR FORTUNA PTY LTD JUNE 2016

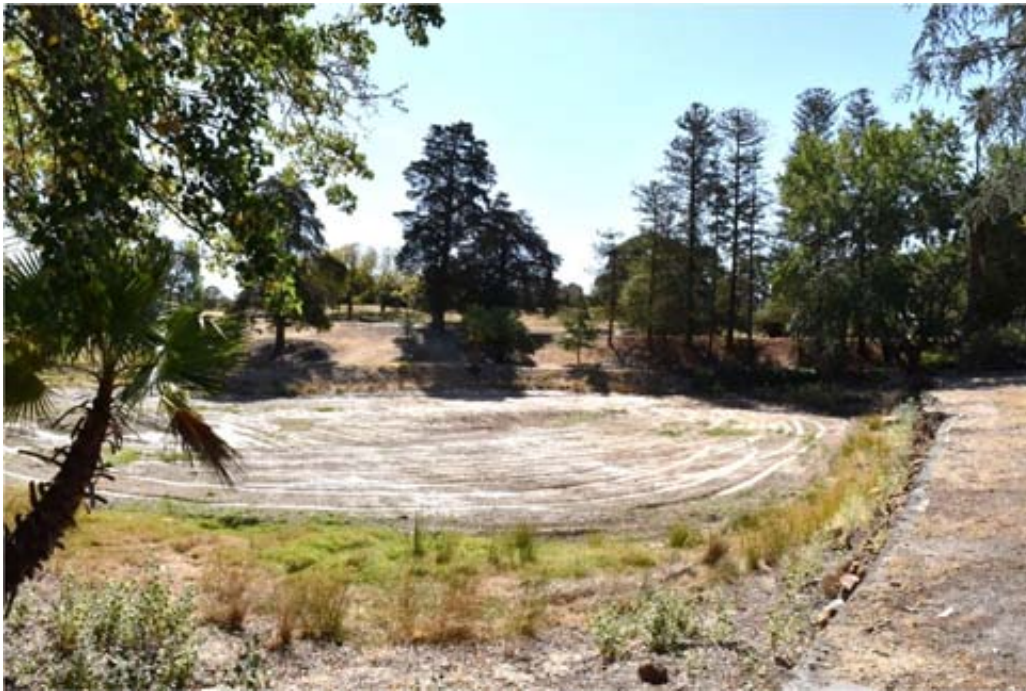
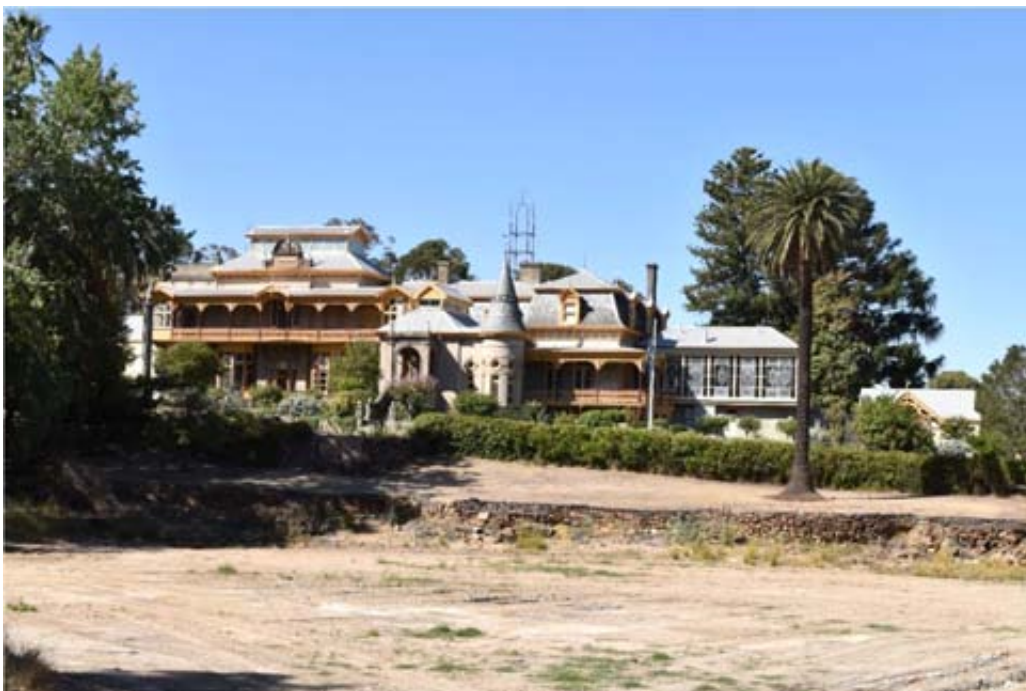
*Figure 193: The lake from the south*

*Figure 194: The lake from the west*

The lake is an early landscape feature, dating from at least c.1895. The stone edging is largely intact, although unsympathetic repairs have been made in places. A number of the mature Canary Island and Thread palms, Blue Atlas cedar, cypress, and Norfolk Island pines would appear to be early plantings around the lake area, with later additions of poplars and willows.

Retain form and fabric of lake and retain and protect early plantings. Reverse unsympathetic repairs to retaining walls and conserve to match existing.

As for all specimen trees, seedlings should be propagated from each of the significant trees for their eventual replacement.

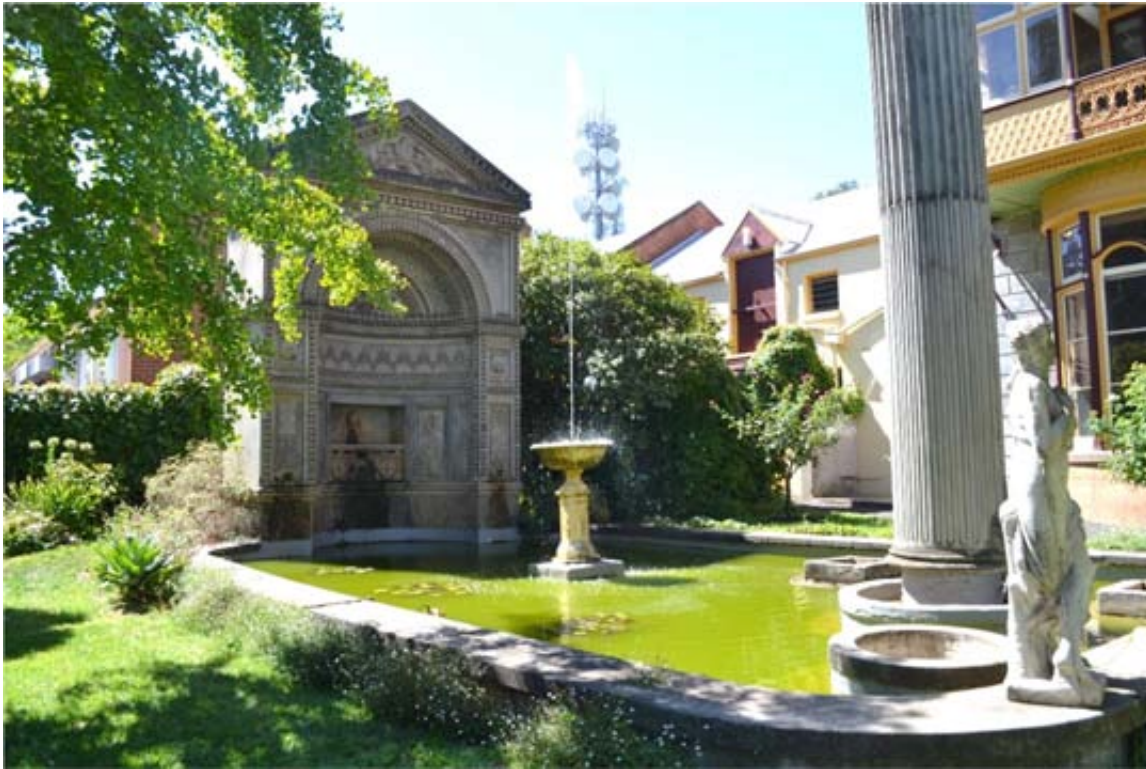
*Figure 205: The Pompeii Fountain from the south-west 2016*

Repairs are required to the rendered elements and plumbing in a number of locations. The fountain has been made partly operational.

The column is rendered over an iron core structure which is showing deterioration at the base on the Southern side.

Restore damaged stucco elements. Restore the fountain to working order.

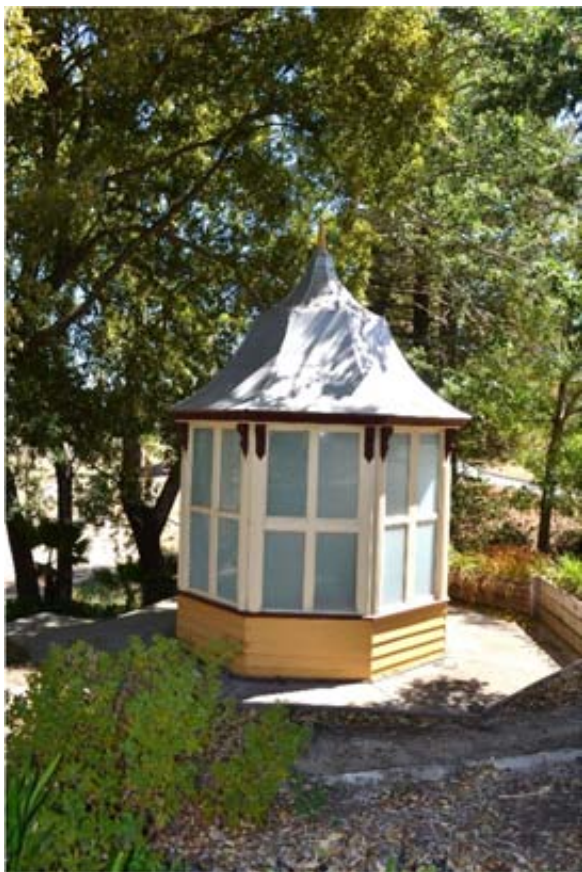
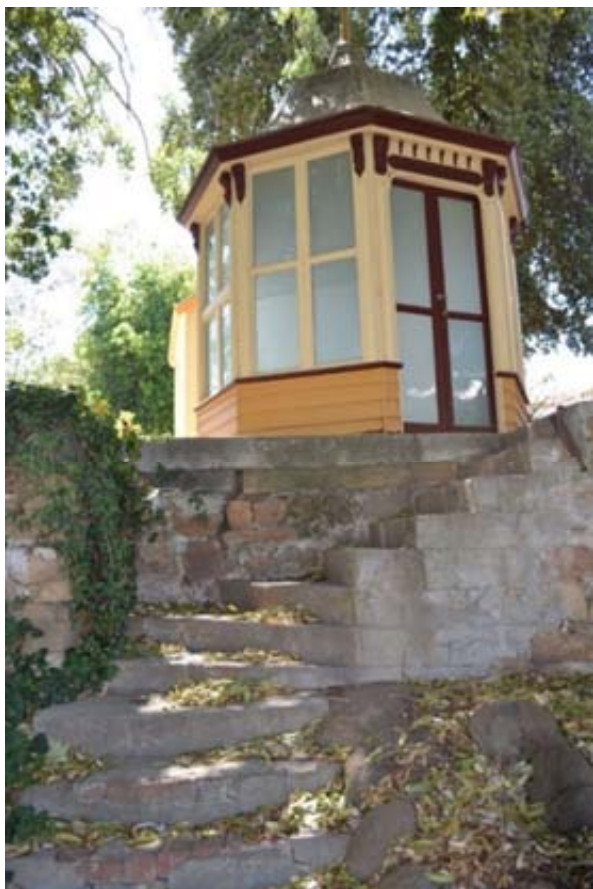
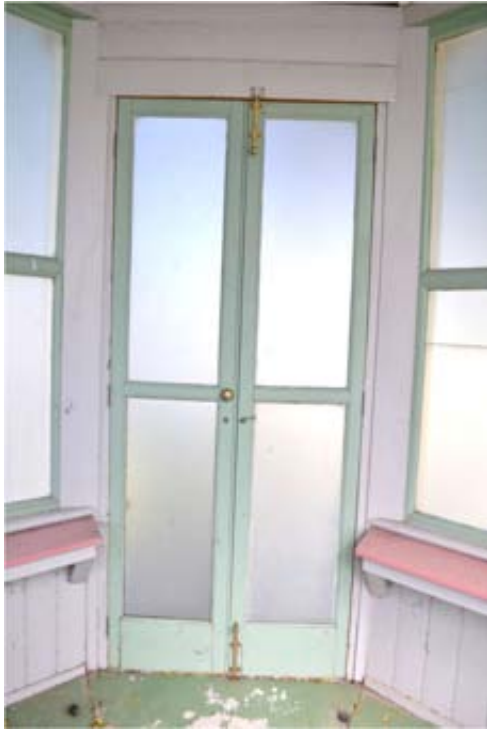
*Figure 212: The summerhouse*

*Figure 213: The Summer House from the south with steps to the lake*

*Figure 214: Interior of the summerhouse*

The roof was originally covered with horizontal zinc sheeting. The finial was capped with a timber orb. The sides originally had timber venetians with French doors at the entrance. The frosted glass is not original. Sections of timber are displaying excessive degradation and require maintenance. There was a balustrade along the retaining wall on the southern side of the summer house which should be reinstated. The Army Survey Mark in the floor should be retained.

Prune back tree over roof and finial to avoid damage.

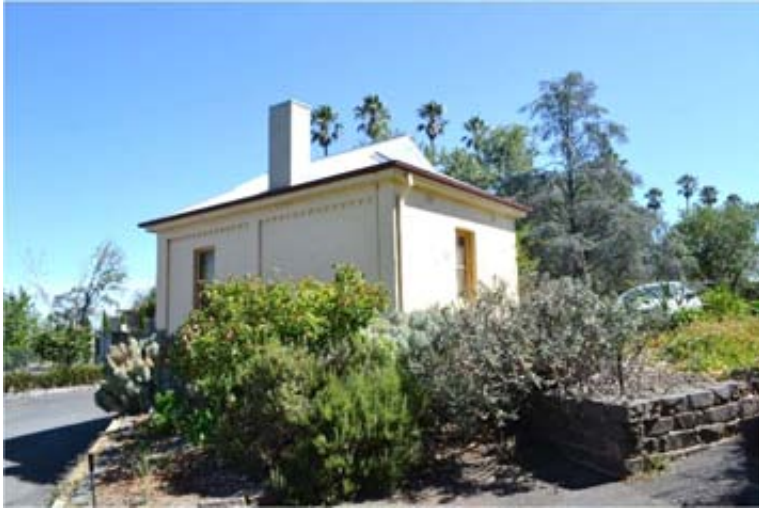
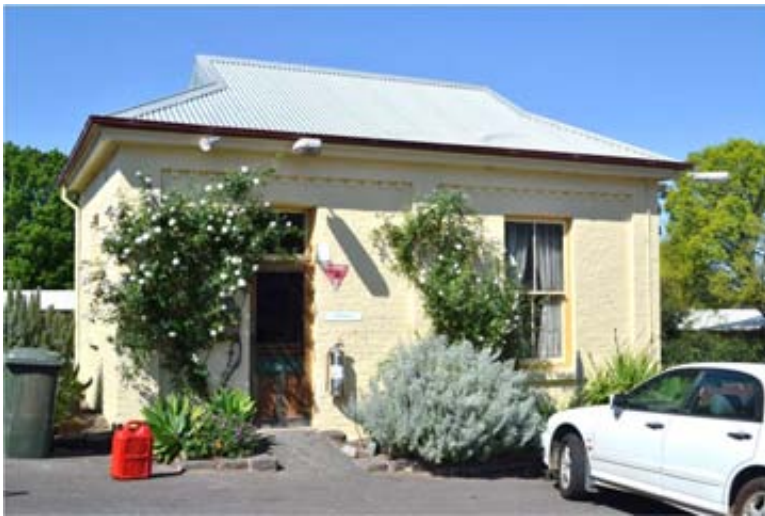
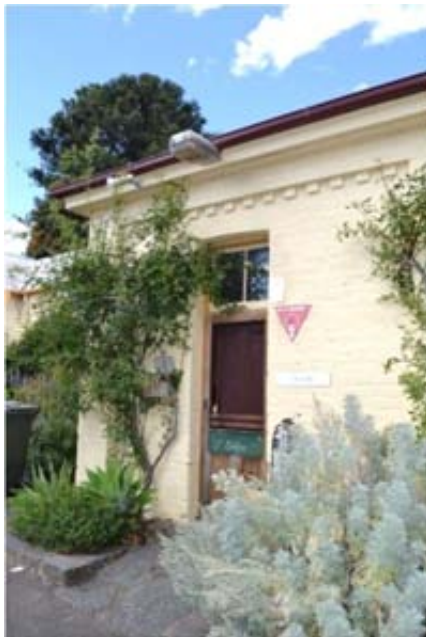
*Figure 221: The laundry from the South-East*

*Figure 222: Laundry from the East*

*Figure 223: The Laundry door*

Recently repainted. Paint should be removed from brickwork. All original internal features of the laundry to be retained, including stove, fireplace, mantel shelf and copper. The concrete floor is early and may be original.

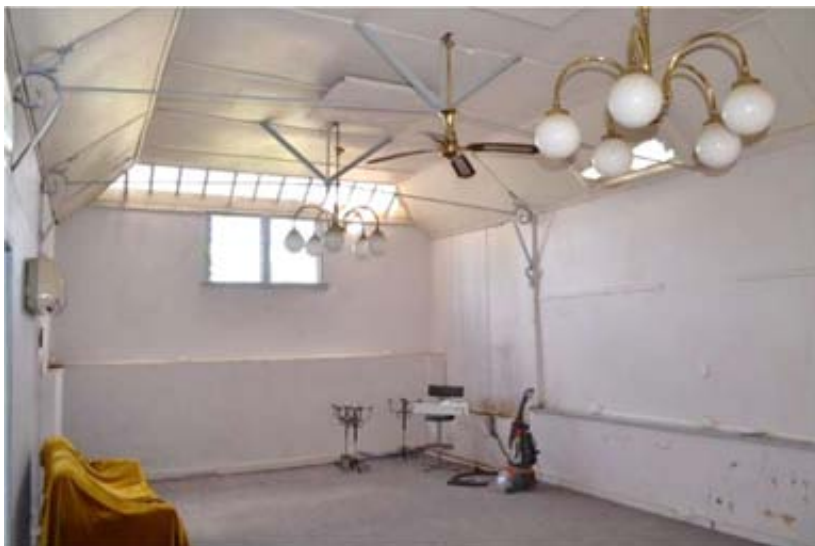
*Figure 229: View of the interior of the former shade house*

The interior has been substantially altered by its conversion to an office (Figure 229).

Demolish rooms 3 and 3A.

Reconstruct original external wall and roofing trellis where photographic evidence survives.

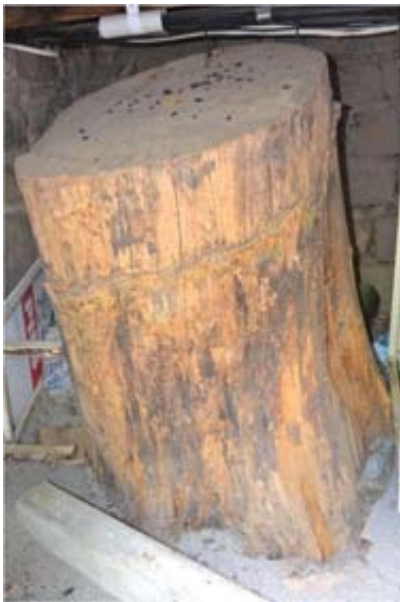
**Figure 232:** *Stump, possibly from the first stamper head*

It is likely that this is the stump referred to as there had been a conscious effort to retain and protect it.

**Policy:** The stump is of historic significance and should be retained and conserved by keeping it in its shed.

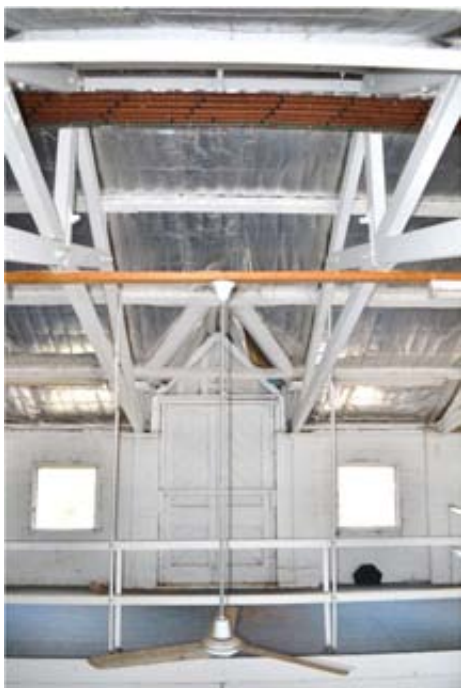
*Figure 235: Former stables interior roof*

Internally, the space has been substantially altered by the forming of an opening in the centre of the former loft floor. The original timber post supports for the loft have been replaced with suspension rods from the timber roof trusses.

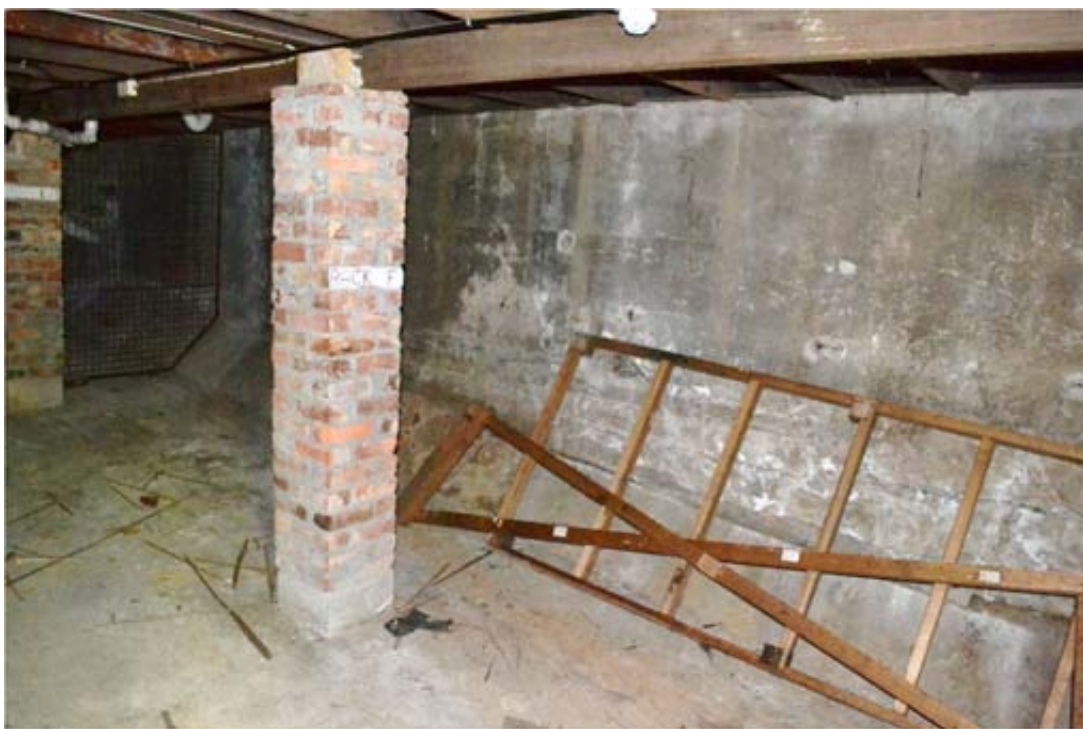
*Figure 243: The original sloping concrete surface of the pool is extant.*

*Policy:* If restored to a bath the original cement rendered appearance of the walls and bottom of the bath should be retained.

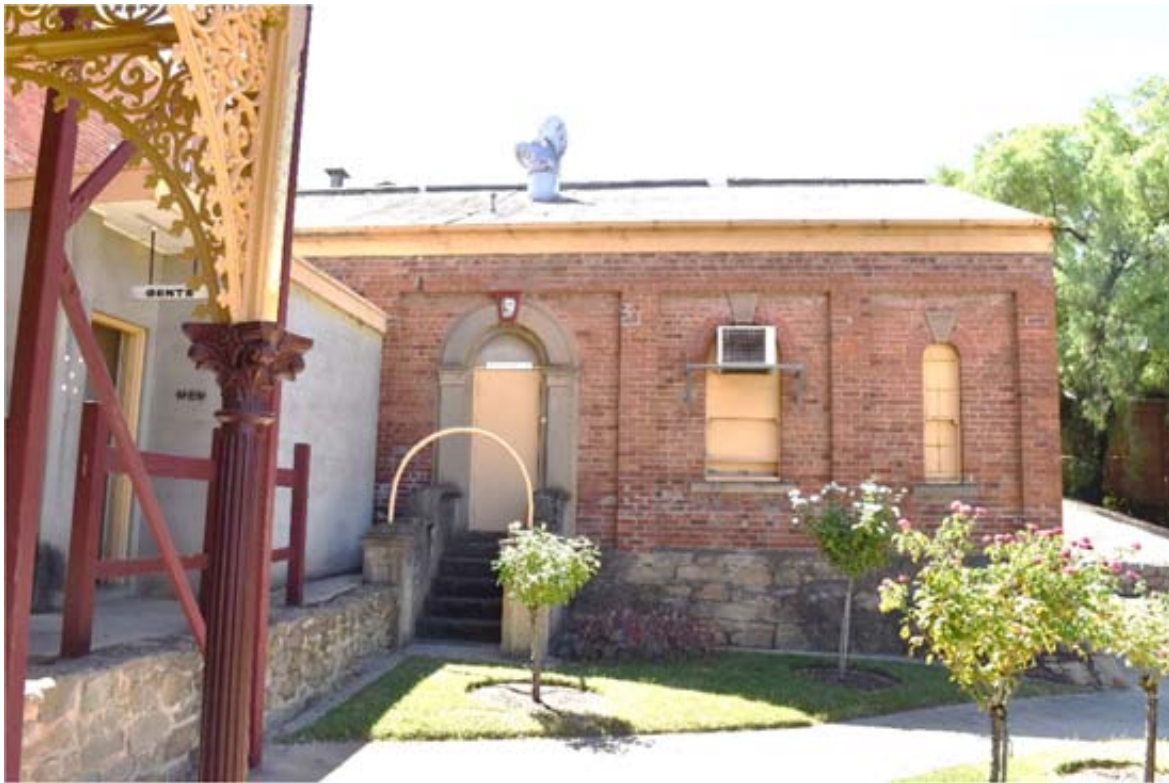
*Figure 245: Exterior of the swimming bath from the south*

Window openings on the east and south elevations are semi-circular arched with vermiculated stone keystones. The original entrance remains, though not used, on the south elevation, accessed by a short flight of bluestone steps (Figure 245). The semi-circular arched opening is flanked by rendered pilasters with moulded caps.

Reconstruction of the swimming bath, including demolition of the roof, floor and interior partitions is recommended.

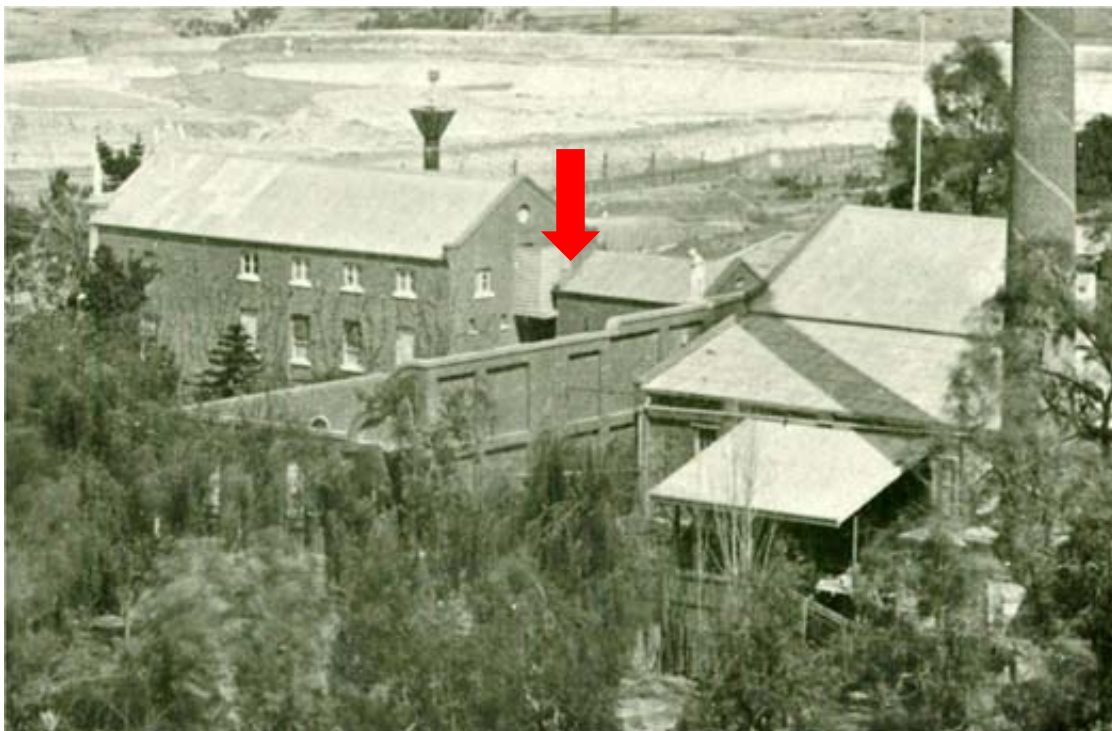
**Figure 248: 'Mr Lansell's bath'**

The wall of 'Mr Lansell's Bath' was damaged when the chimney stack of Lansell's new crushing battery fell during a violent storm in 1874. As can be seen in Figure 248 the north wall was originally higher.

The rooms at the rear of the baths with arched openings run under the extant coach house and possibly predate it. They were most likely related to Ballerstedt's retort and treatment works (arrowed in Figure 248). Portion of an original Ballerstedt era building stonework wall is exposed at the rear of this structure.

*The bath and retort room can be seen in this detail of an 1879 photo by N J Caire.*

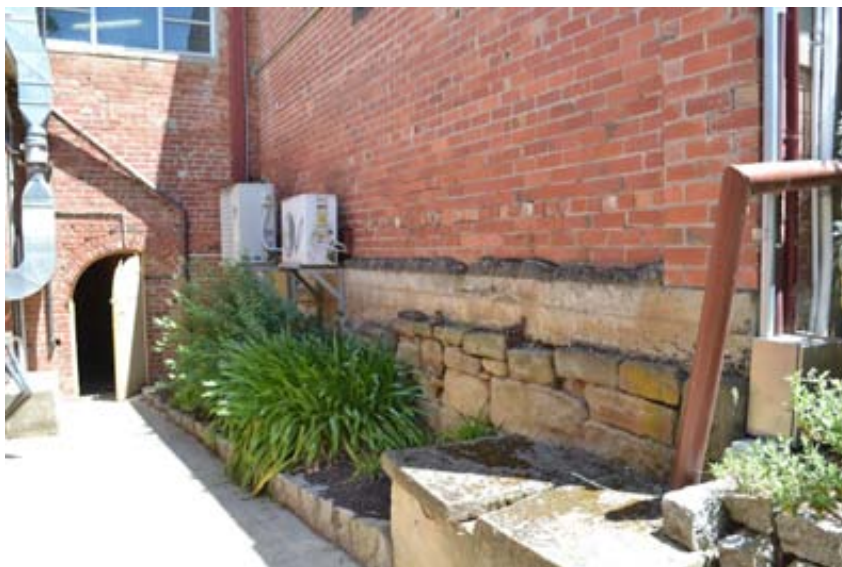
This building is incorrectly identified in the 2002 CMP as the Lansell battery which was modified by the inclusion of a weatherboard highlight wall. It is the current battery's predecessor and became the engine house for the extant battery which was built to the north of this structure in 1874 as seen in Figure 254 (2016 Review). It was replaced by building 8F (Photo Printing Building East Annexe), but its stone foundations are extant.

*Figure 259: Stone foundations of Ballerstedt's crushing battery under building 8F*

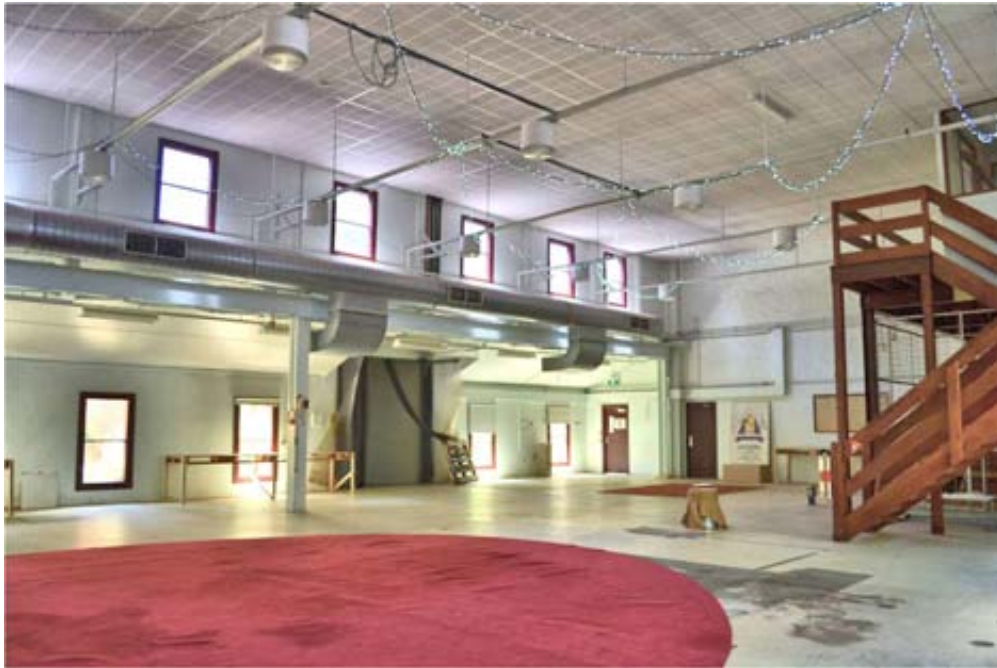
*Figure 262: Interior of the former battery*

Internally, the building comprises a single large room with painted and rendered brick walls, and the floor is painted concrete. The interior has been altered by the installation of a false ceiling and the addition of a mezzanine office in the south-west corner.

A steel mezzanine housing air conditioning plant has been built along the north wall. The west

wall has been altered following its use as a battery with new steel lintels, brickwork and steel framed windows in two bays at the southern end ground floor. A timber beam supporting the upper level wall, a central timber post and the two end posts of the eastern highlight wall are original. This is the last remaining original in situ crushing battery building in Victoria.

Adapt and refurbish the altered interior as required.

**Policies:** All original elements should be retained. The current false ceiling should be removed to expose the original king post trusses seen in the 1945 photo below.

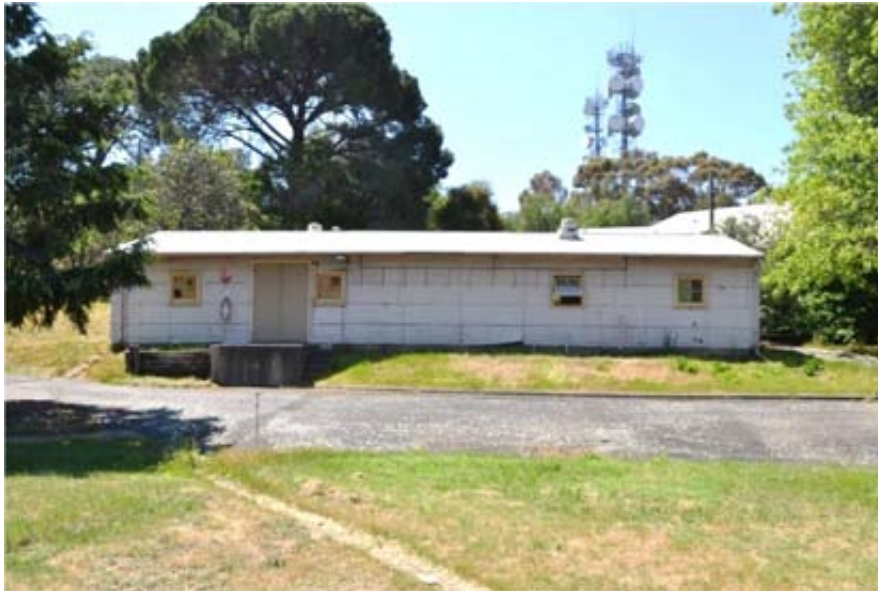
*Figure 270: P1 Hut Former Change Room*

This significant example of a P1 type hut is the only currently known example with steel angle iron posts supporting steel angle iron roof trusses. There is some cladding missing from the north wall and some borer damage to sap wood of some timber elements and the south door has suffered some recent impact damage. P1 huts in their original configuration have become increasingly rare since 2002.

- repair or replace corner cover strips where damaged.
- make roof possum proof. Infill all holes (excluding pipe access) in external walls to exclude vermin.
- refix corrugated galvanised steel sheets where lifted.
- replace external architraves and door frame at back end to match existing.
- repair broken glazing.
- repaint generally.

**Policy:** The P1 hut should be retained and conserved. It may be relocated to another position on the site.

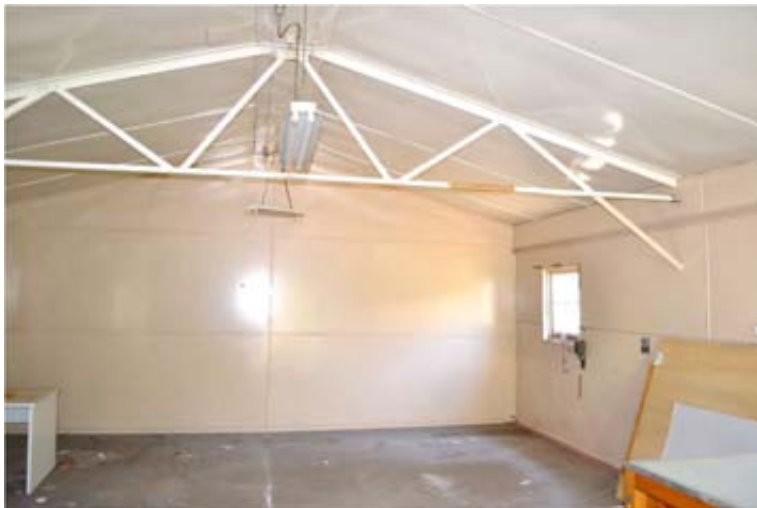
*Figure 271: Steel truss inside the P1 hut*

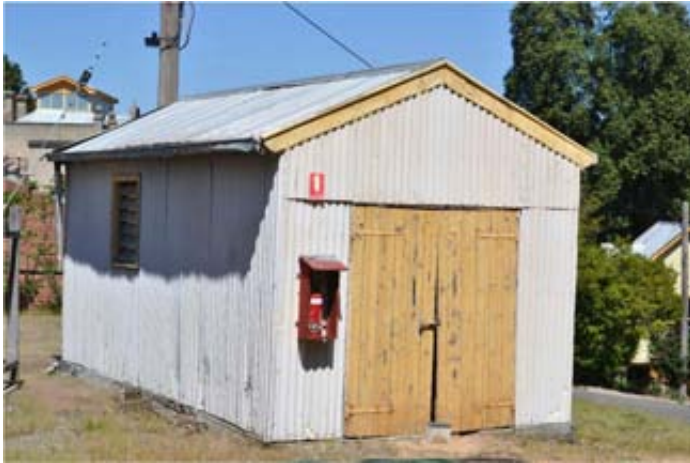
*Figure 273: Building 5 Storage Shed*

The electrical control cabinets and air conditioning units located to the east of Building 5 are intrusive and, when no longer required, should be removed.

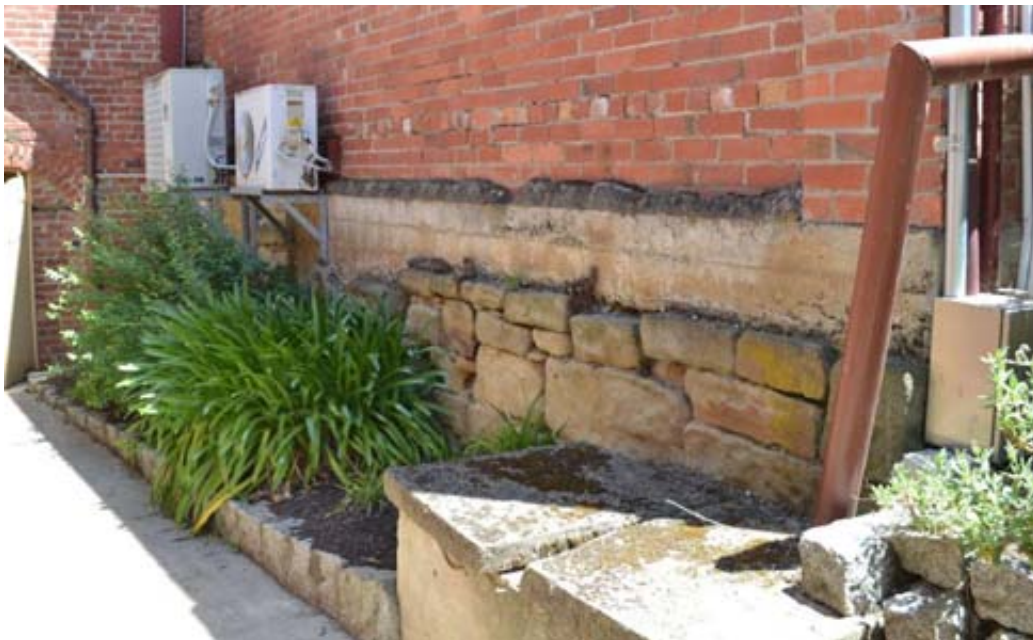
*Figure 279: Stone foundation of Ballerstedts' crushing battery*

*Policy:* Demolition is desirable. If removed no new building or hard surface should be constructed within 5 metres of an original wall. Care should be taken to conserve the stone foundation of the original crushing battery upon which this building was constructed. There may be significant archaeology in this area.

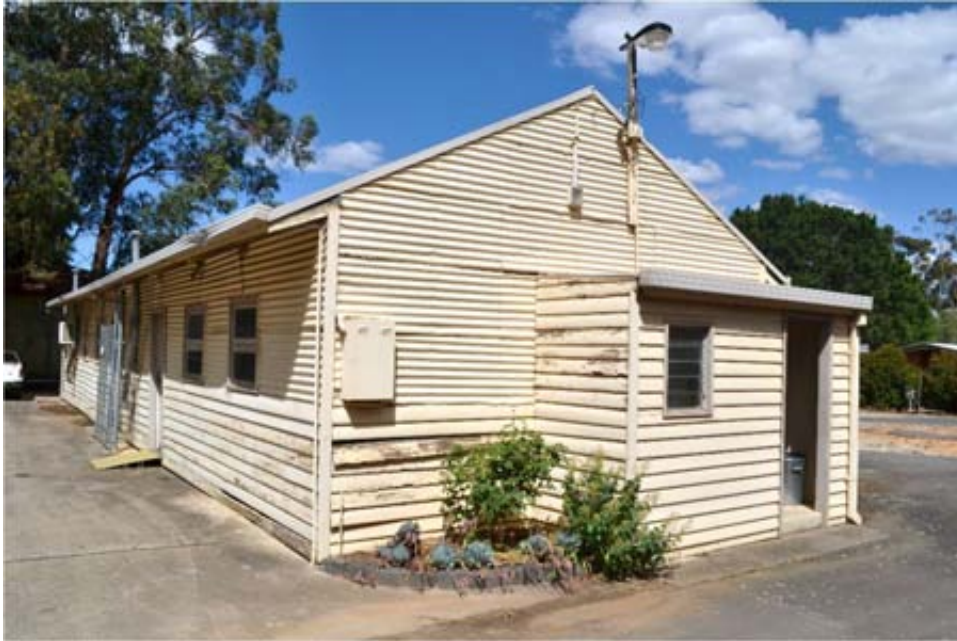
*Figure 282: Building 14 Q Store*

A number of P huts were on the property by 1945 (Figure 272). Intact original P1 huts have become rarer since 2002. With the removal of the front porch this is a good example of a P1 variant and should be retained and conserved. The carport is not physically attached to the building.

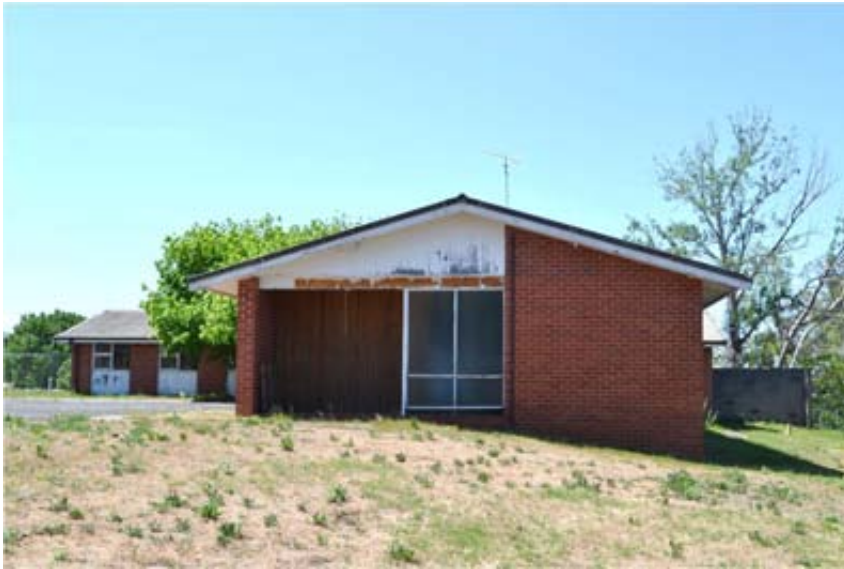
*Figure 285: Building 19 Sergeants' Quarters*

No restrictions on future use/demolition. The building is visually intrusive when view from the west side of the lake, and should preferably be demolished.

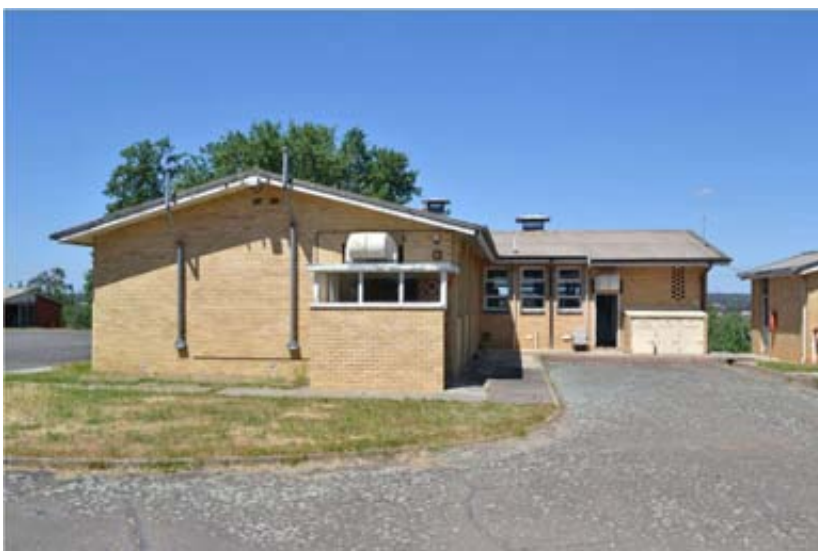
*Figure 286: Building 20 Kitchen and Mess Building*

No restrictions on future use/demolition. The building is visually intrusive when view from the west side of the lake, and should preferably be demolished.

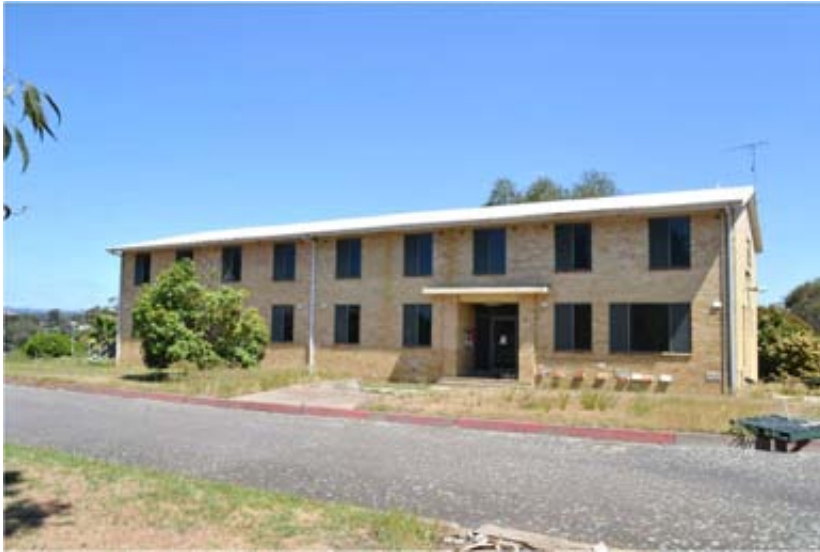
*Figure 289: Building 22 Officers' Quarters*

Building 22 is a rectangular plan, double-storey residential building of cream brick construction with a gabled roof, constructed c.1950s or 1960s. The original steel-framed windows have recently been replaced with aluminium-framed windows, and the roof re-clad in corrugated galvanised steel.

No restrictions on future use/demolition. The building is visually intrusive when view from the west side of the lake, and should preferably be demolished.

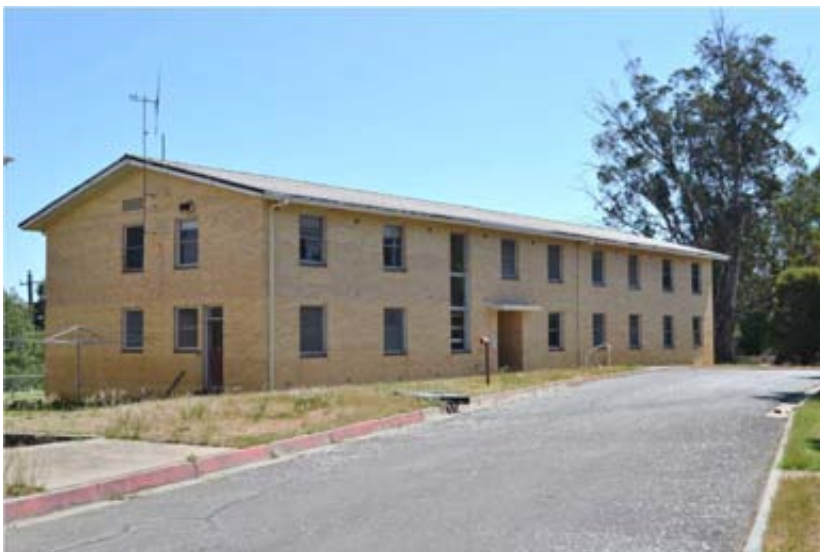
*Figure 290: Building 23 Officers' Quarters*

No restrictions on future use/demolition. The building is visually intrusive when view from the west side of the lake, and should preferably be demolished.

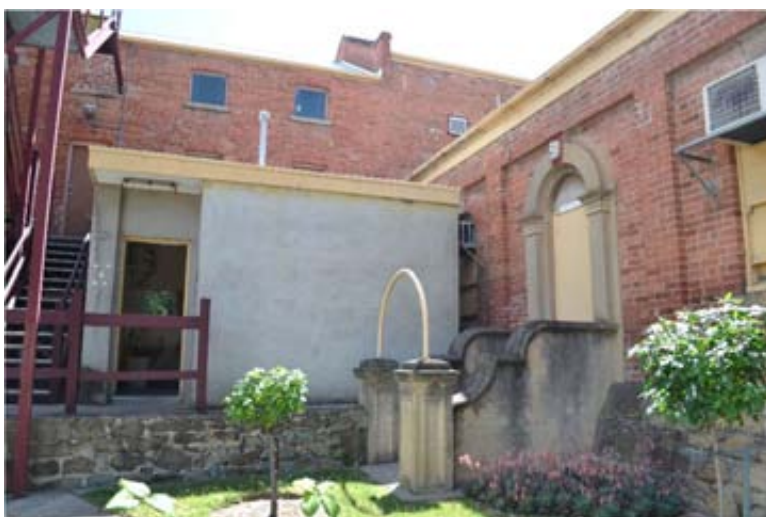
*Figure 293: Men's WCs*

Ensure clear air circulation around building at all times while it remains to protect the walls of surrounding buildings from damp.
